## Home Inspection Report

**4225**

**Arrowhead**

**Memphis, Tn 38118**

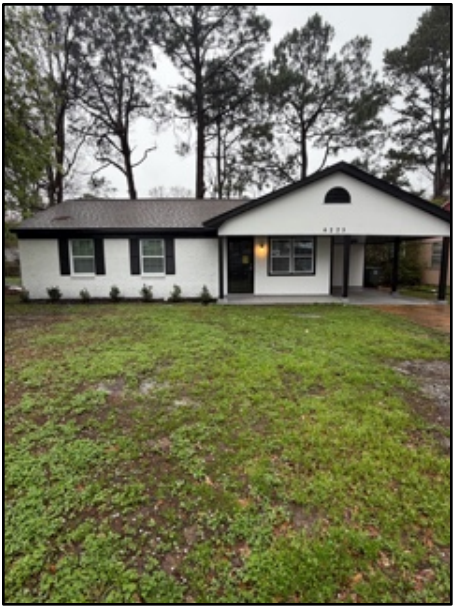
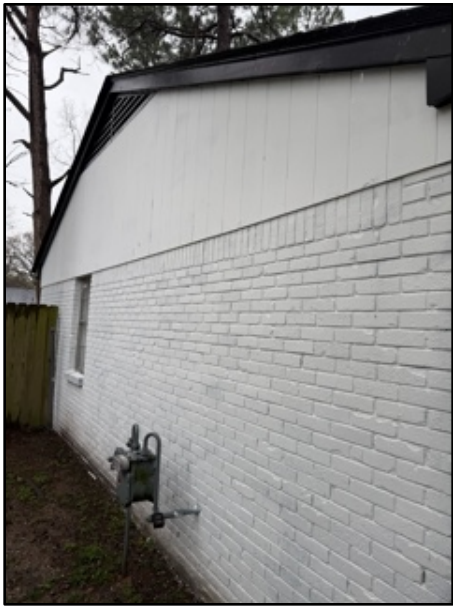
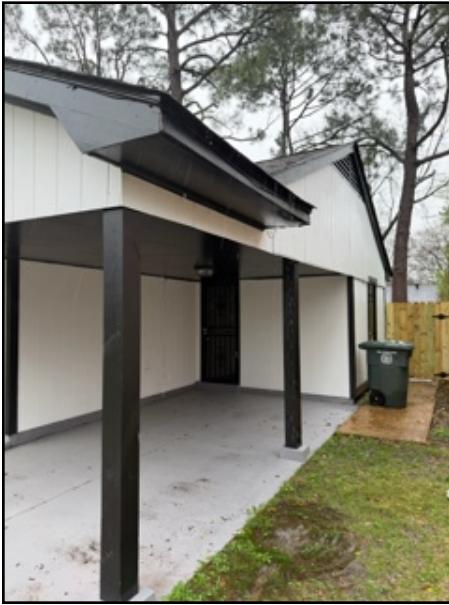
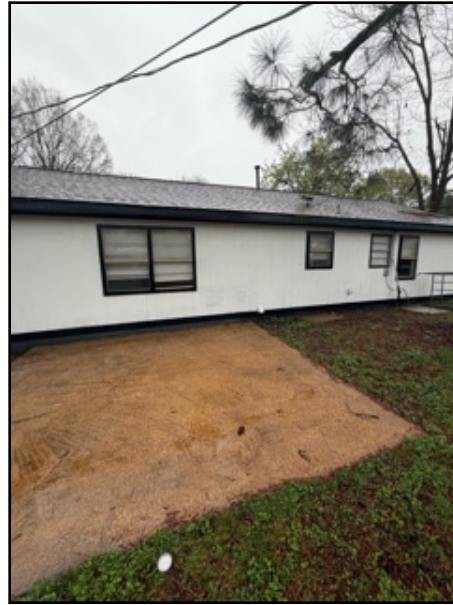
Comment 2:  
General pictures of exterior.

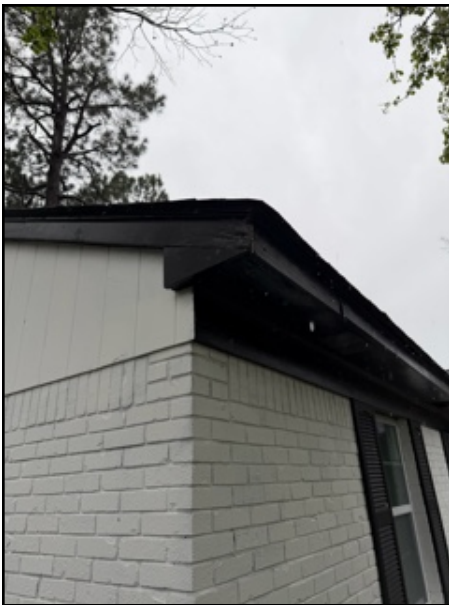
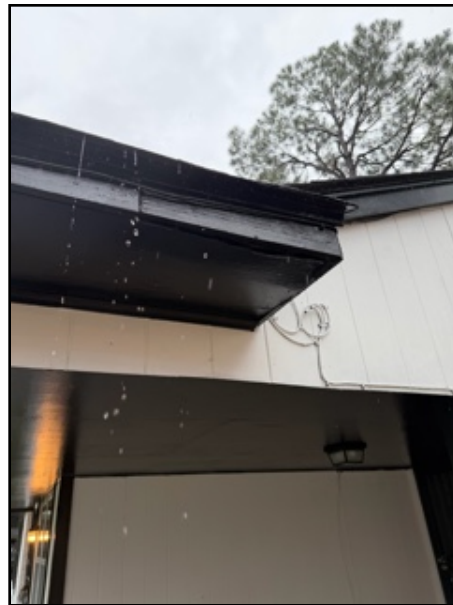
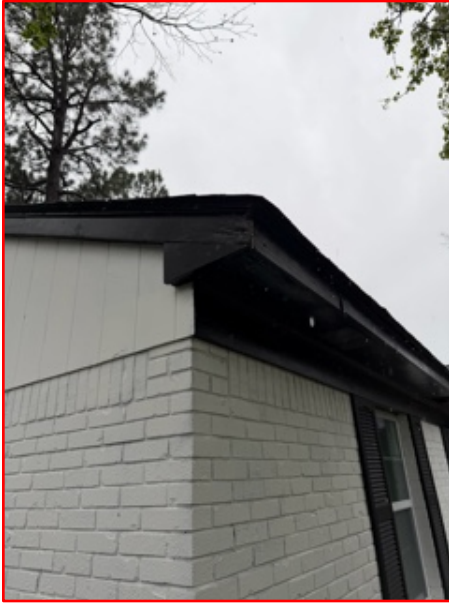
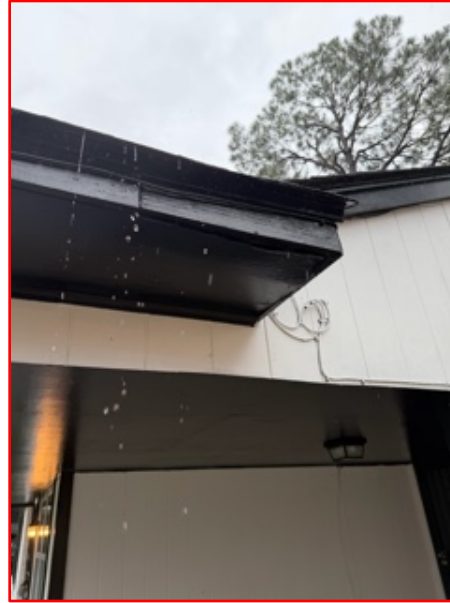
soffit and fascia damage at left front corner and right front corner of house as noted by pictures.

1) soffit and fascia damage at left front corner and right front corner of house as noted by pictures.

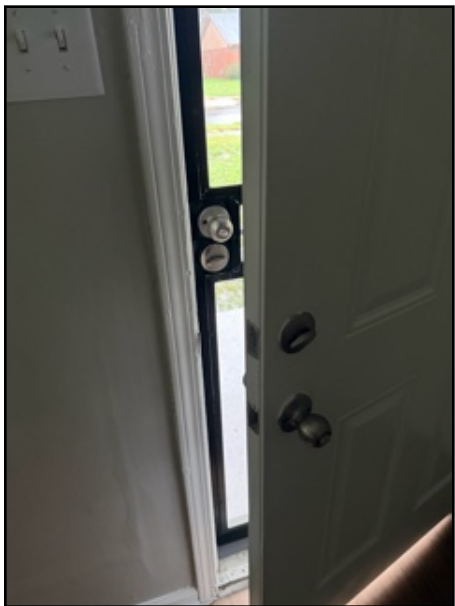
Figure 4-1

Comment 4:  
no doorbell installed at time of inspection.

2) no doorbell installed at time of inspection.

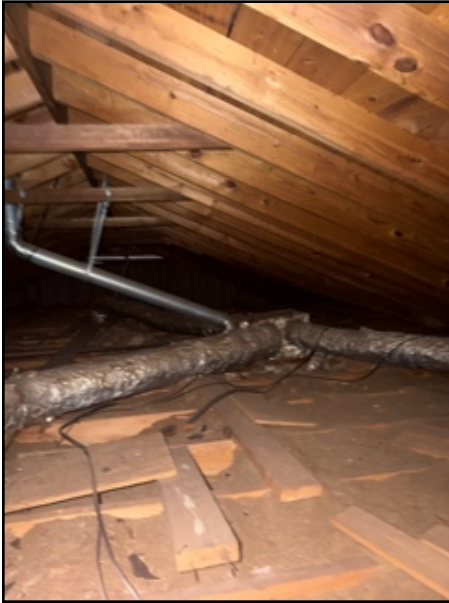
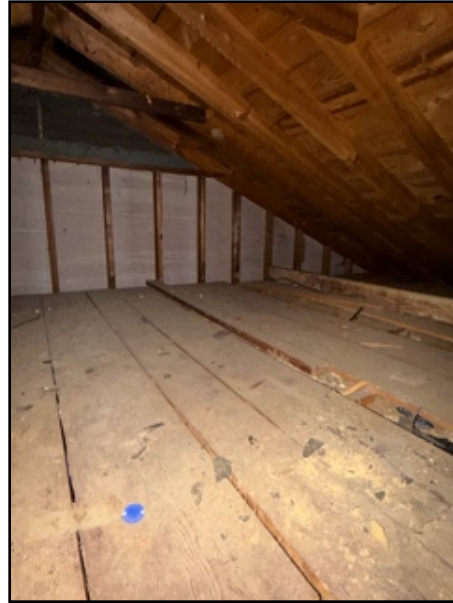
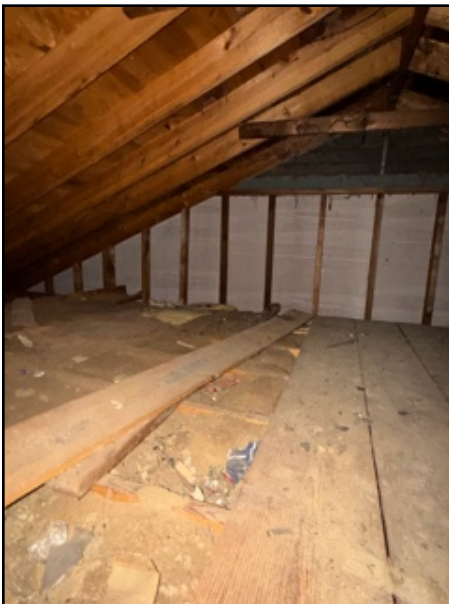
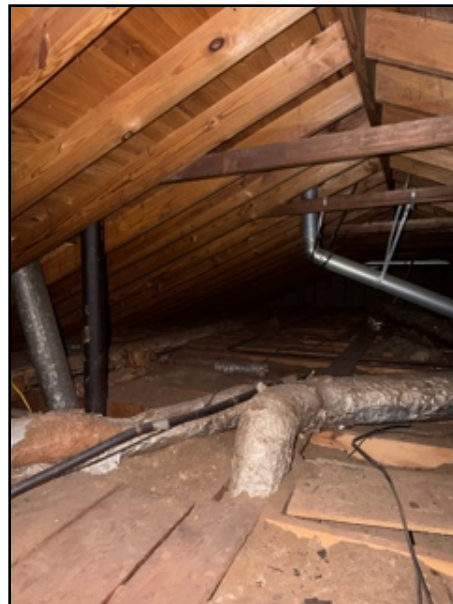
Attic is in good condition.. Framing is sound and there is no evidence of leaks

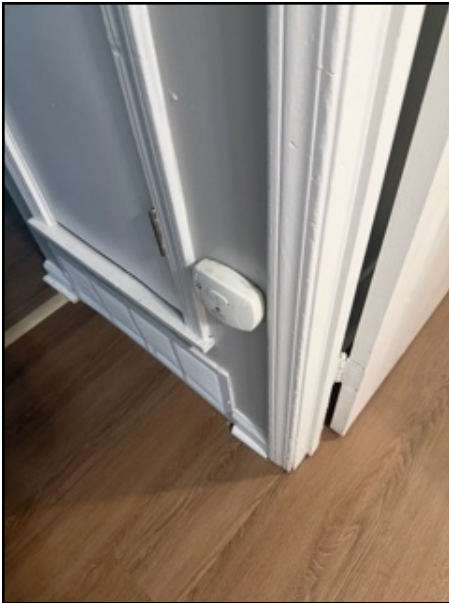
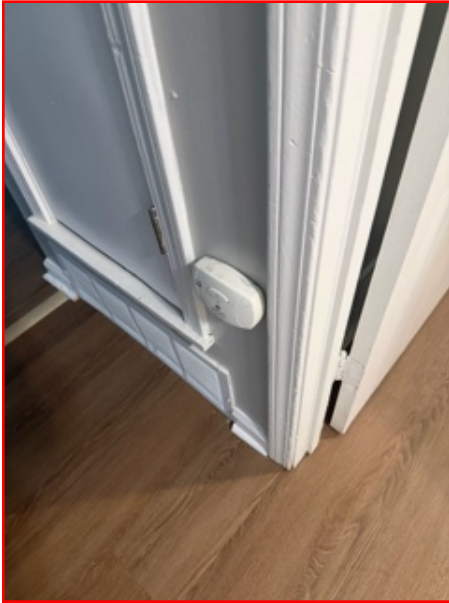
Figure 7-1

carbon monoxide detector should be approximately light switch height.

3) carbon monoxide detector should be approximately light switch height.

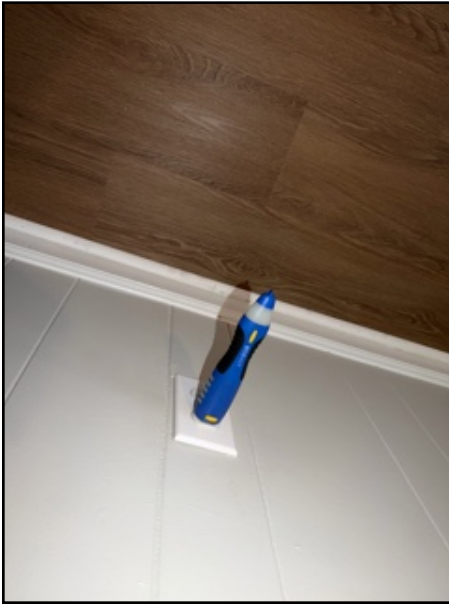
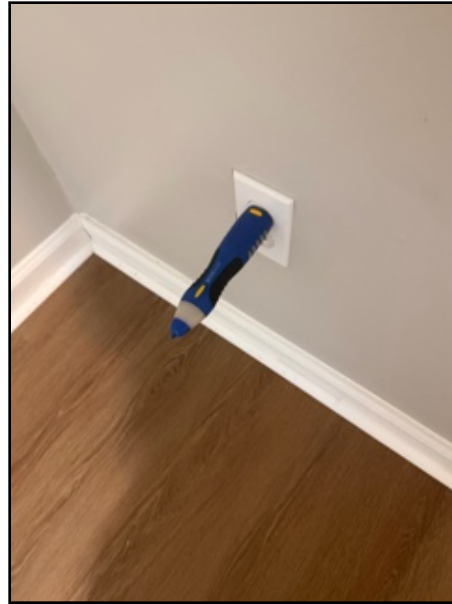
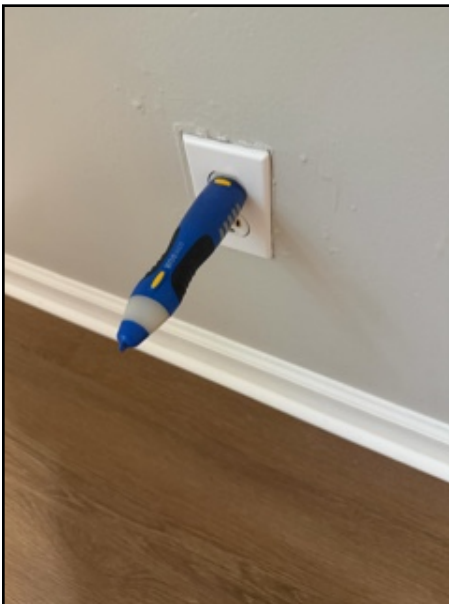
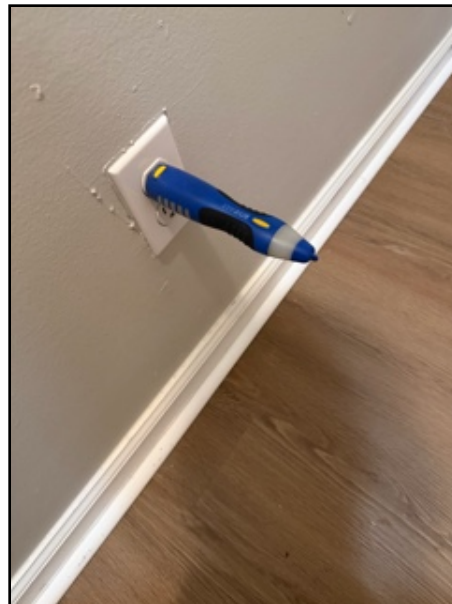
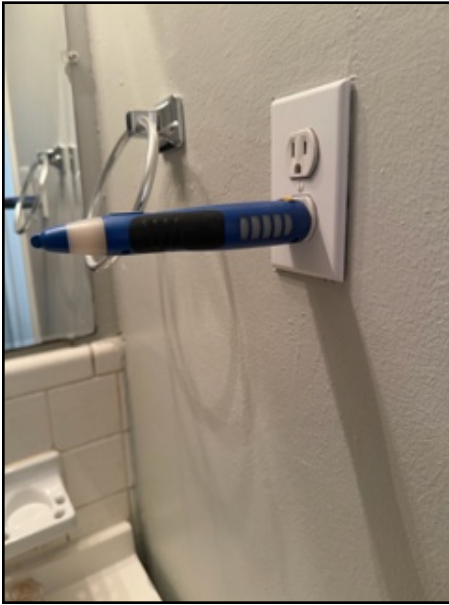
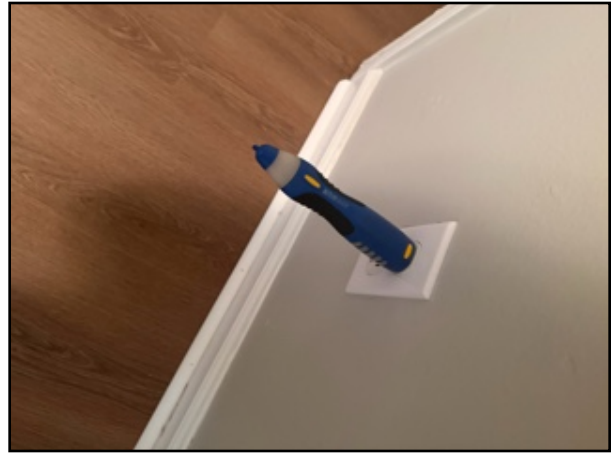
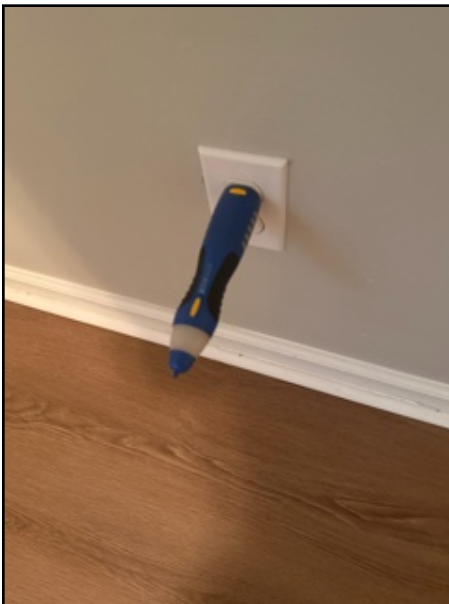
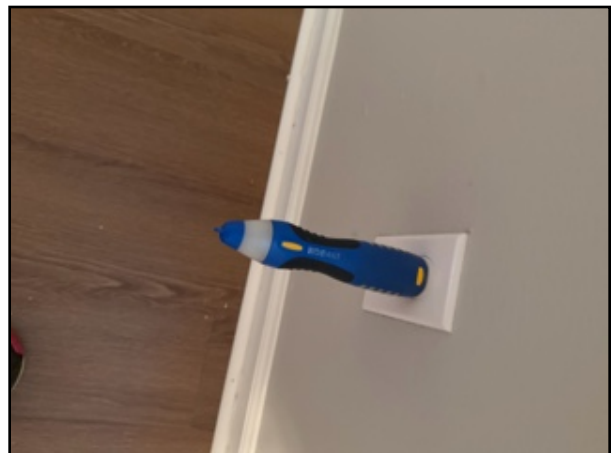
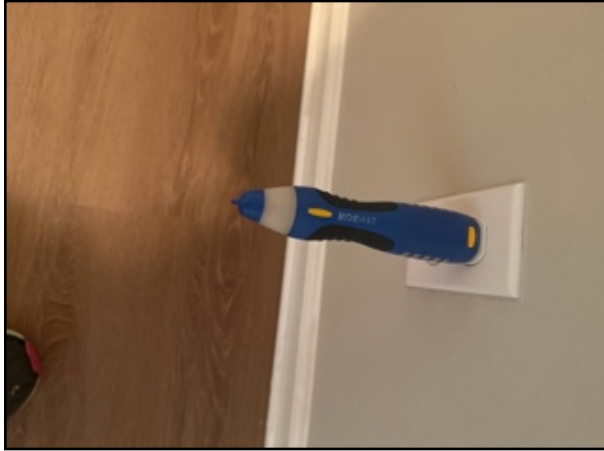
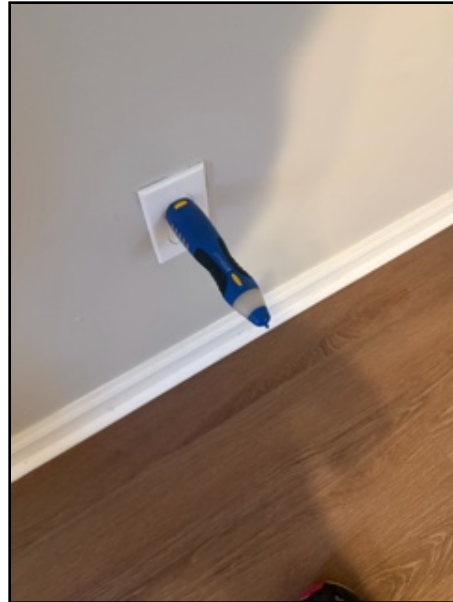
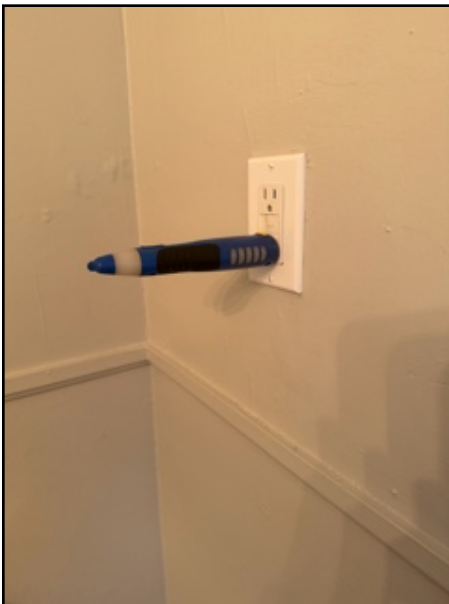
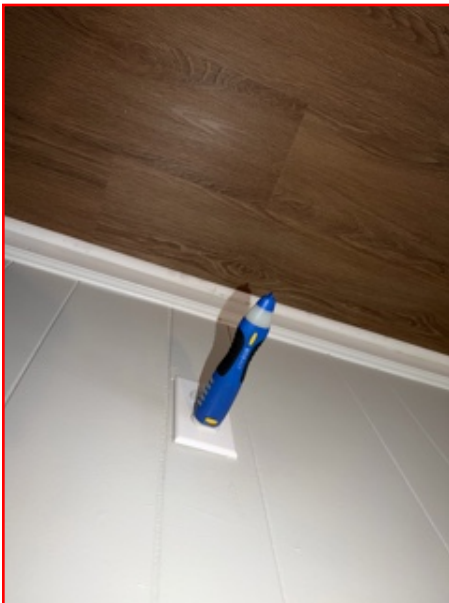
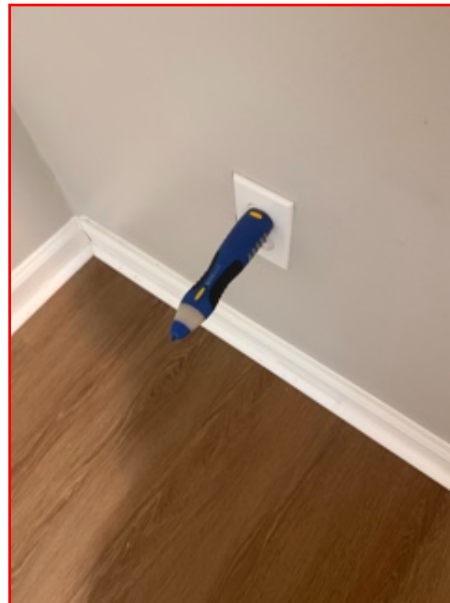
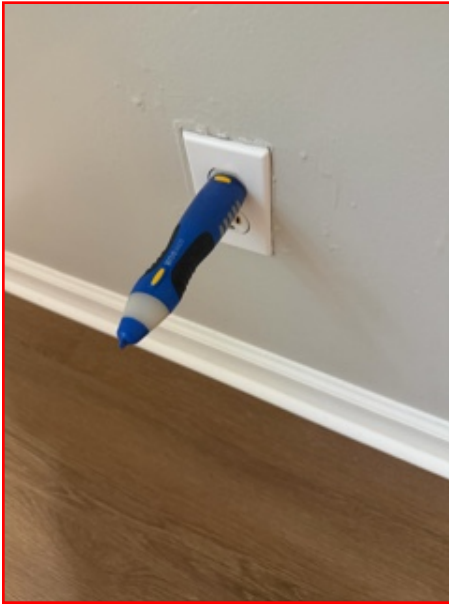
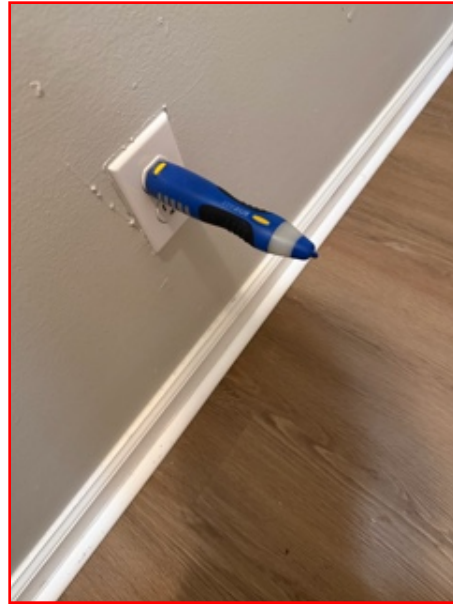
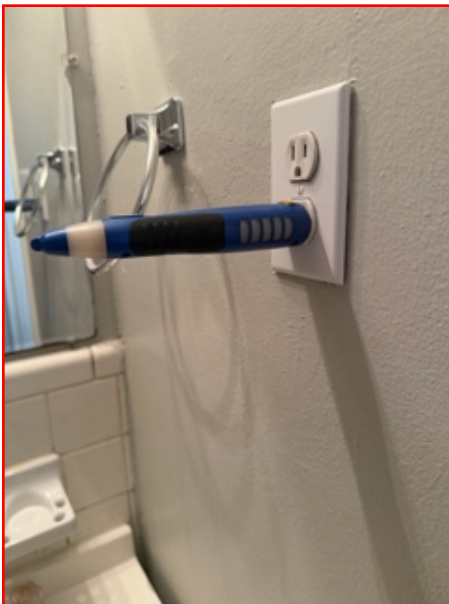
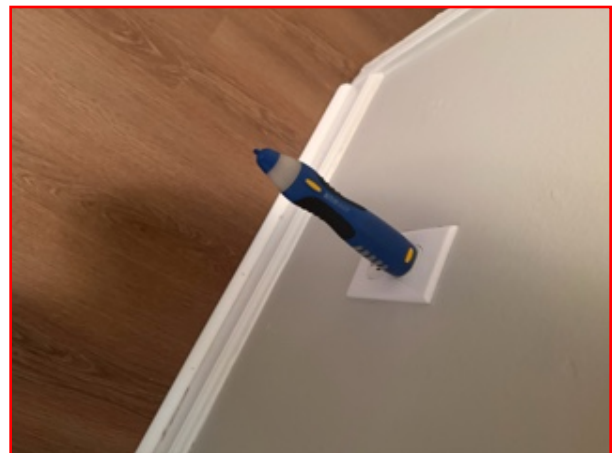
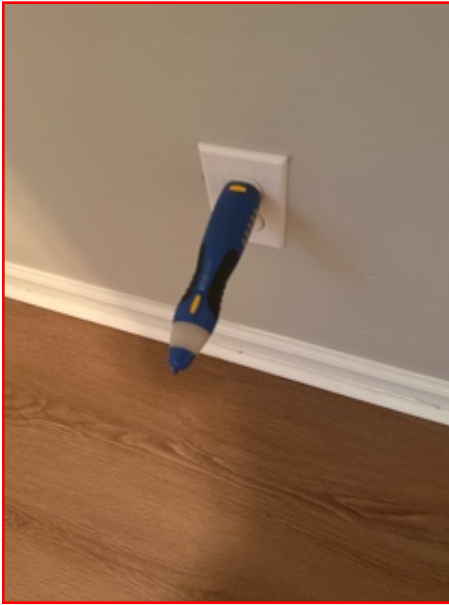
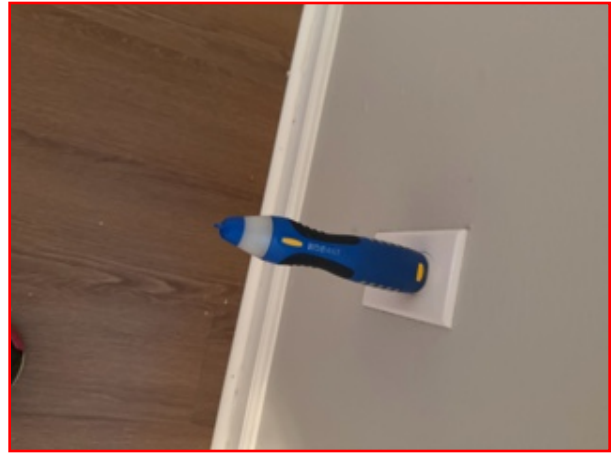
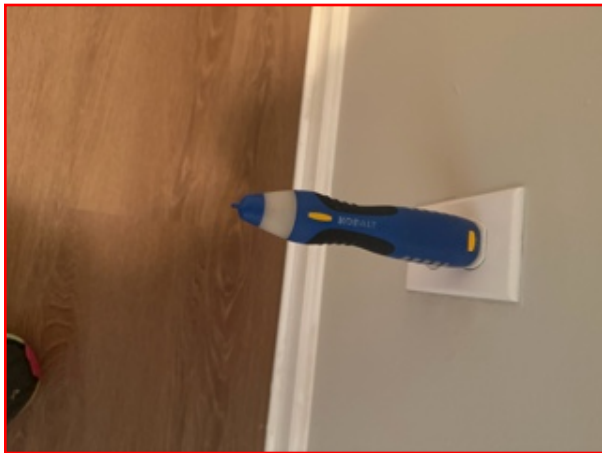
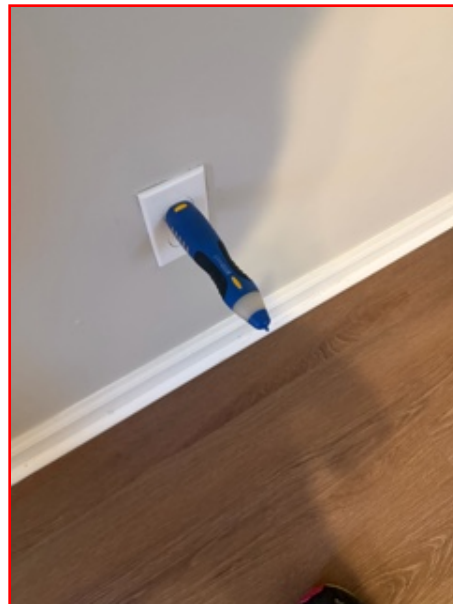
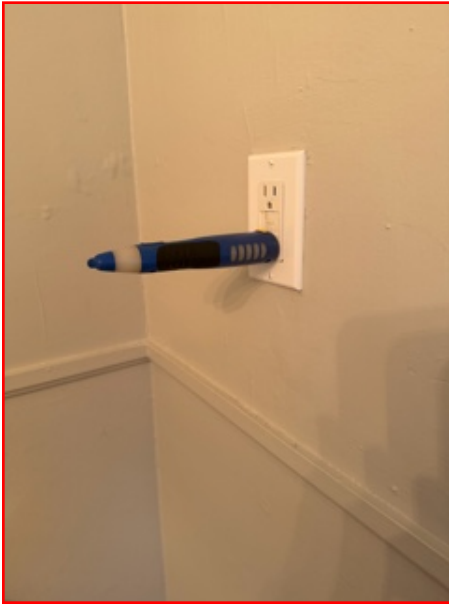
Two electrical outlets, one outlet in hallway and hall bathroom and all electrical outlet outlets not working in second bedroom and master bedroom and GFI outlet not working in master bathroom Further evaluation needed by electrician, outlets in first bedroom,.

4) Two electrical outlets, one outlet in hallway and hall bathroom and all electrical outlet outlets not working in second bedroom and master bedroom and GFI outlet not working in master bathroom Further evaluation needed by electrician, outlets in first bedroom,.

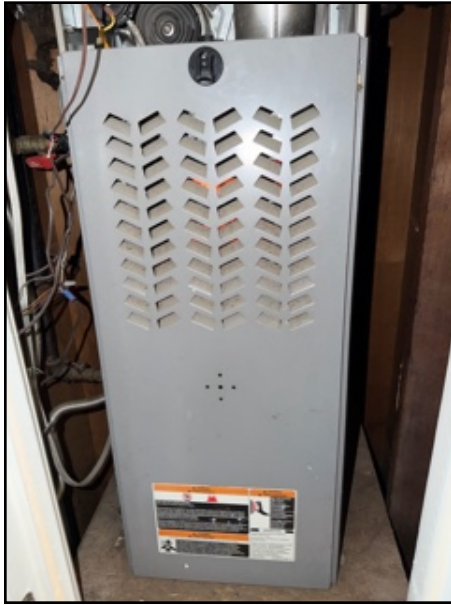
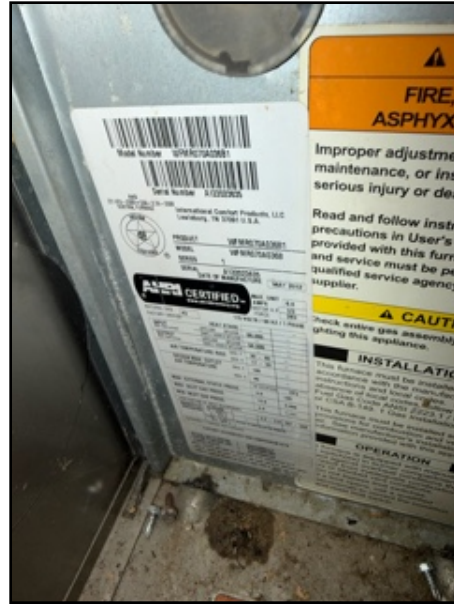
Comment 9:  
Heat operating as intended.  
Register temps above 95 degrees

Furnaces over 10 years old should be checked, cleaned and serviced yearly by a licensed contractor.

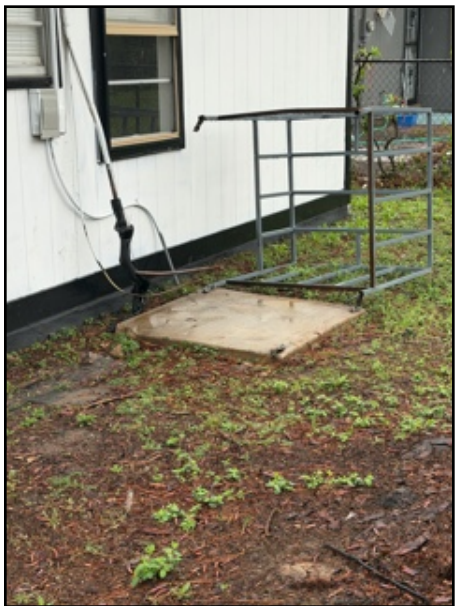
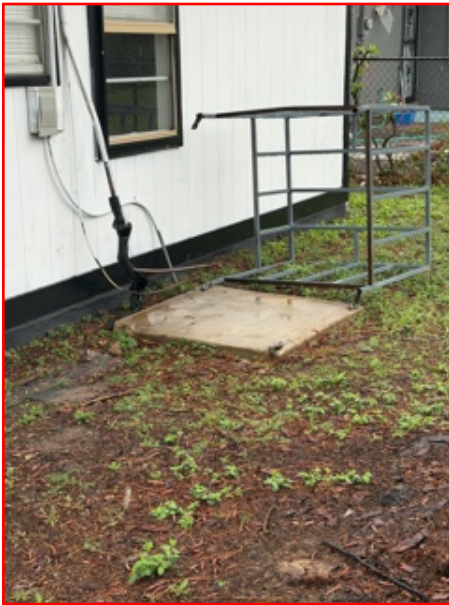
Comment 10:  
no AC condenser installed at time of inspection.

5) no AC condenser installed at time of inspection.

Air conditioners over 10 years old and heat pumps over 5 years old should be checked, cleaned and serviced yearly by a licensed contractor.

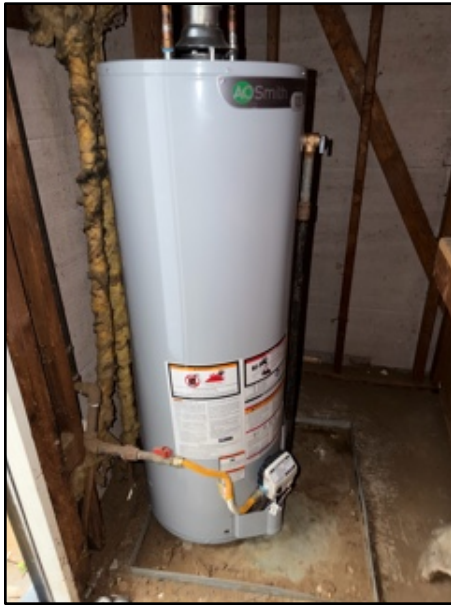
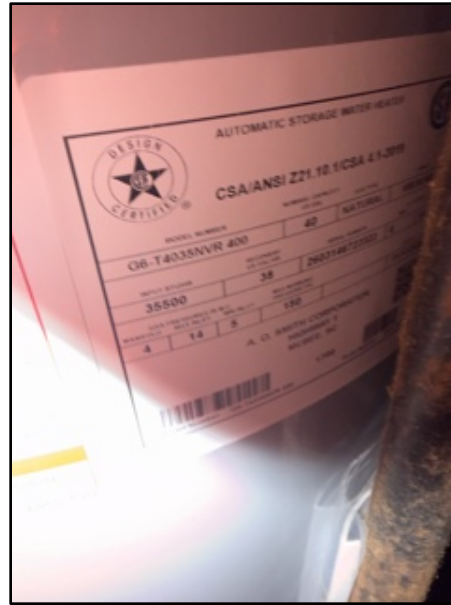
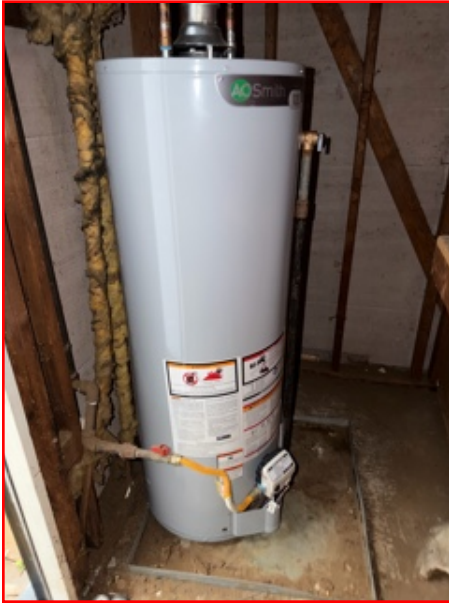
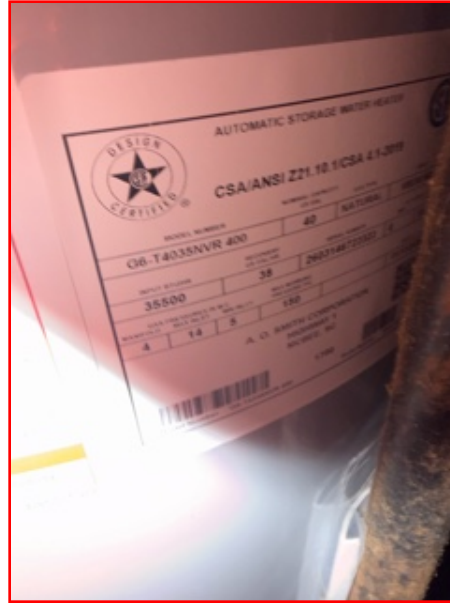
Hot water heater not operating at time of inspection.

6) Hot water heater not operating at time of inspection.

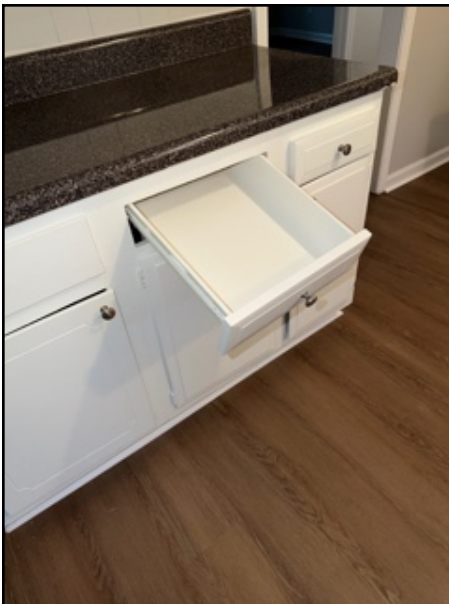
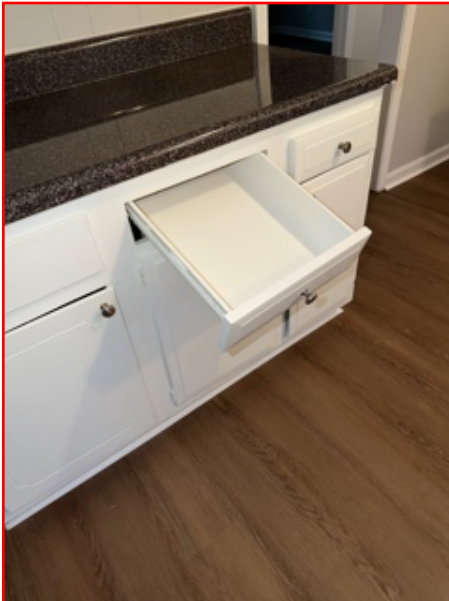
Figure 14-1

Comment 14:  
drawer in kitchen needs minor repair.

7) drawer in kitchen needs minor repair.

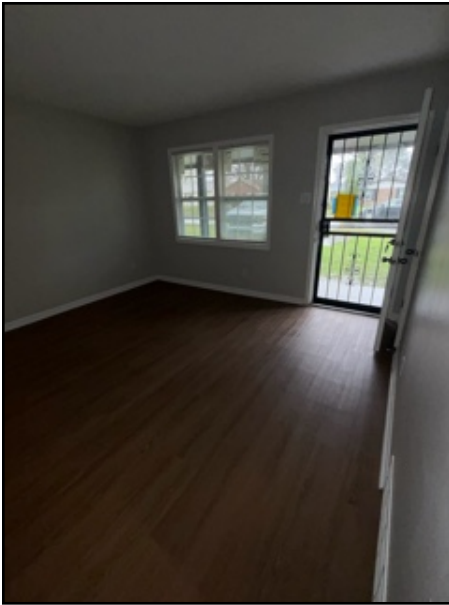
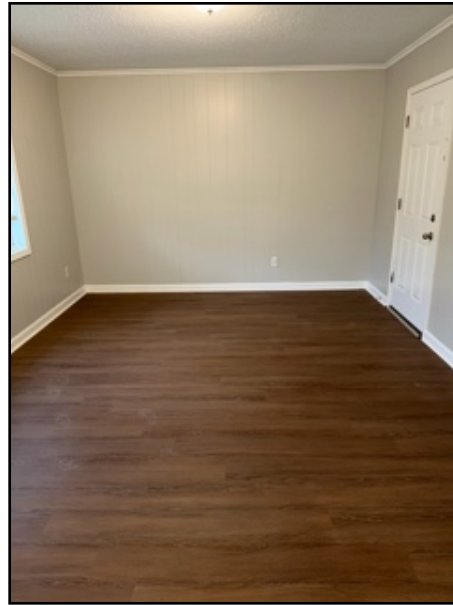
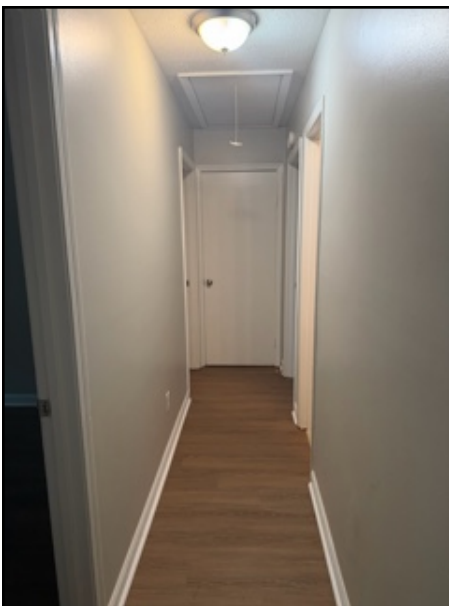
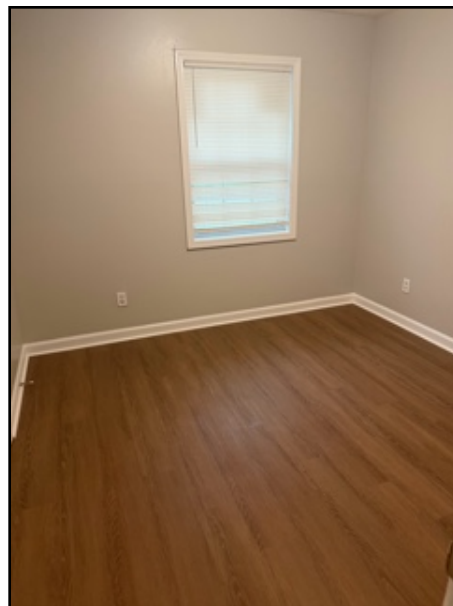
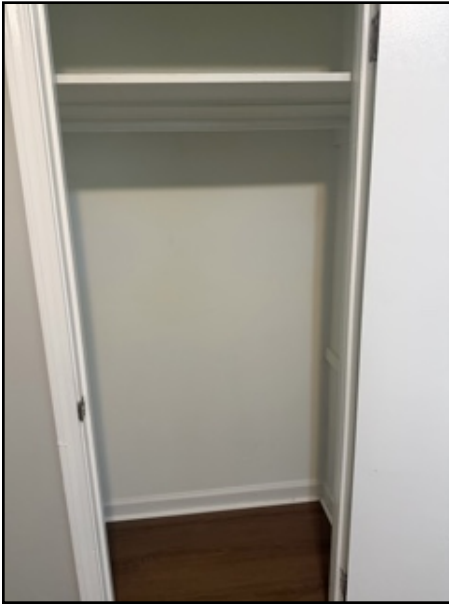
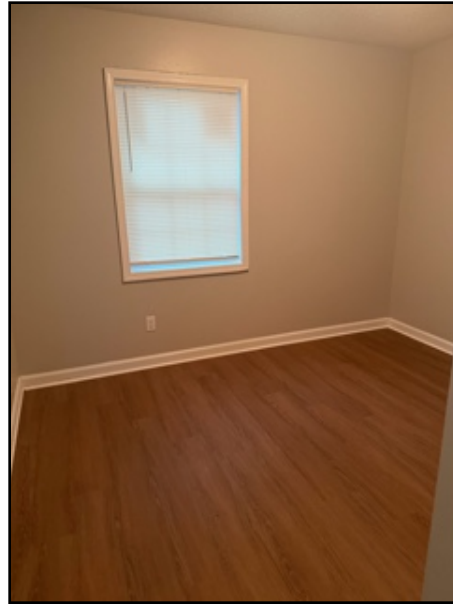
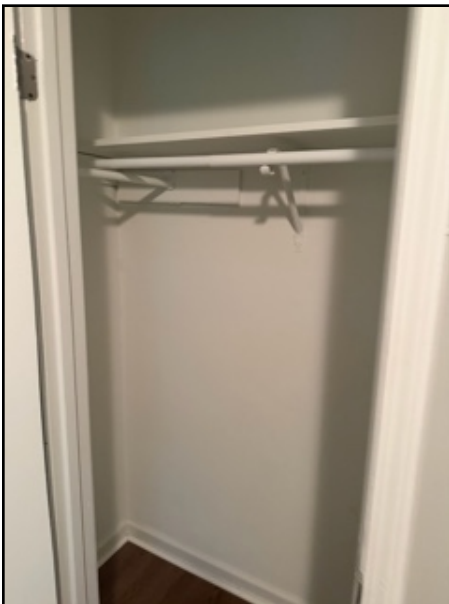
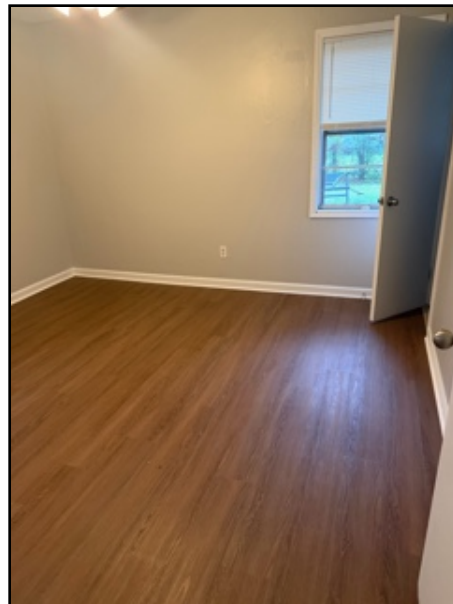
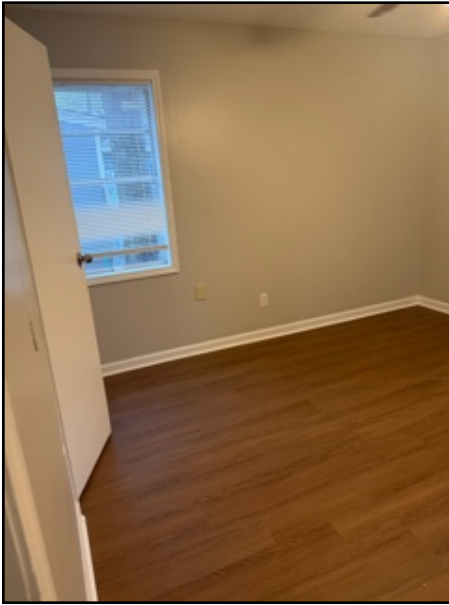
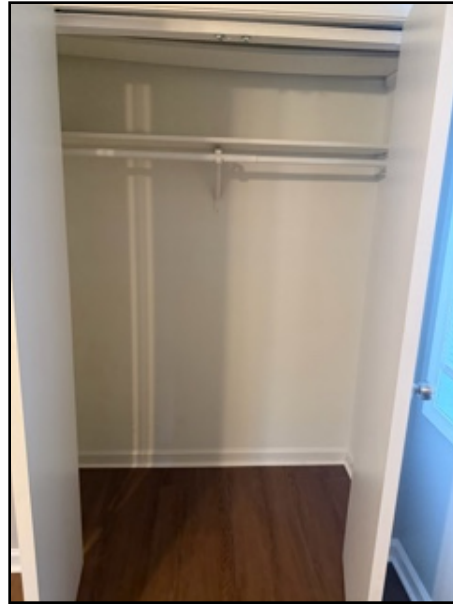
Comment 16:  
General pictures of Living room, dining area, bedrooms and closets.

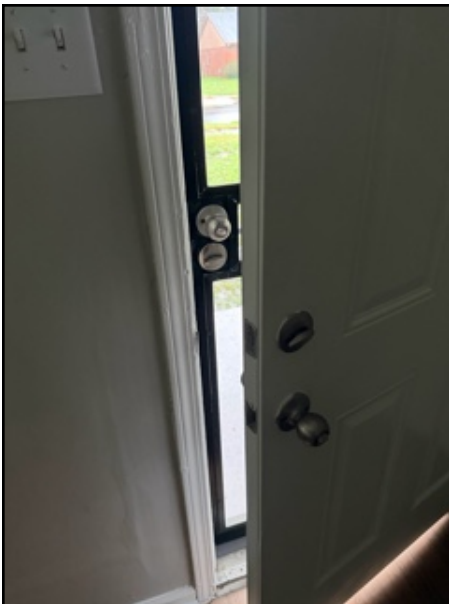
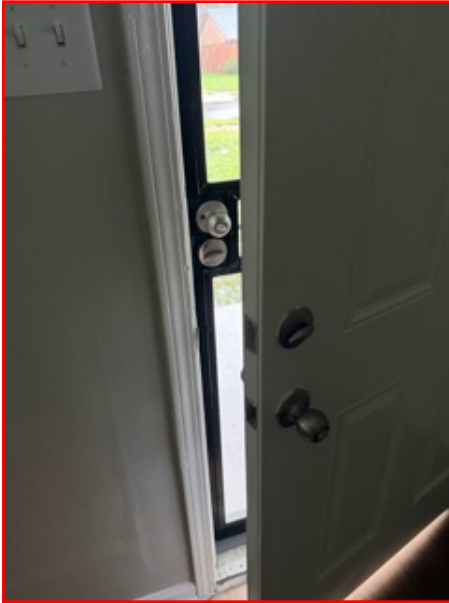
Figure 17-1

Comment 17:  
weatherstripping needed for front door.

8) weatherstripping needed for front door.

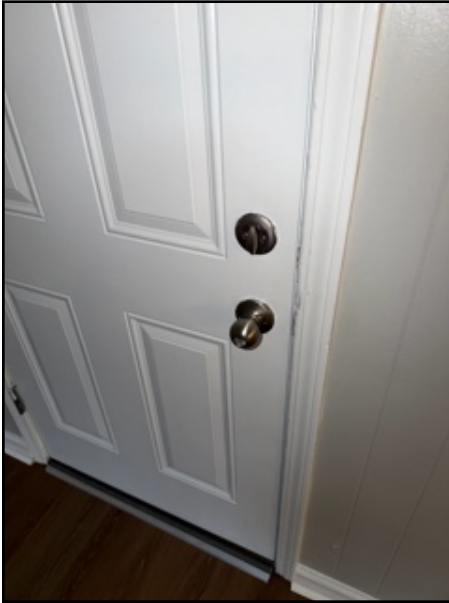
Figure 18-1

Comment 18:  
door leading to carport will not open.

9) door leading to carport will not open.
