## Home Inspection Report

**3723**

**Merritt**

**Memphis, Tn 38128**

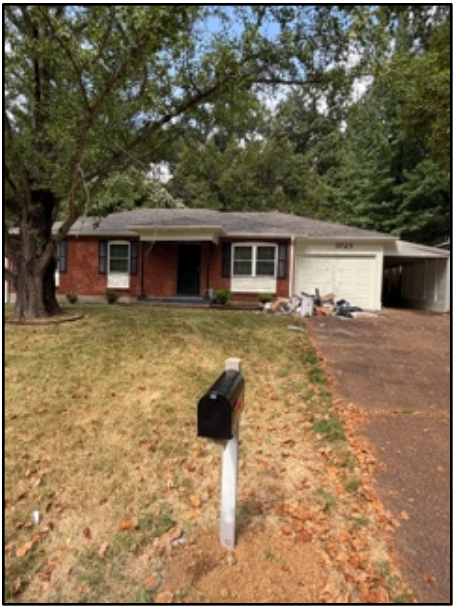
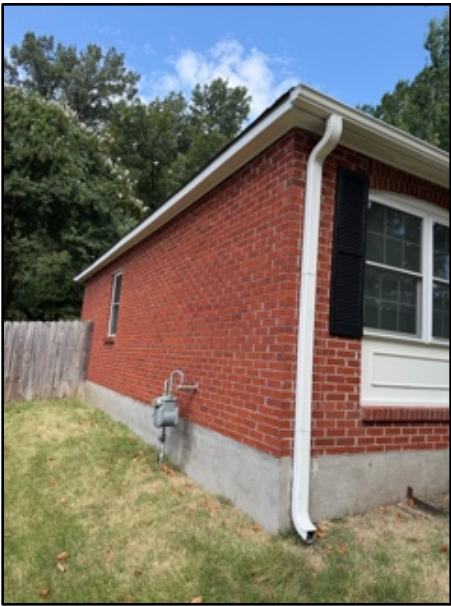
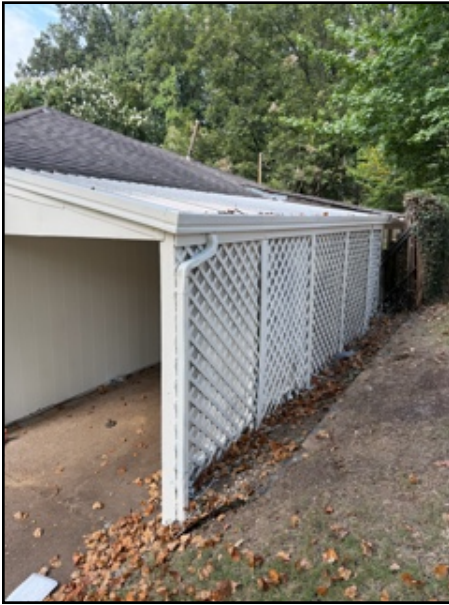
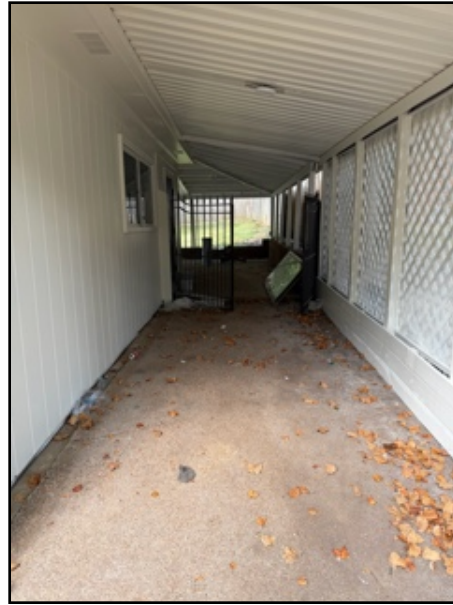
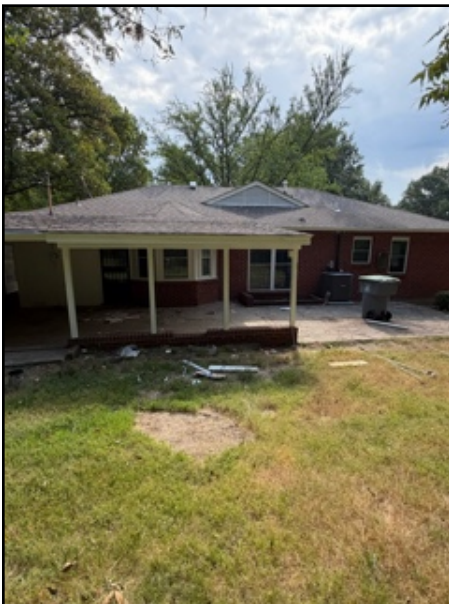
Comment 2:  
General pictures of exterior.

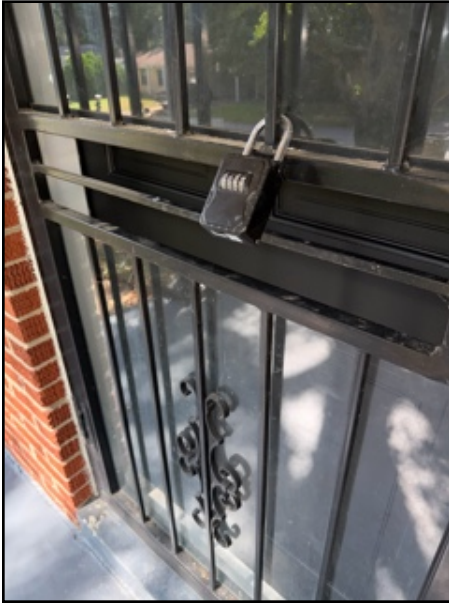
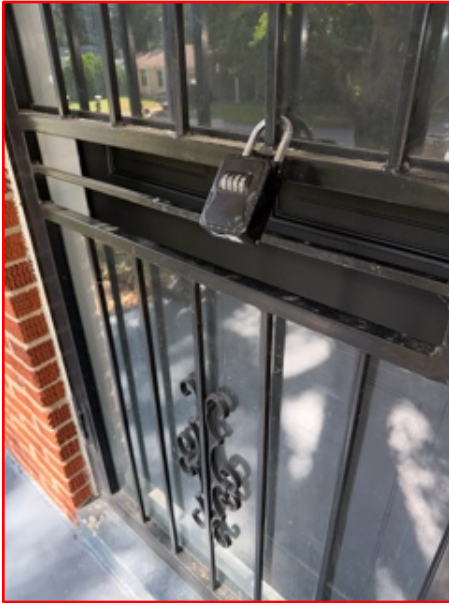
Figure 3-1

Comment 3:  
Center glass missing from front security door.

1) Center glass missing from front security door.

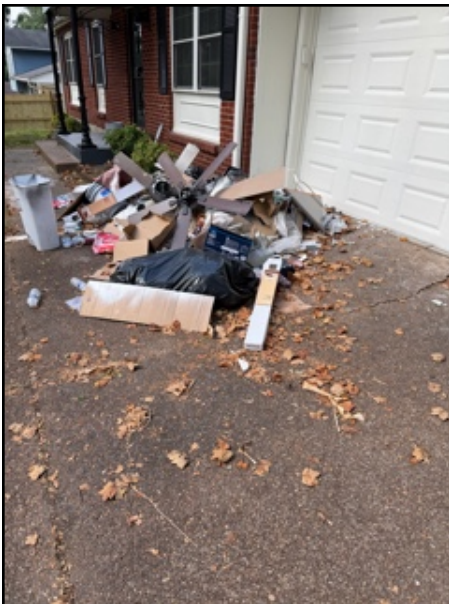
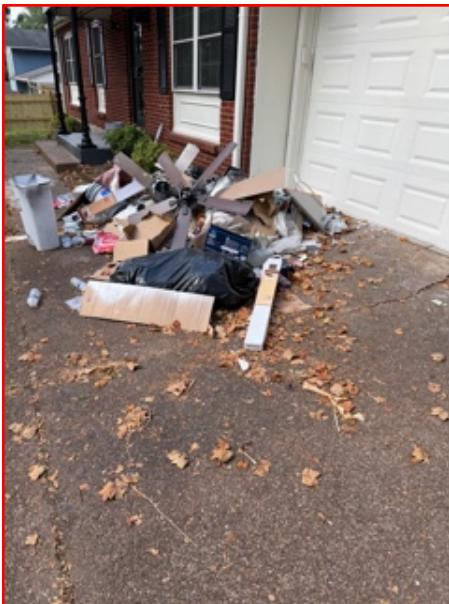
Figure 4-1

Comment 4:  
debris needs to be removed from front yard.

2) debris needs to be removed from front yard.

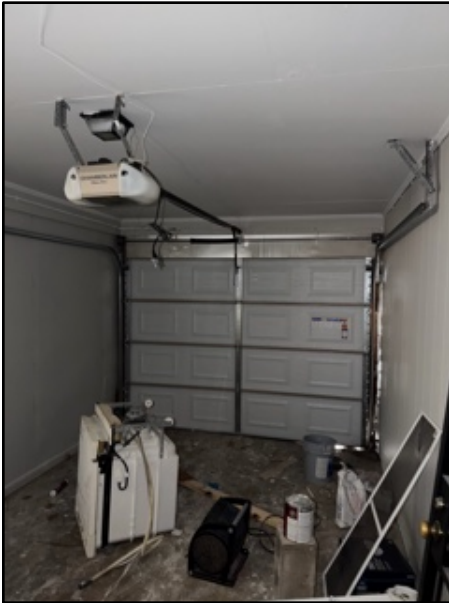
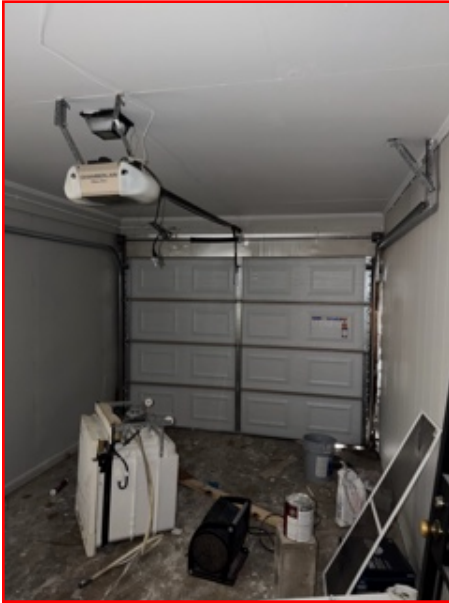
Figure 5-1

Comment 5:  
garage door not operating at time of inspection.

3) garage door not operating at time of inspection.

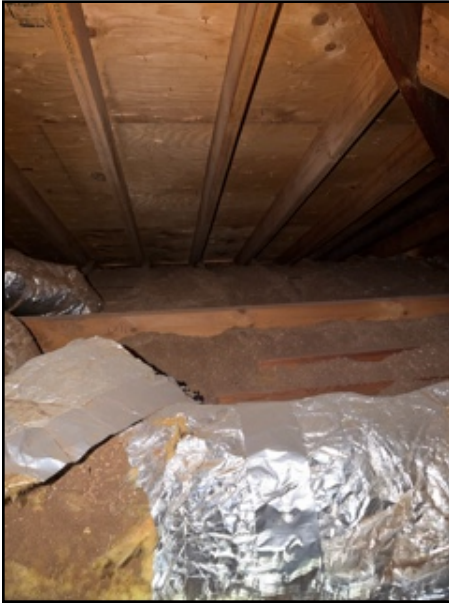
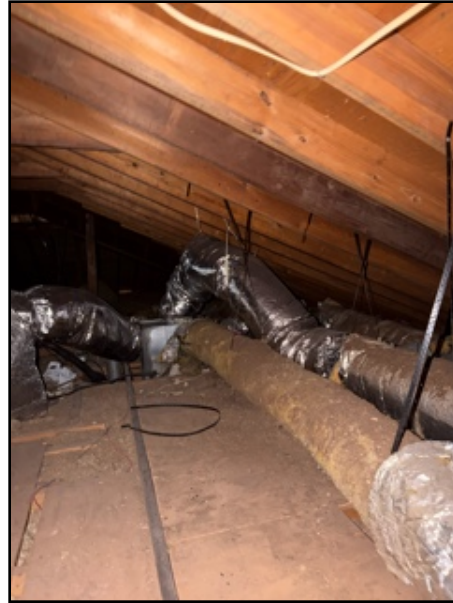
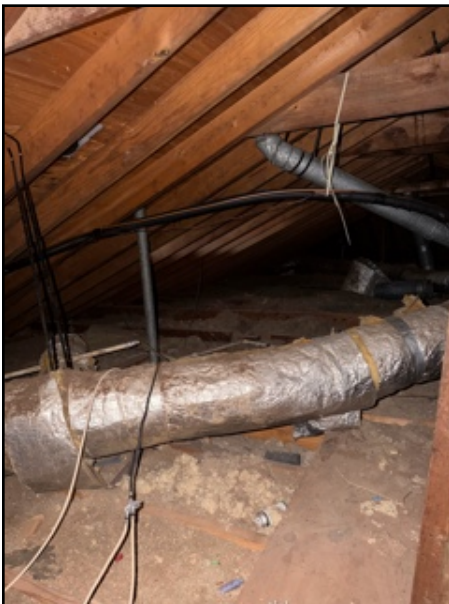
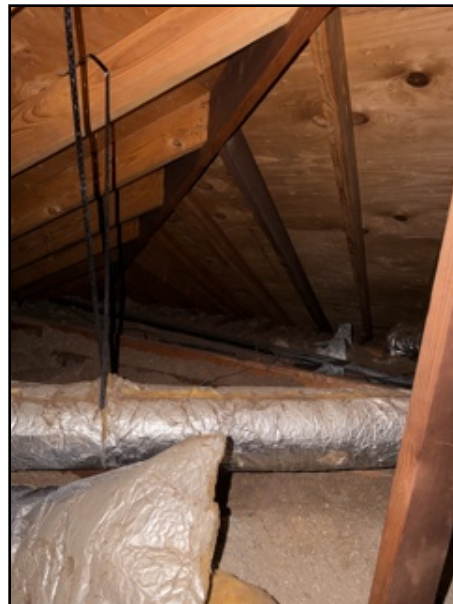
Attic is in good condition.. Framing is sound and there is no evidence of leaks

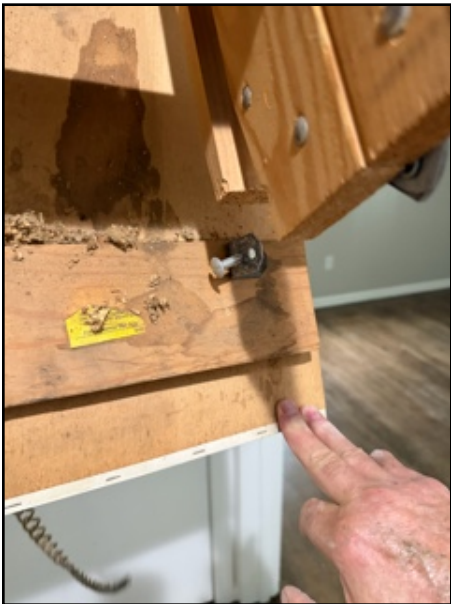
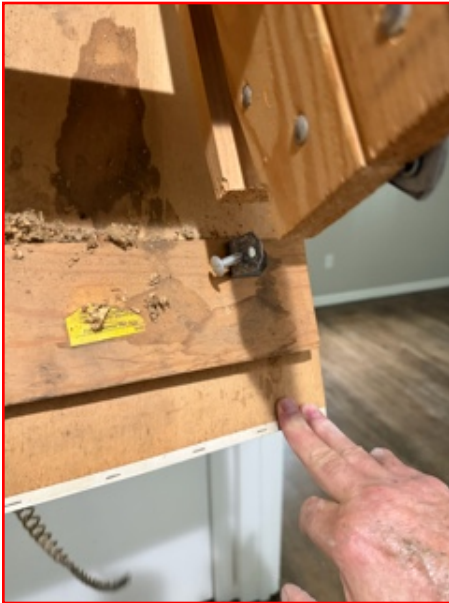
Figure 7-1

Comment 7:  
attic stairs damaged as noted by picture.

4) attic stairs damaged as noted by picture.

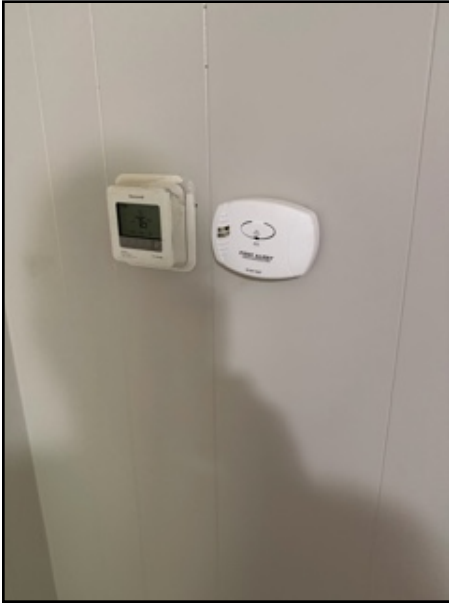
Figure 9-1

Comment 9:  
carbon monoxide detector is installed.

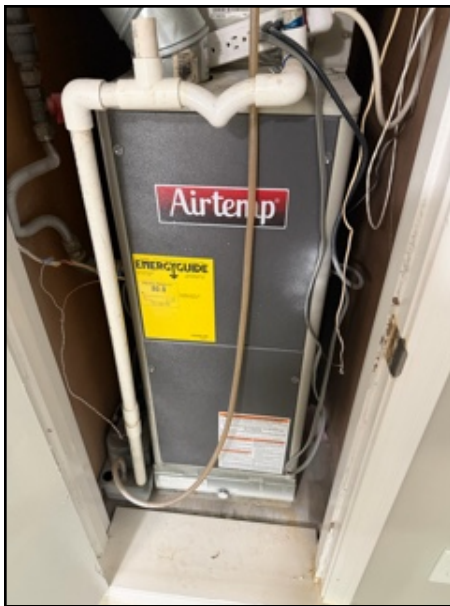
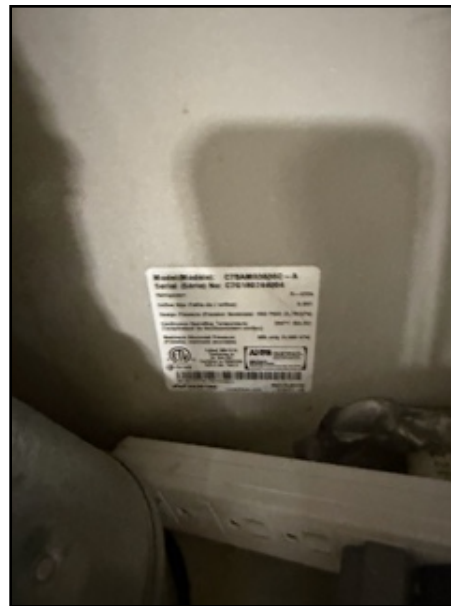
Heat operating as intended.

Register temps above 100 degrees

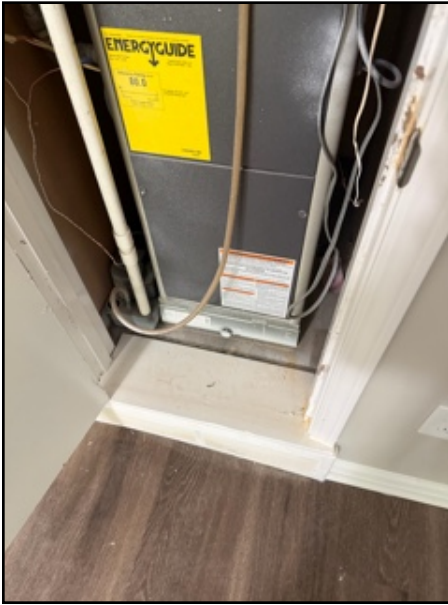
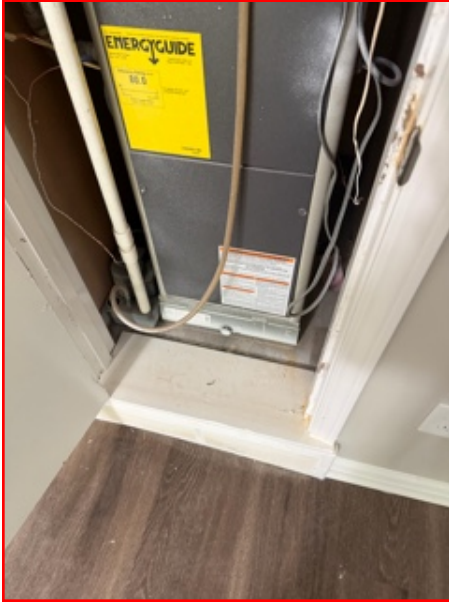
Figure 11-1

Furnace fan motor makes odd or unusual noise Further evaluation needed by HVAC technician.

5) Furnace fan motor makes odd or unusual noise Further evaluation needed by HVAC technician.

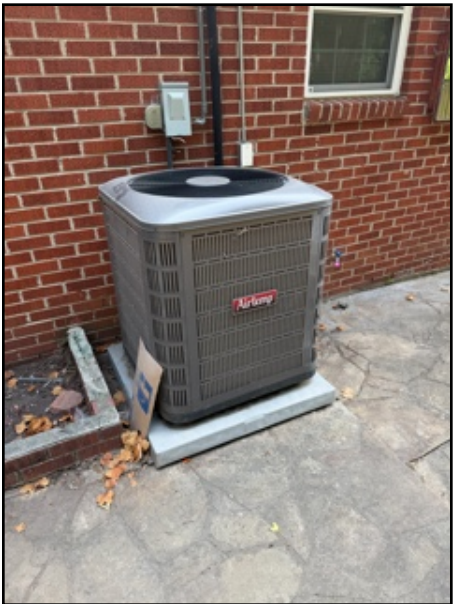
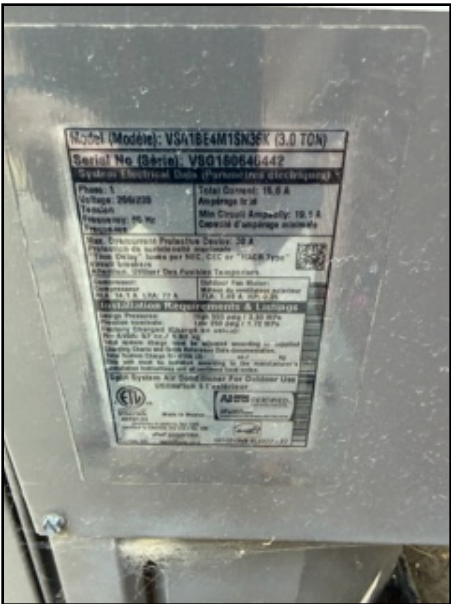
Comment 12:  
Cooling as intended At time of inspection  
Register temps around 65 degrees.

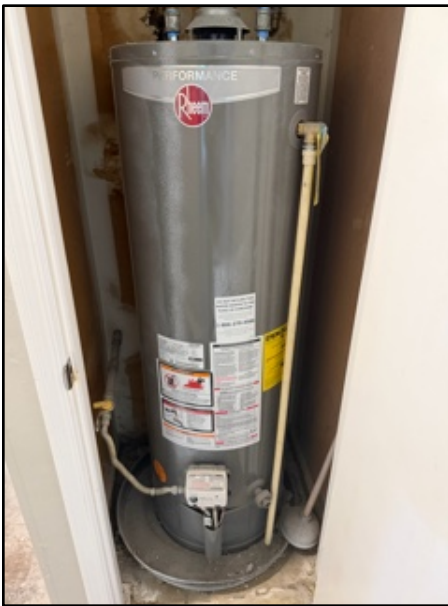
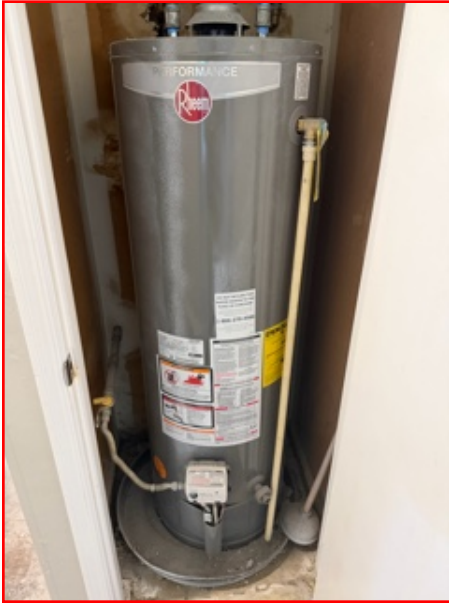
Figure 13-1

Hot water heater not operating at time inspection.

6) Hot water heater not operating at time inspection.

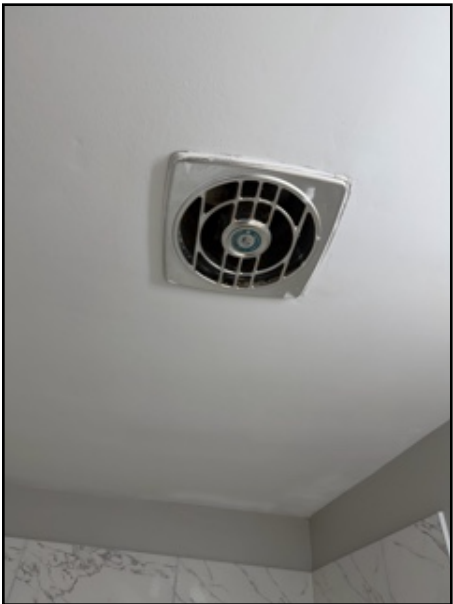
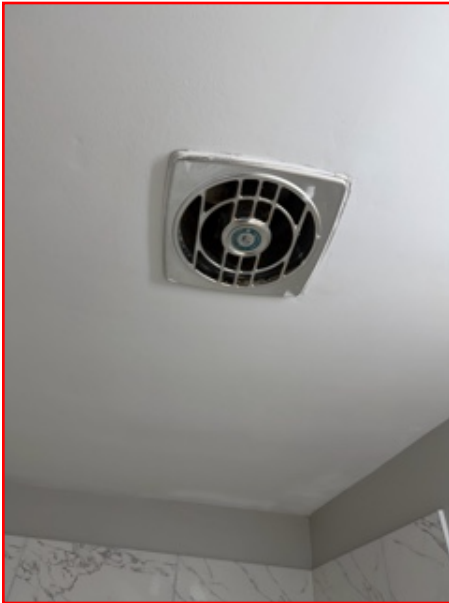
Figure 15-1

Comment 15:  
exhaust fan not working in Hall bathroom.

7) exhaust fan not working in Hall bathroom.

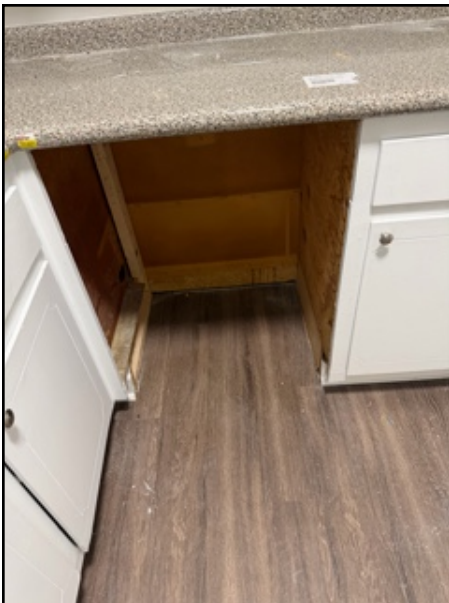
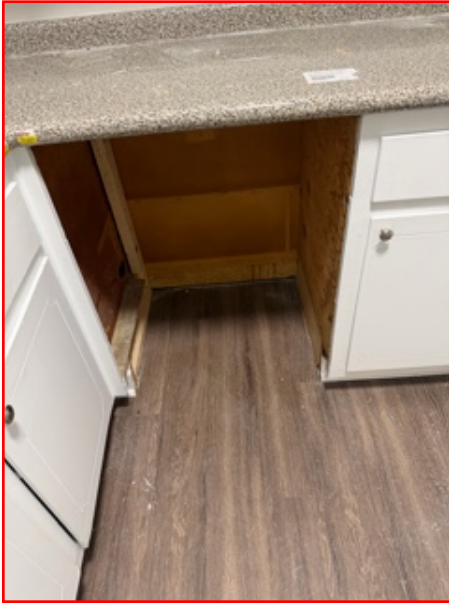
Figure 17-1

Comment 17:  
no dishwasher installed at time inspection.

8) no dishwasher installed at time inspection.

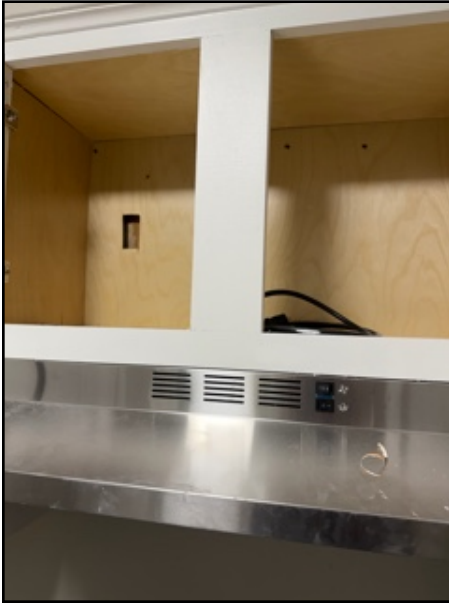
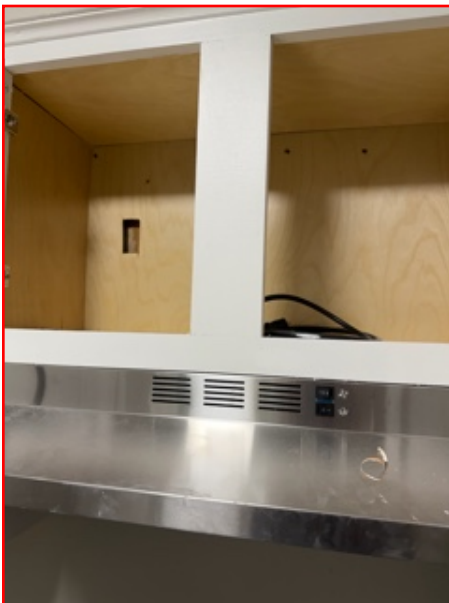
Figure 18-1

Comment 18:  
no electrical outlet installed for vent hood.

9) no electrical outlet installed for vent hood.

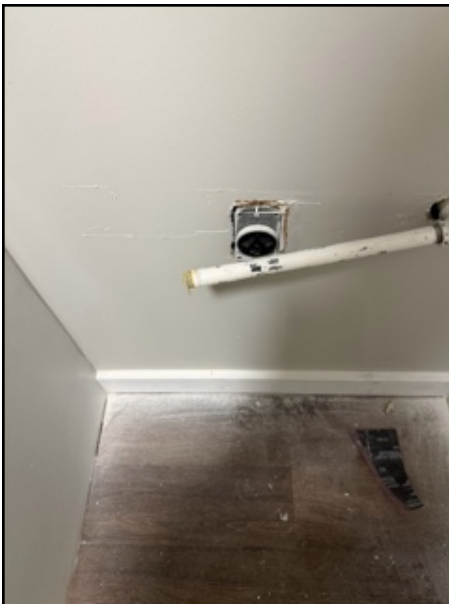
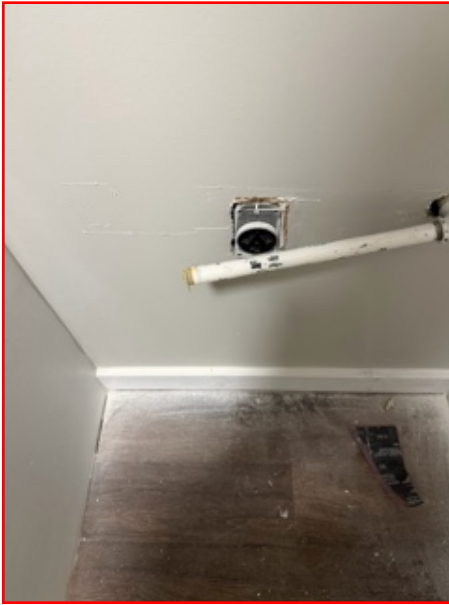
Figure 19-1

Comment 19:  
cap needed on gas line in kitchen.

10) cap needed on gas line in kitchen.

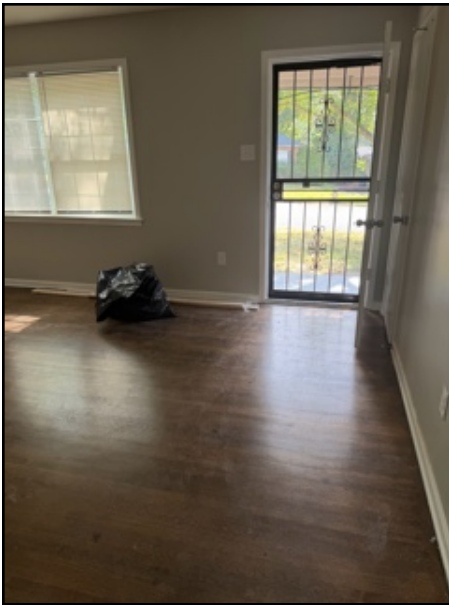
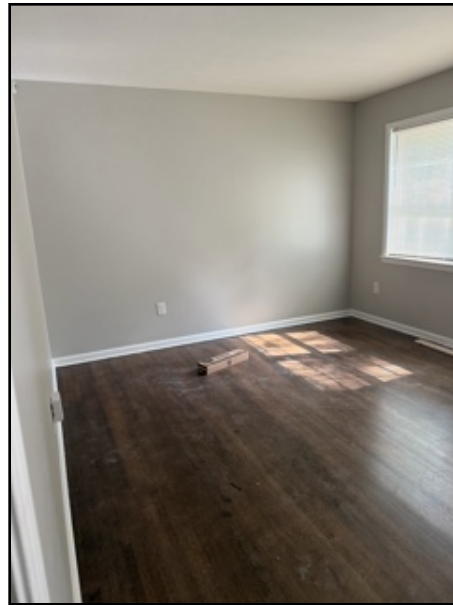
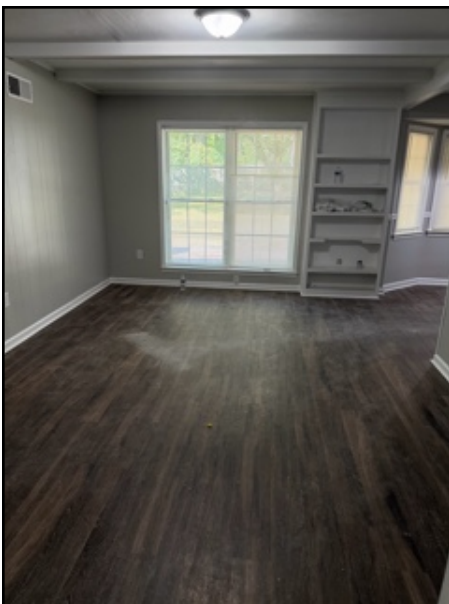
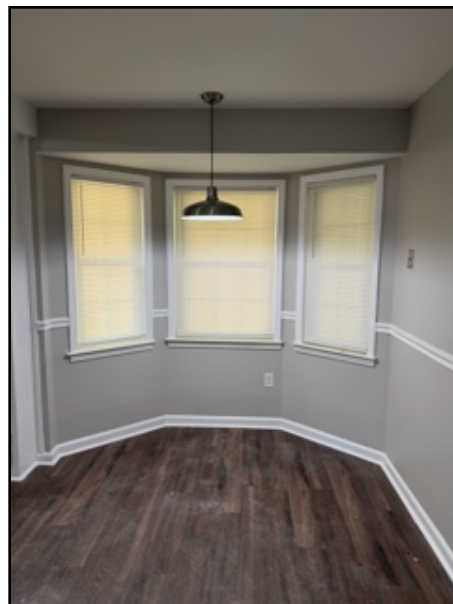
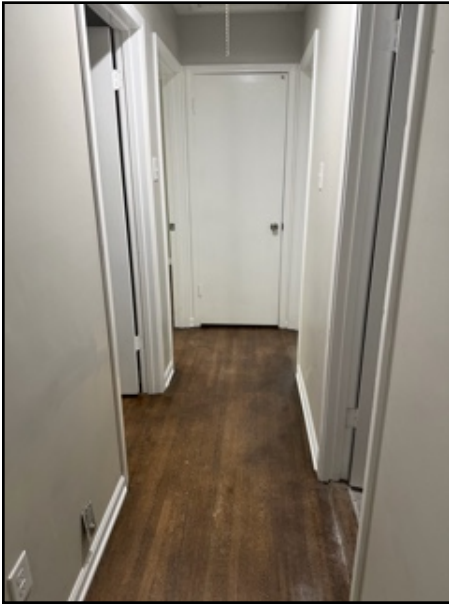
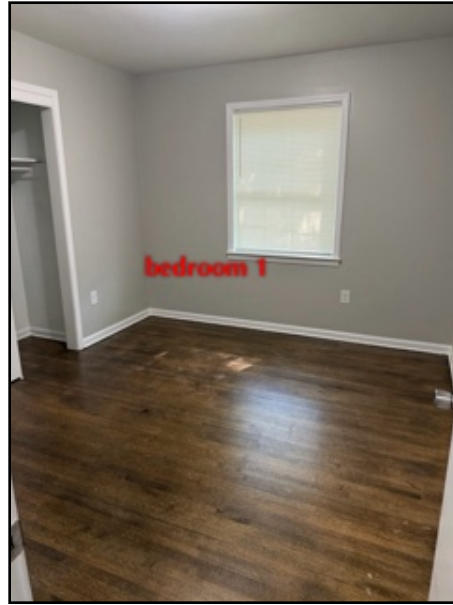
General pictures of Living room, dining area, bedrooms and closets.

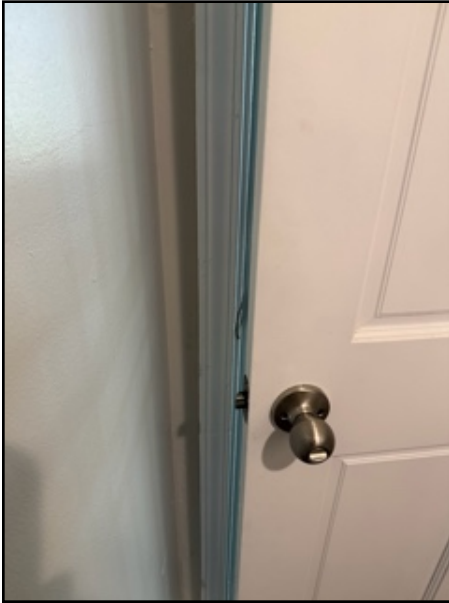
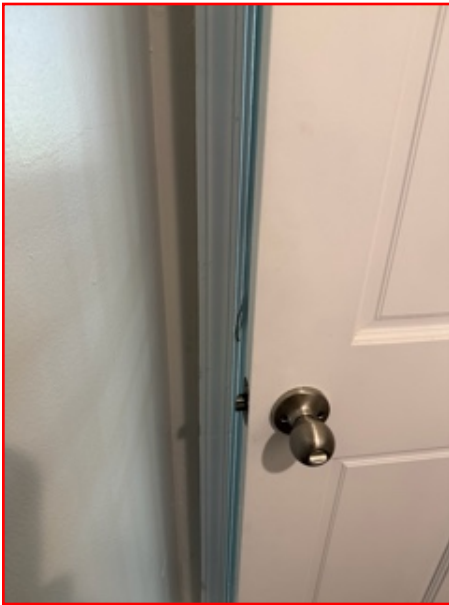
Figure 22-1

Comment 22:  
weatherstripping needed for door leading to patio.

11) weatherstripping needed for door leading to patio.

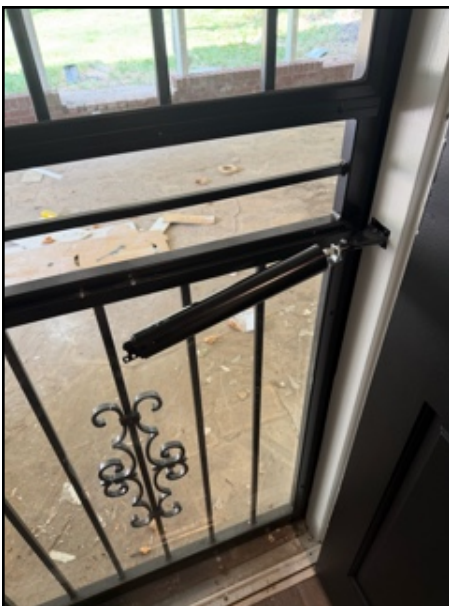
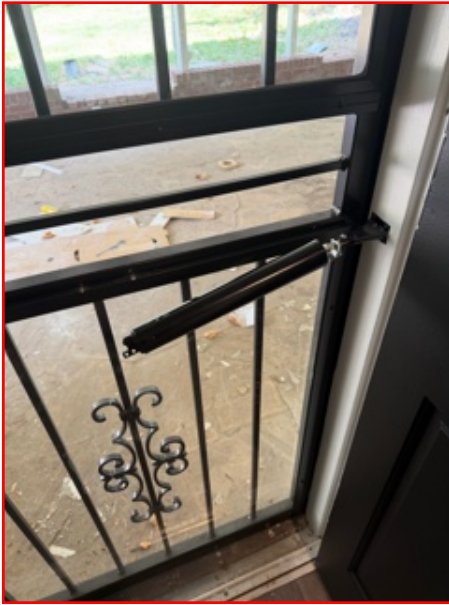
Figure 23-1

Comment 23:  
door return needs to be attached on security door that leads to patio.

12) door return needs to be attached on security door that leads to patio.

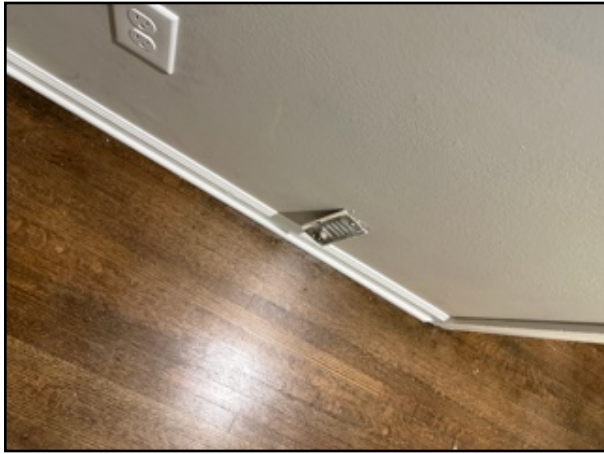
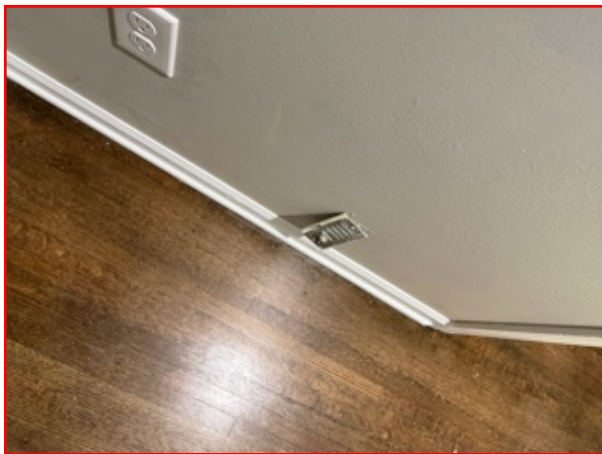
Figure 24-1

Comment 24:  
evaluation needed by Electrician for old nightlight in hallway.

13) evaluation needed by Electrician for old nightlight in hallway.

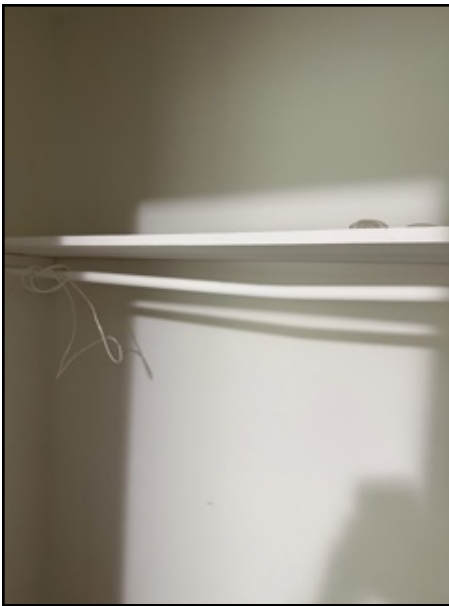
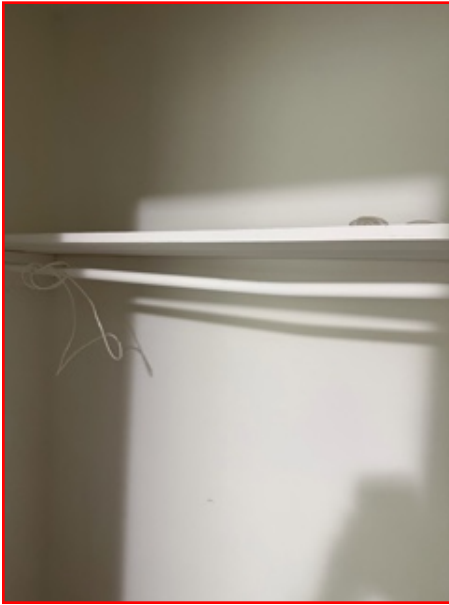
Figure 25-1

Comment 25:  
Center support needed in second bedroom closet.

14) Center support needed in second bedroom closet.

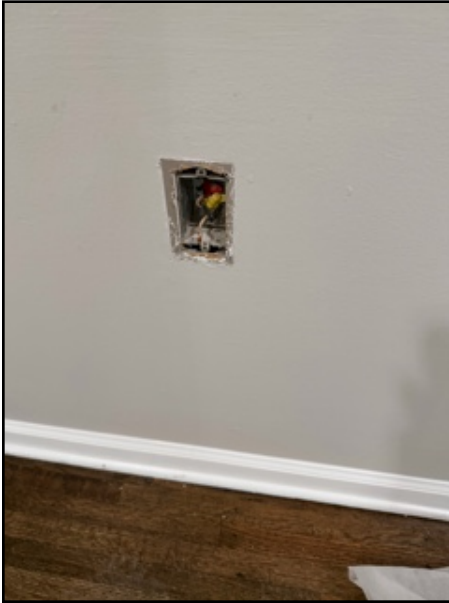
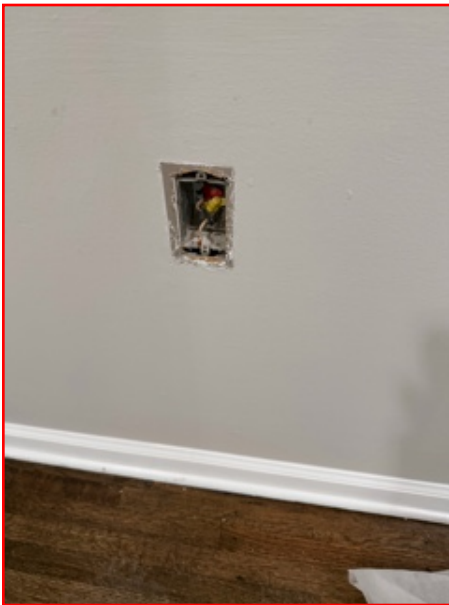
Figure 26-1

Comment 26:  
exposed wires noted in master bedroom.

15) exposed wires noted in master bedroom.

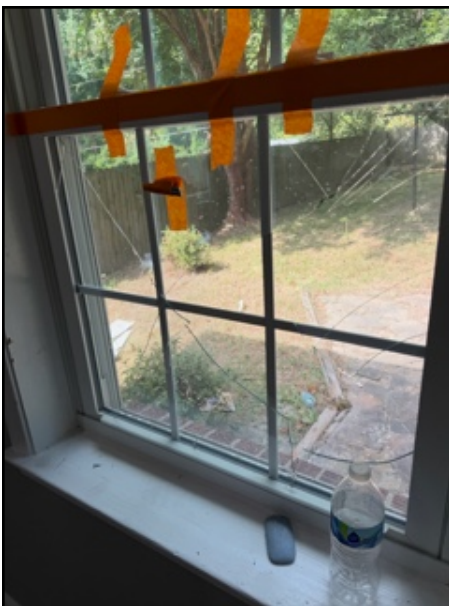
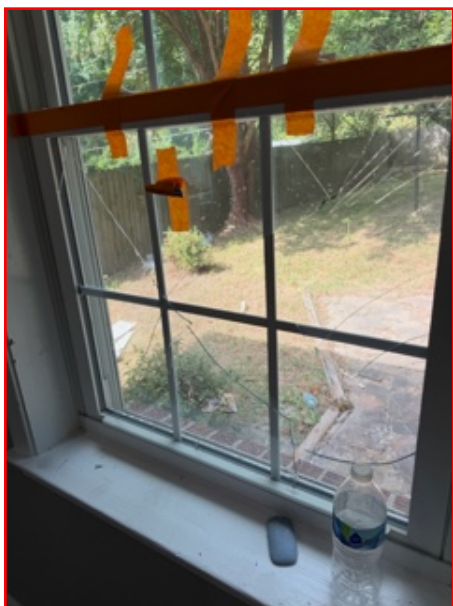
Figure 27-1

Comment 27:  
Window Glass broken in master bedroom.

16) Window Glass broken in master bedroom.
