## Home Inspection Report

**2278**

**Arlene**

**Memphis, Tn 38127**

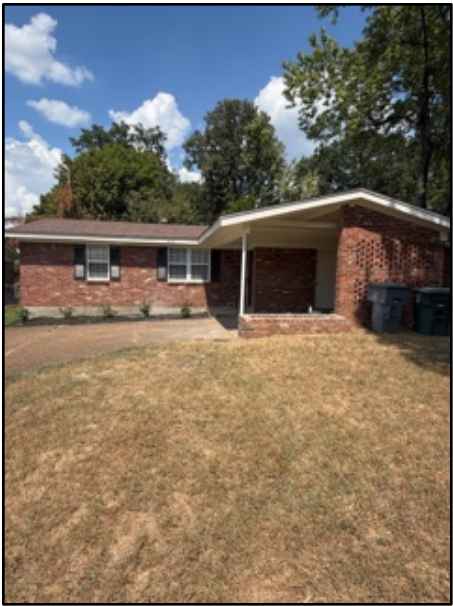
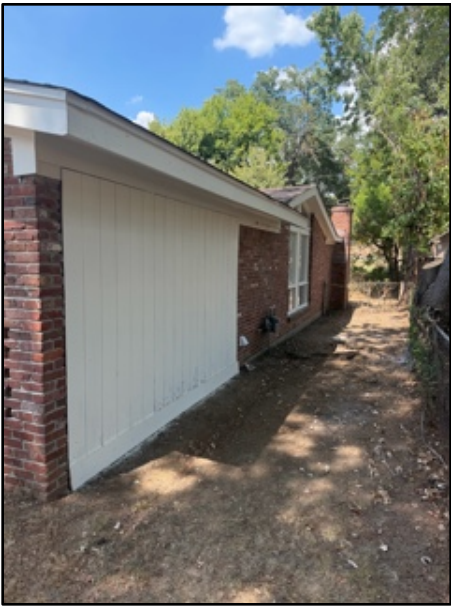
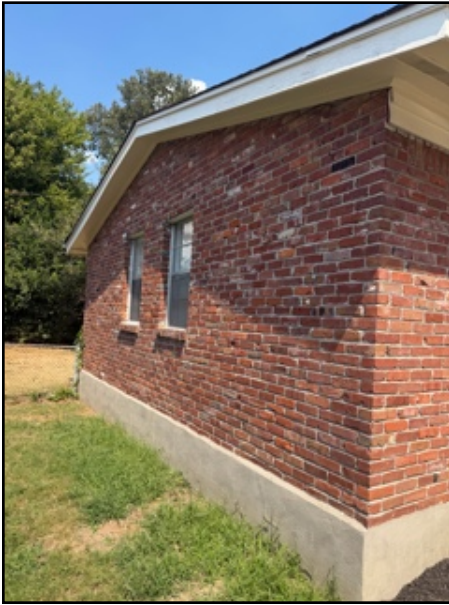
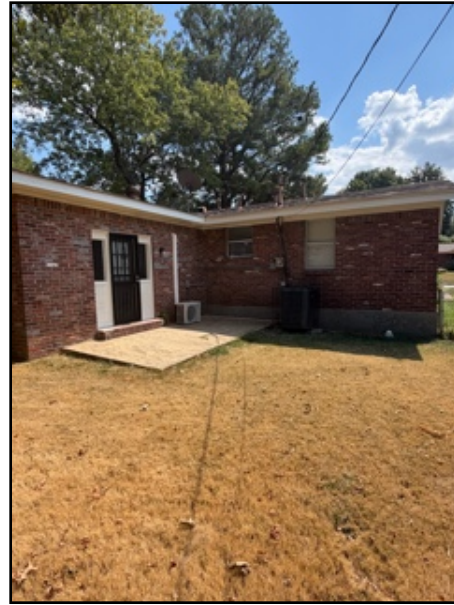
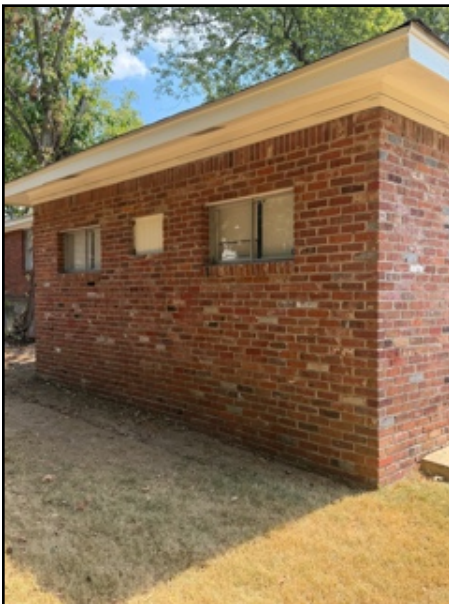
Comment 2:  
General pictures of exterior.

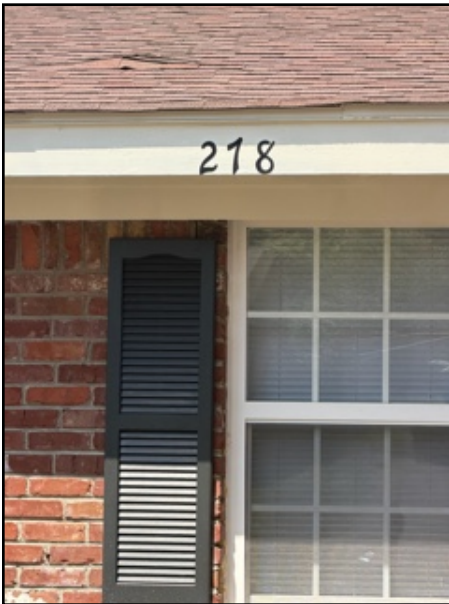
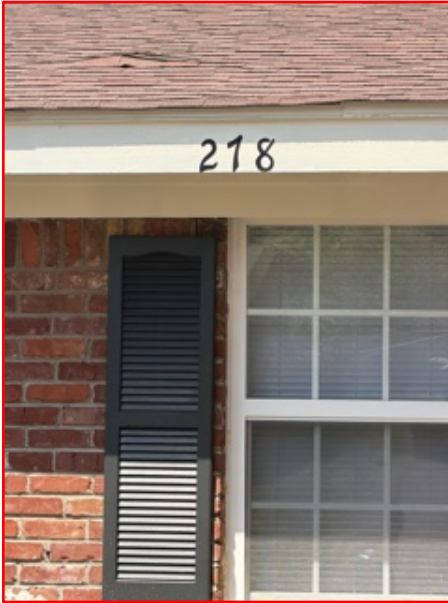
Figure 3-1

Comment 3:  
Number missing for house as noted by picture.

1) Number missing for house as noted by picture.

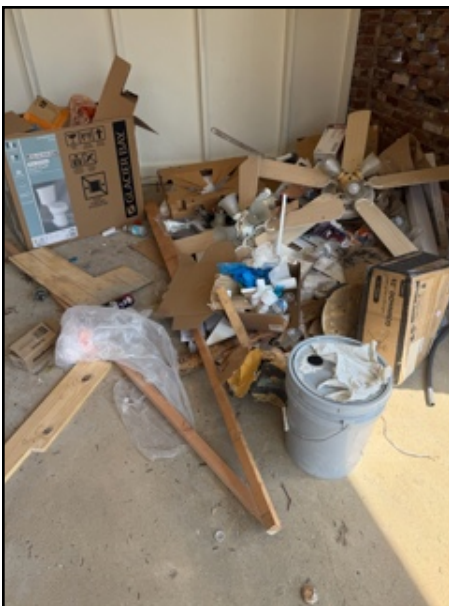
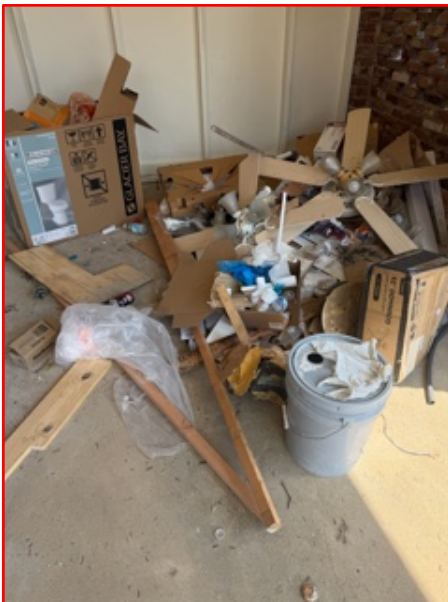
Figure 4-1

Comment 4:  
debris removal needed in carport area.

2) debris removal needed in carport area.

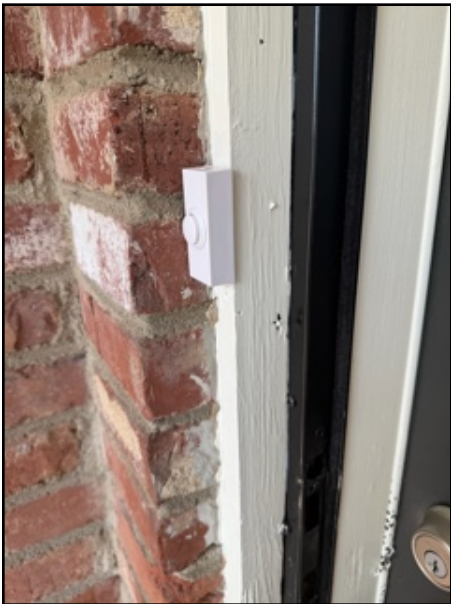
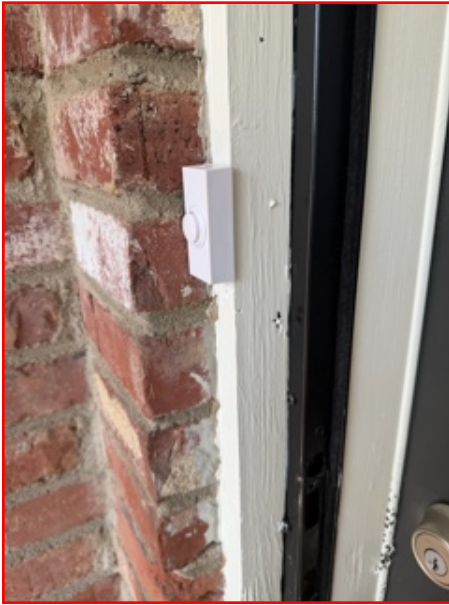
Figure 5-1

Comment 5:  
doorbell not working at time of inspection.

3) doorbell not working at time of inspection.

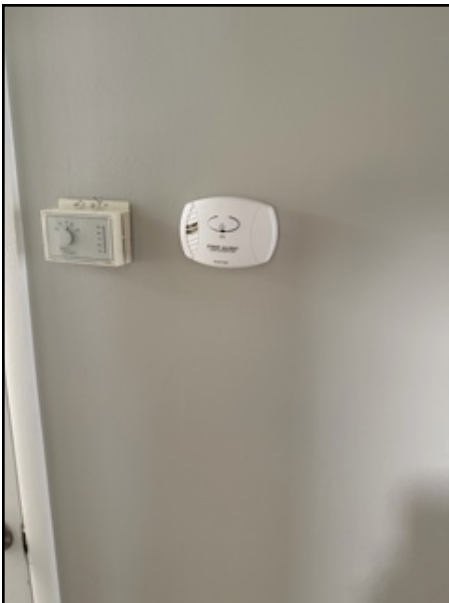
Figure 7-1

Comment 7:  
carbon monoxide detector is installed.

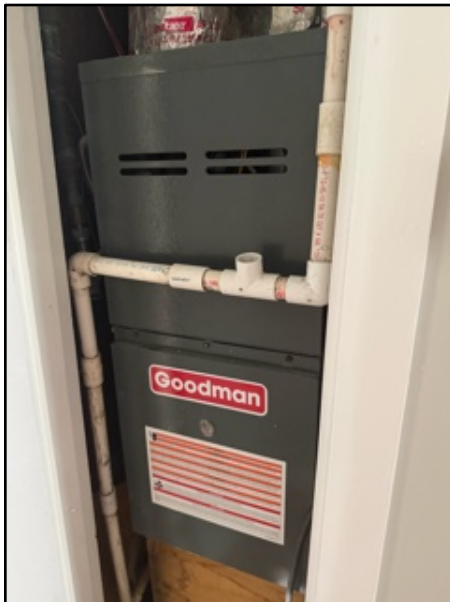
Figure 8-1

Heat operating as intended.

Register temps above 100 degrees

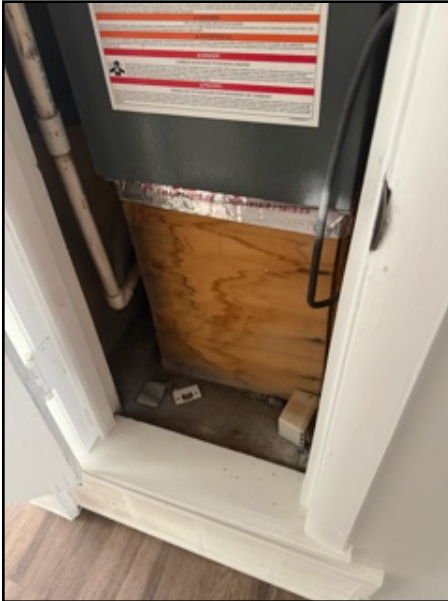
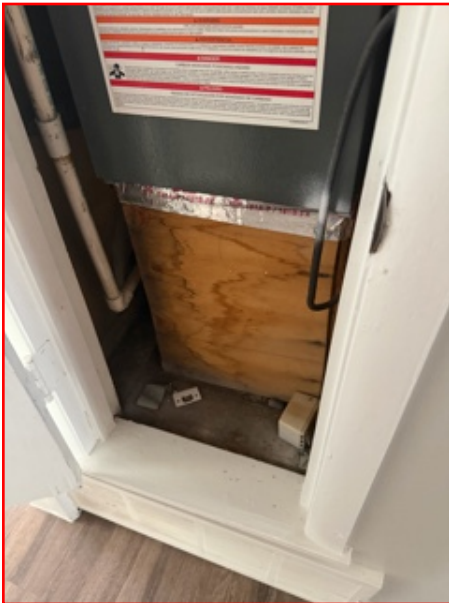
Figure 9-1

Comment 9:  
no air filter box installed under furnace.

4) no air filter box installed under furnace.

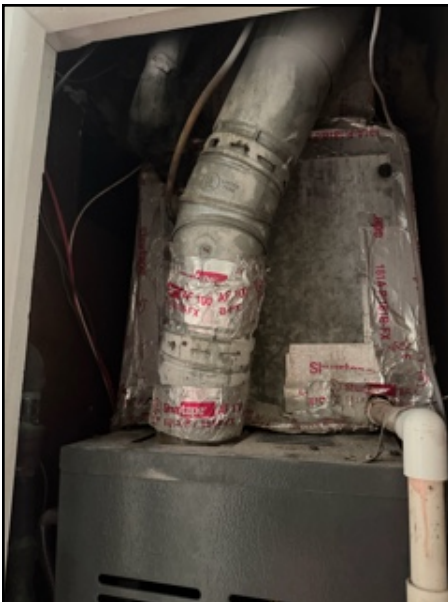
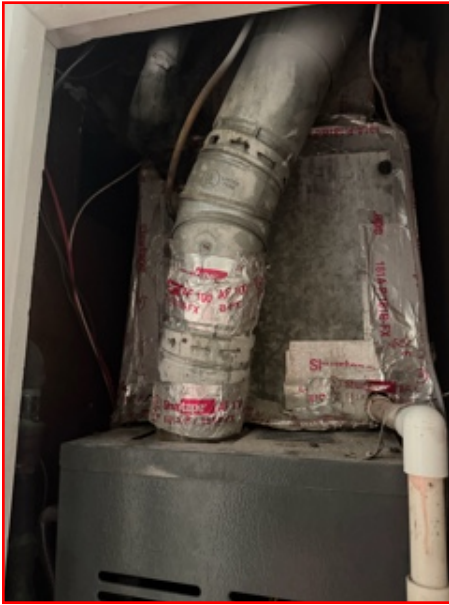
Figure 10-1

Comment 10:  
there should not be any tape on furnace vent Piping should overlap from top to bottom.

5) there should not be any tape on furnace vent Piping should overlap from top to bottom.

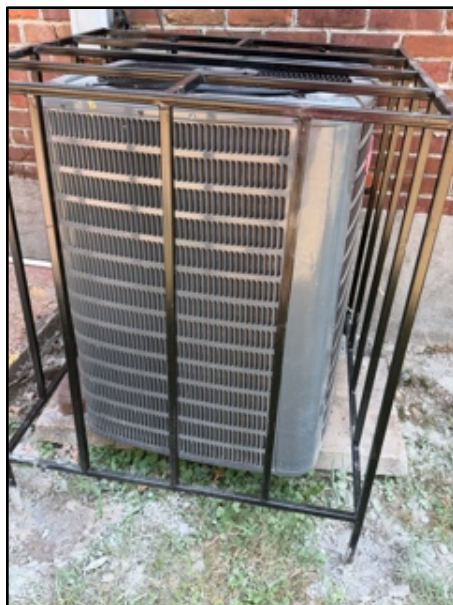
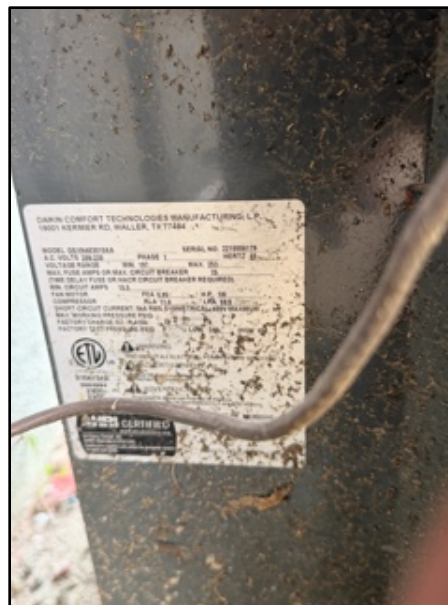
Comment 11:  
Cooling as intended At time of inspection  
Register temps around 65 degrees.

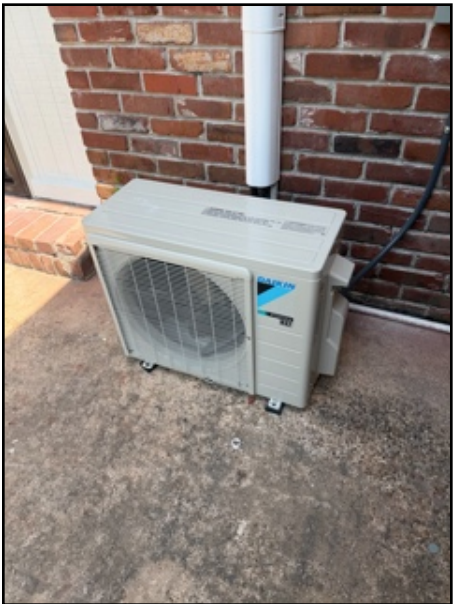
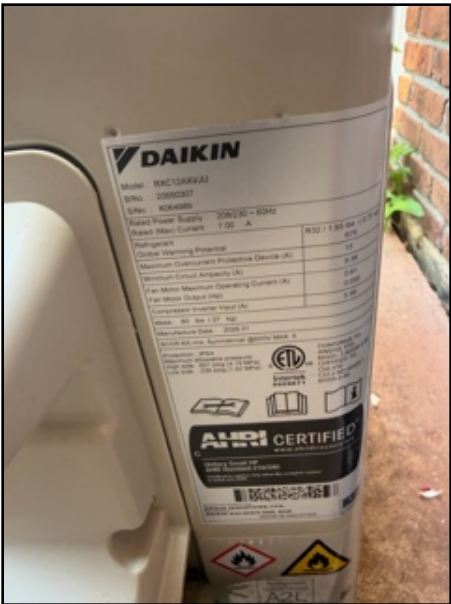
Comment 12:  
dalkin mini split cooling as intended.

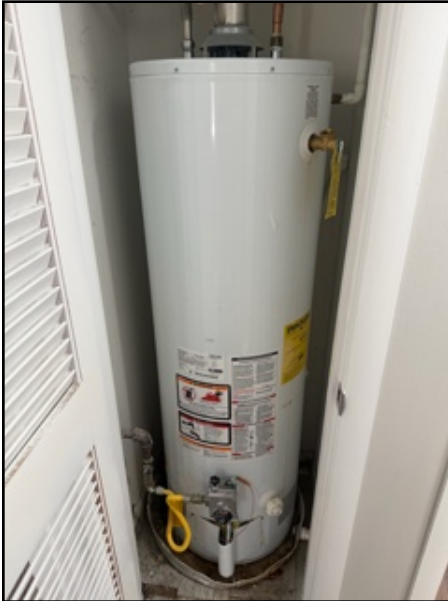
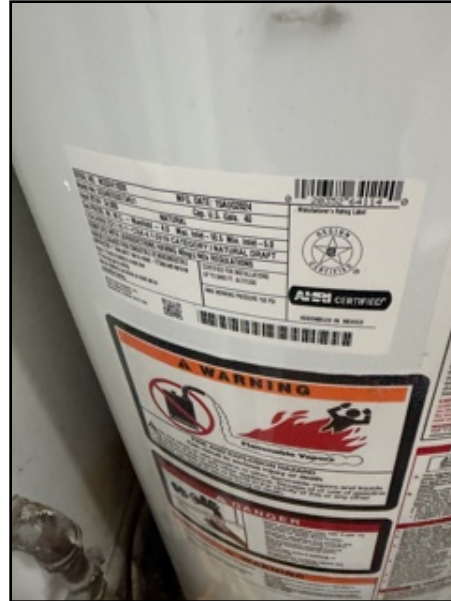
Comment 14:  
Hot water temperature 120°.

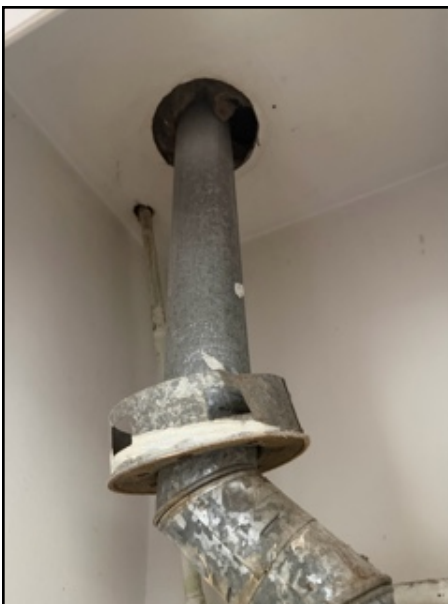
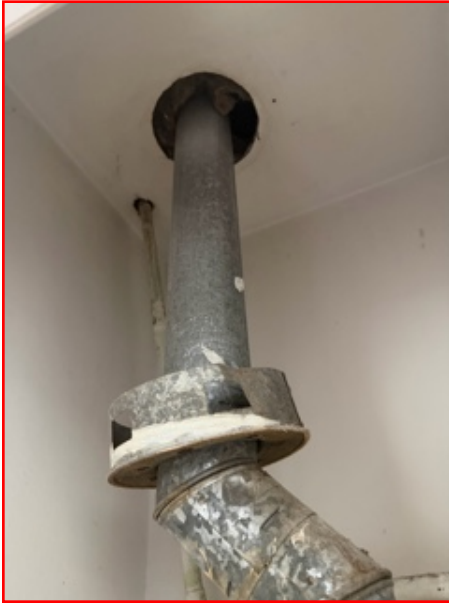
Figure 15-1

Comment 15:  
vent collar needs to be attached to ceiling in hot water heater room.

7) vent collar needs to be attached to ceiling in hot water heater room.

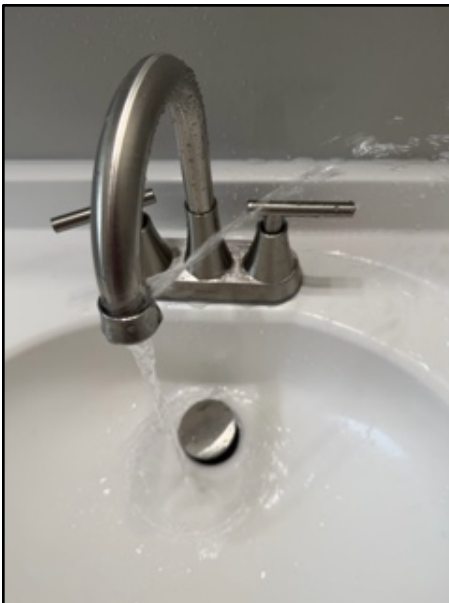
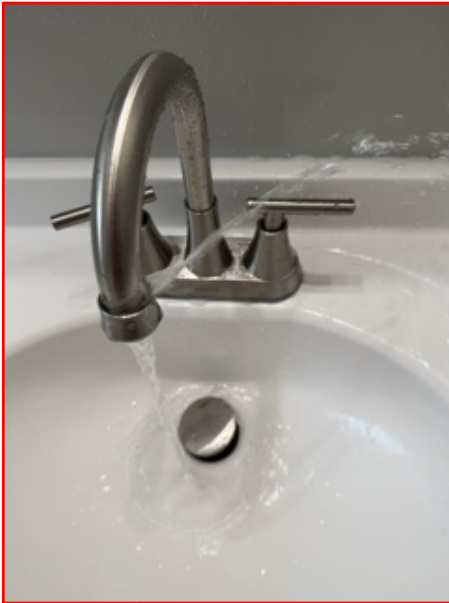
Figure 17-1

water spurts out of top of faucet in bathroom Further evaluation needed by plumber.

8) water spurts out of top of faucet in bathroom Further evaluation needed by plumber.

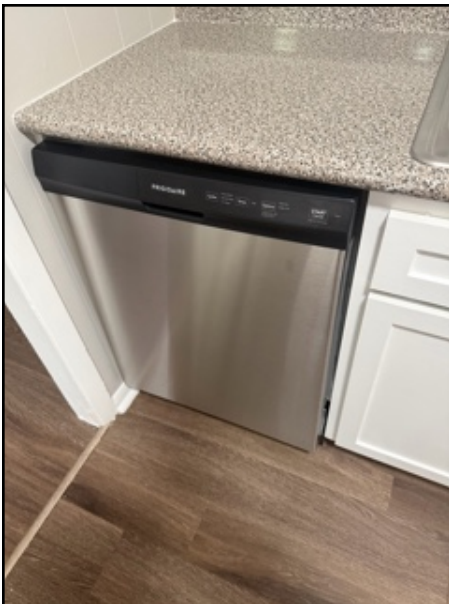
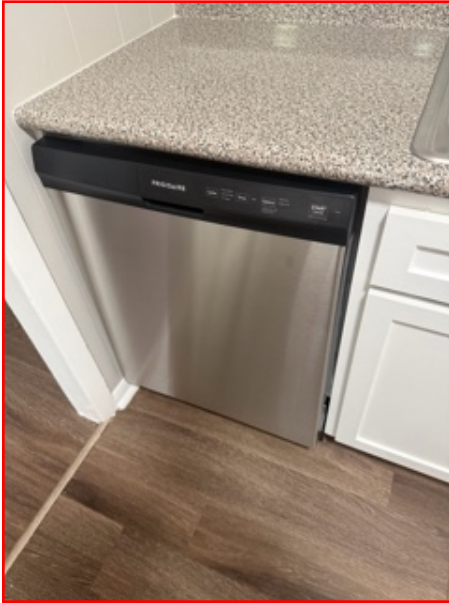
Figure 19-1

Comment 19:  
dishwasher not working at time of inspection.

9) dishwasher not working at time of inspection.

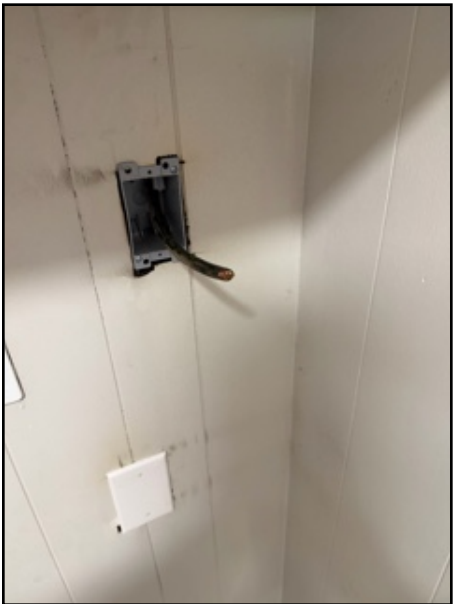
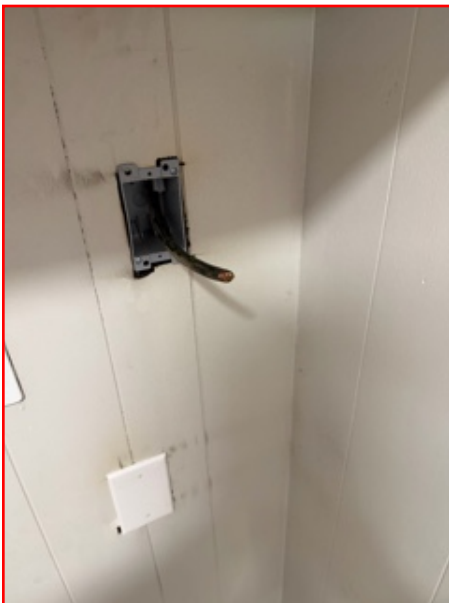
Figure 20-1

Comment 20:  
exposed wiring noted in kitchen area.

10) exposed wiring noted in kitchen area.

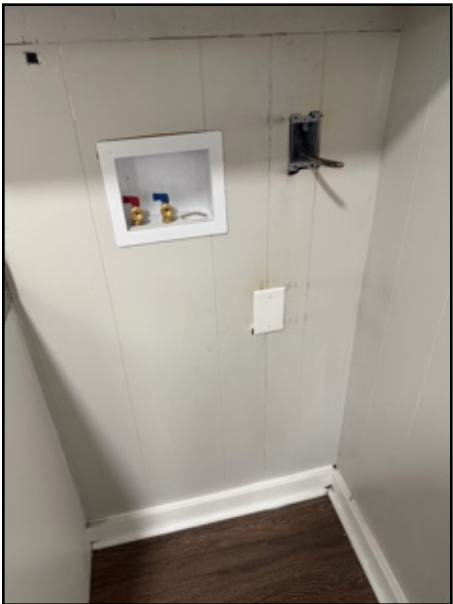
Figure 21-1

| Dryer Venting: | No Venting<br>Condition: Further Evaluation Required |

Comment 21:  
no clothes dryer Connections installed at time of inspection.

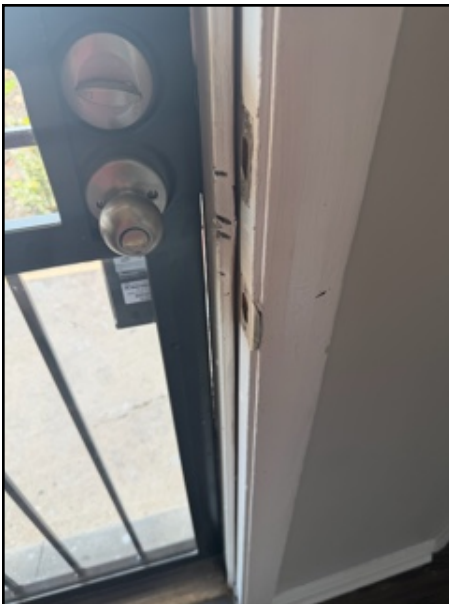
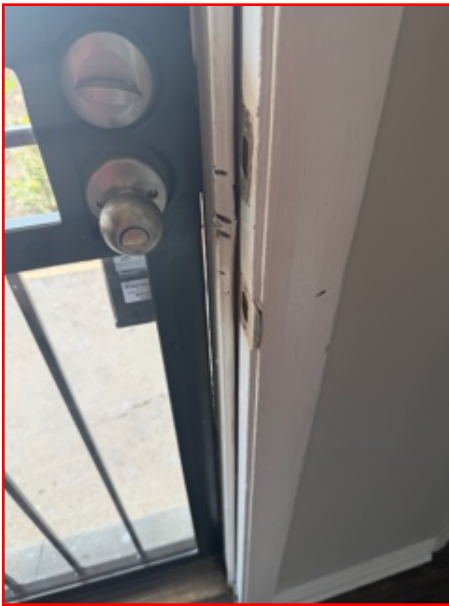
Figure 23-1

Comment 23:  
Air gap noted around front security door.

11) Air gap noted around front security door.

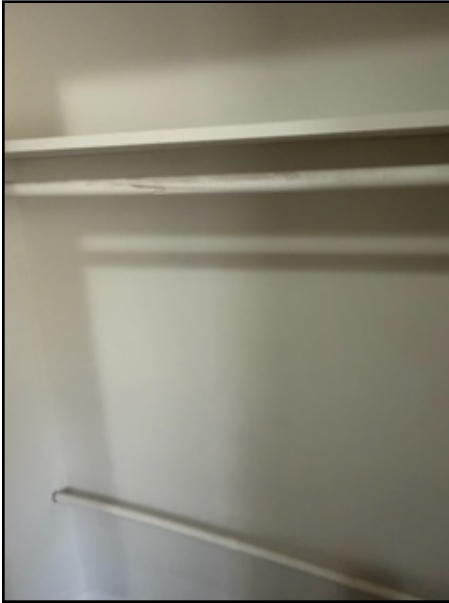
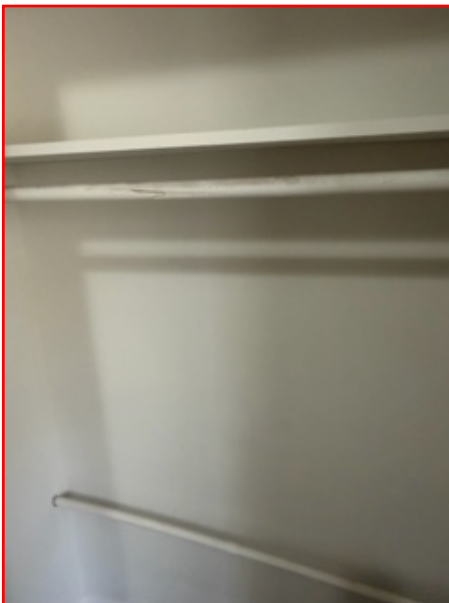
Figure 24-1

**Comment 24:**  
support bracket needed in first bedroom closet or stronger rod installed.

12) support bracket needed in first bedroom closet or stronger rod installed.

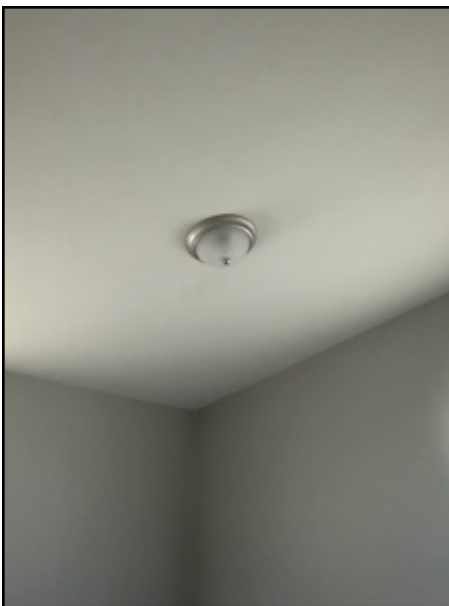
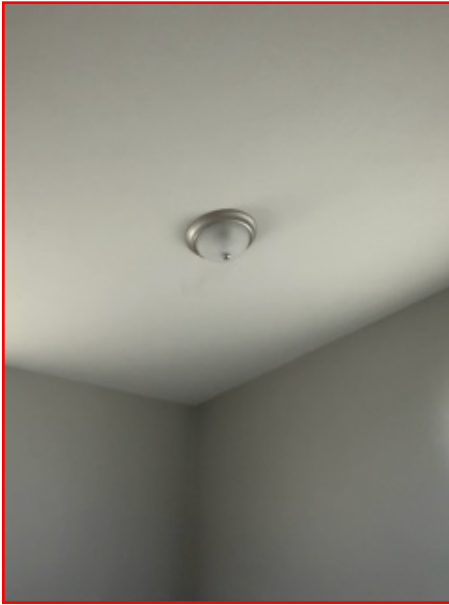
Figure 25-1

**Comment 25:**  
overhead light not working in third bedroom.

13) overhead light not working in third bedroom.
