## RESIDENTIAL REPORT

701 S Mesa Dr  
Mesa, AZ 85210

Brett Atkins  
10/20/2026

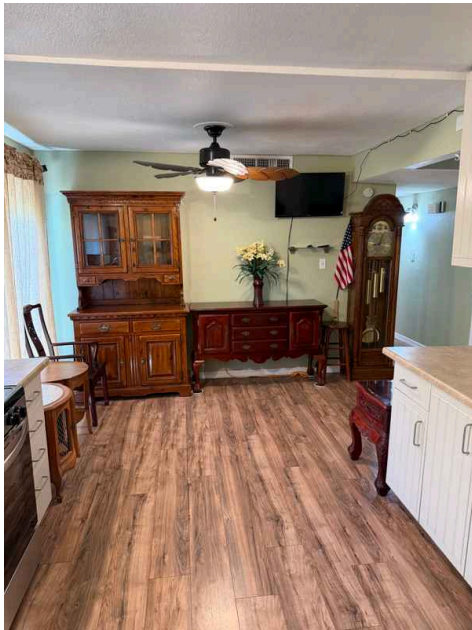
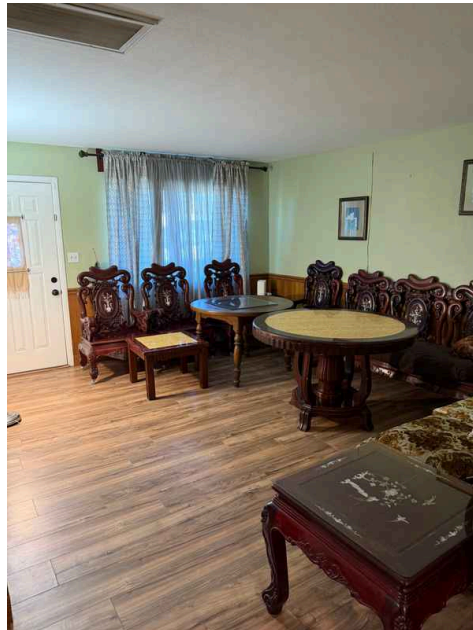
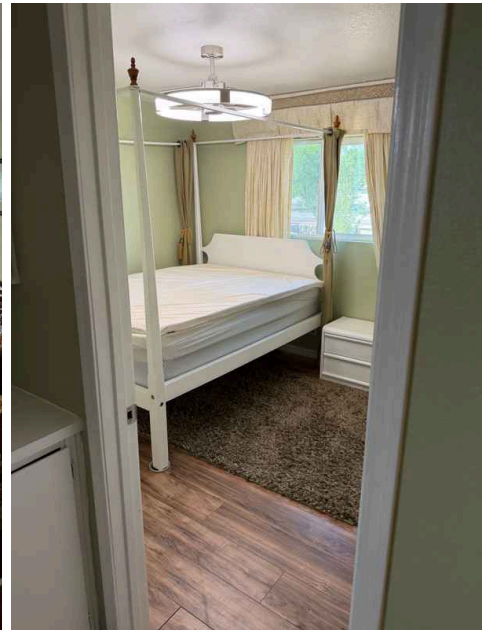
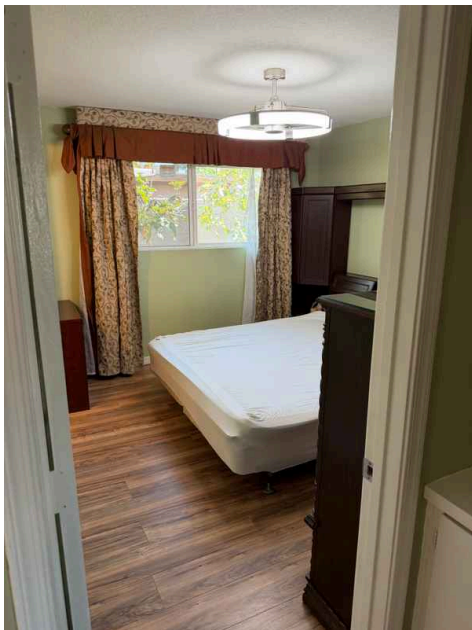
### 1.1.1 General

There was a lot of misc personal property inside of the house at the time of the inspection. It is unknown if all personal property is going to be removed.

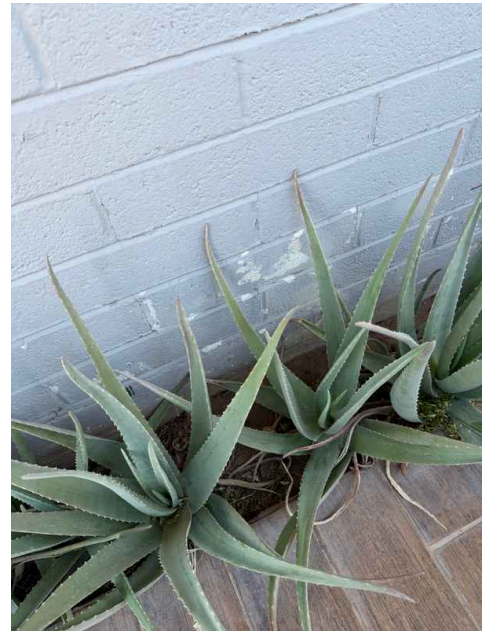
### 1.1.2 General

There is peeling paint to the front planter bed area due to excessive watering. Too much water can continue to erode the paint and bricks. The (2) sheds in the backyard were closed and locked at the time of the inspection. They were not inspected.

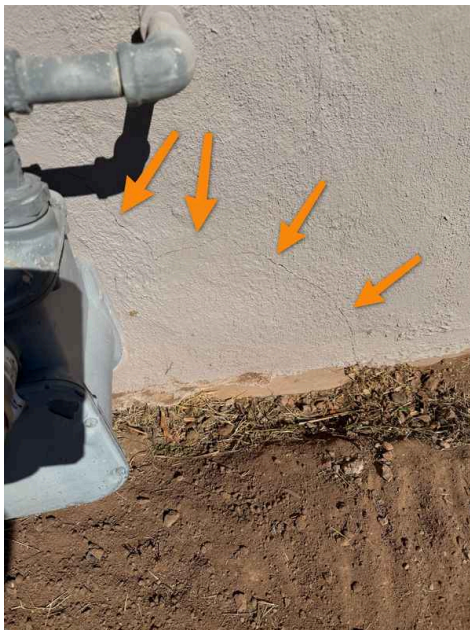
### 1.2.1 Siding, Flashing & Trim

Siding showed cracking on the right side near the gas meter. Recommend monitoring.

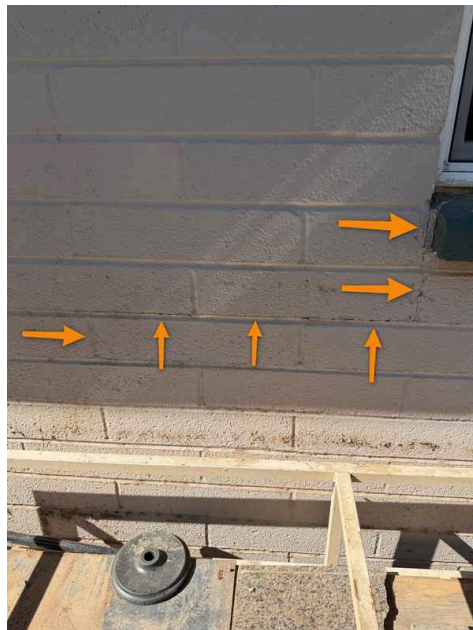
There was cracking in the siding in the rear of the house near the window. Recommend monitoring,

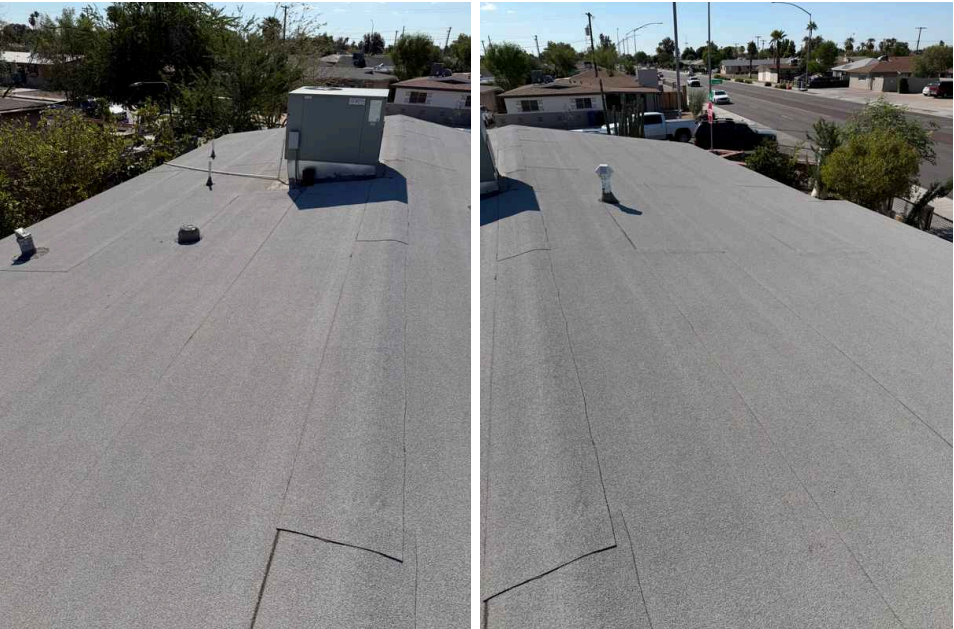
2.1.1 Coverings

The roof is rolled bitumen roof. The roof was in good condition at the time of the inspection.

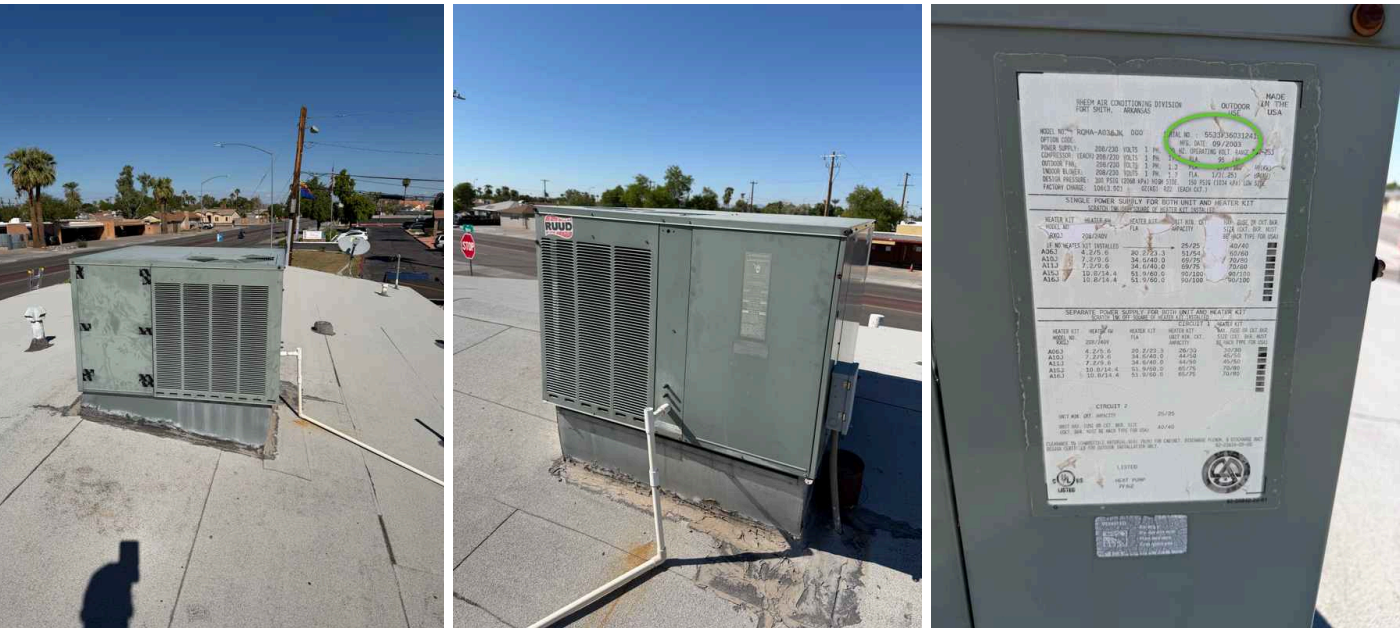
### A/C Age

The HVAC is a roof mounted Ruud heat pump from 09/2003.

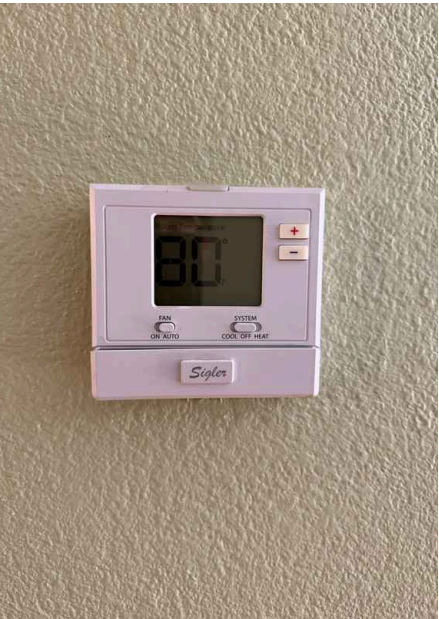
### A/C Temperature

The HVAC was off at the time of the inspection.

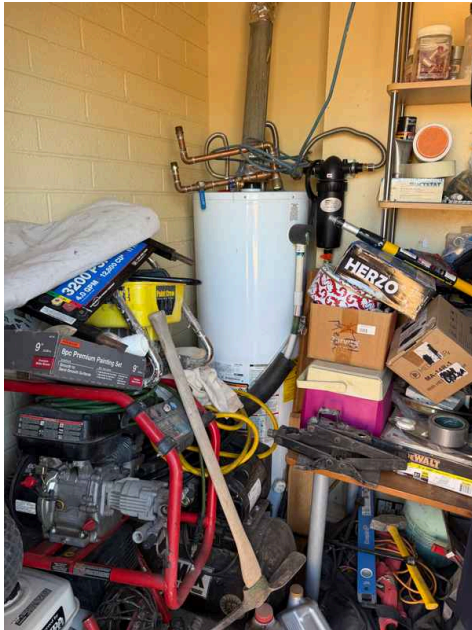
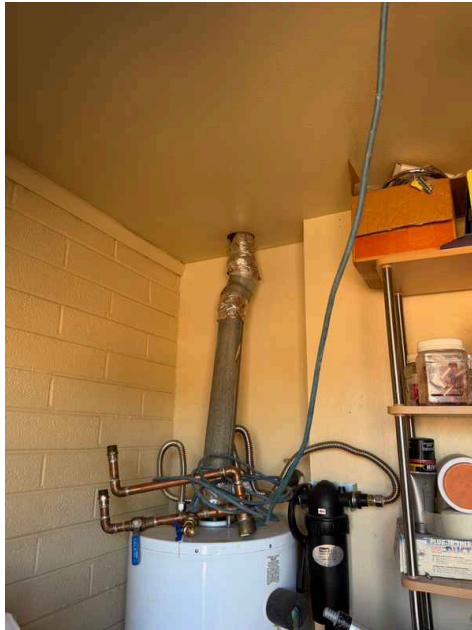
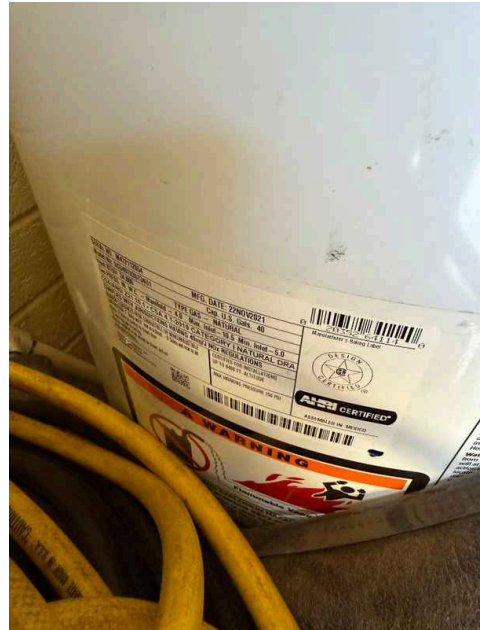
#### 4.4.1 Hot Water Systems, Controls, Flues & Vents

The water heater mfg. date is 11/2021.

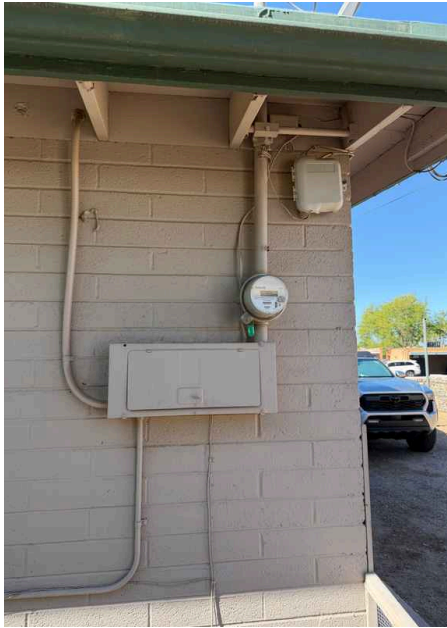
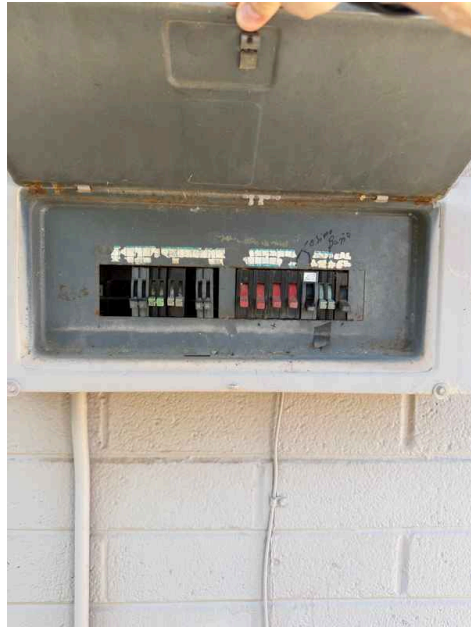
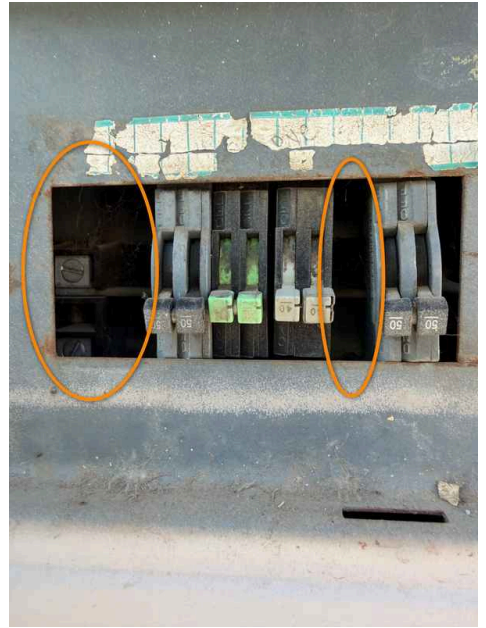
#### Electrical Panel

The electrical panel is located on the backside of the house. It is a 50 amp panel. There are numerous breakers missing. It is unknown if there is a main disconnect.
