## Home Inspection Report

**4734**

**Quintell**

**Memphis, Tn 38128**

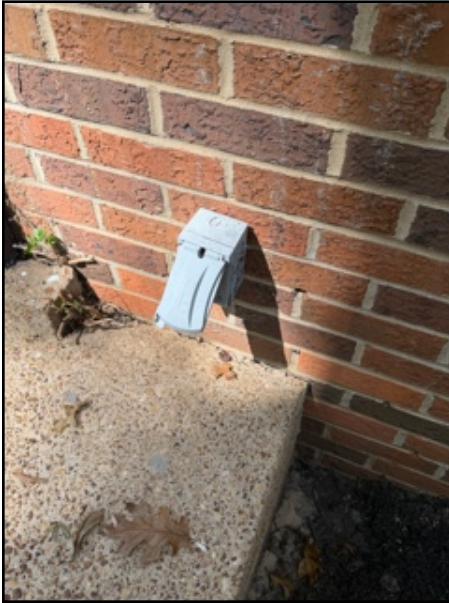
Figure 3-1

Comment 3:  
GFI outlet not working at front of house.

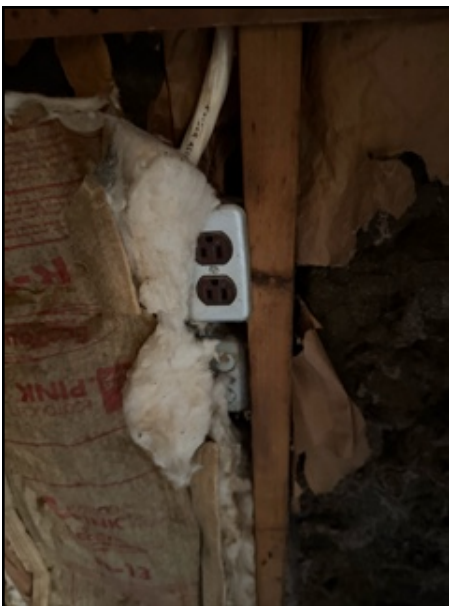
Figure 4-1

Comment 4:  
electrical outlet not working in storage room.

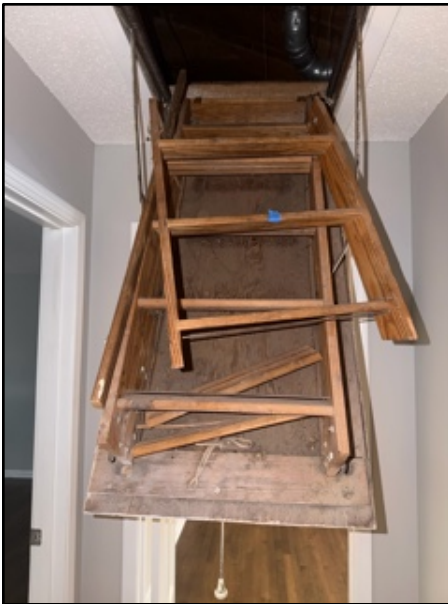
Figure 6-1

Comment 6:  
was not able to access attic due to attic stairs damage.

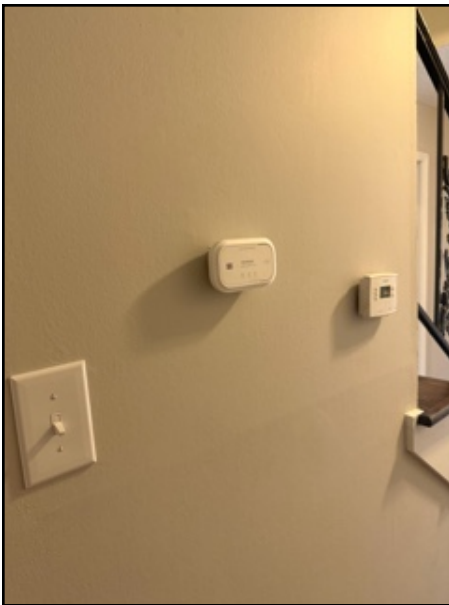
Figure 8-1

Comment 8:  
carbon monoxide detector is installed.

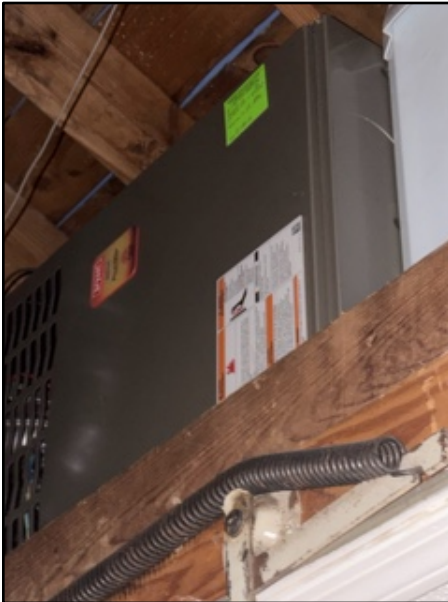
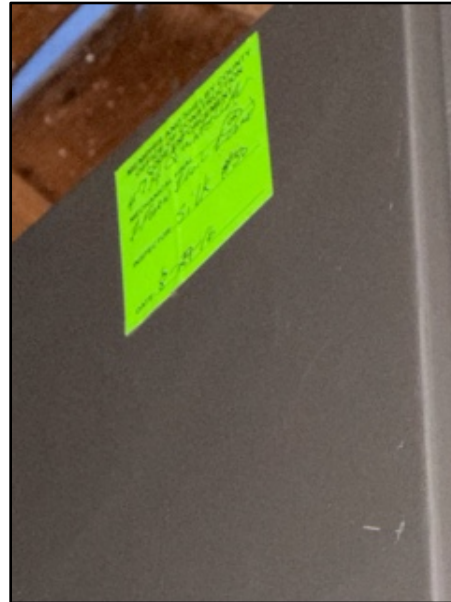
furnace not operating at time of inspection Further evaluation needed by HVAC tech technician.

Furnaces over 10 years old should be checked, cleaned and serviced yearly

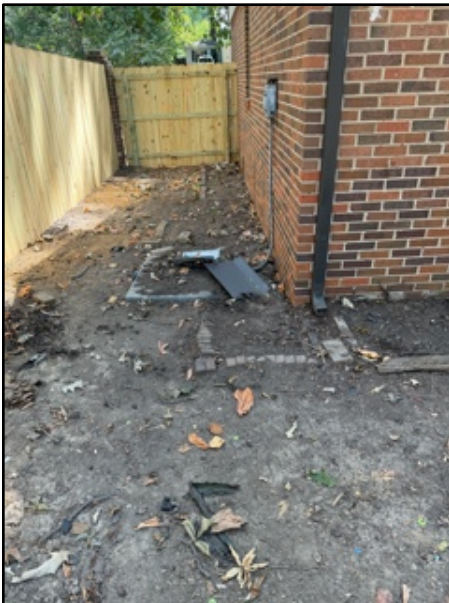
Figure 10-1

no AC condenser installed at time of inspection.

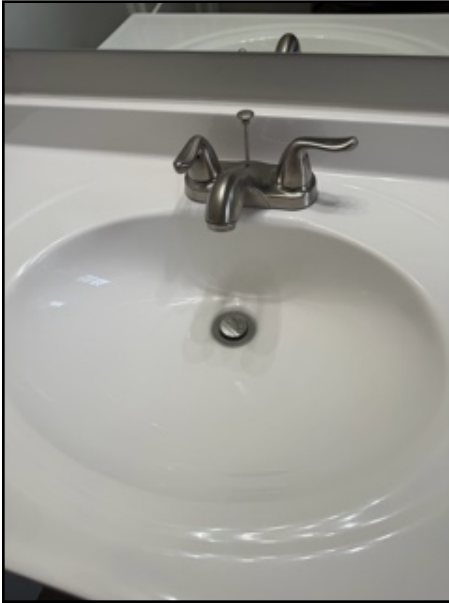
Figure 13-1

no hot water flowing in Hall bathroom downstairs although valve is turned on.

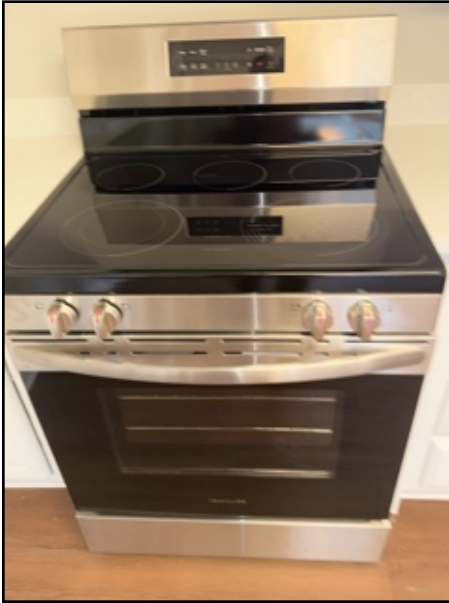
Figure 15-1

Comment 15:  
stove not operating at time of inspection.

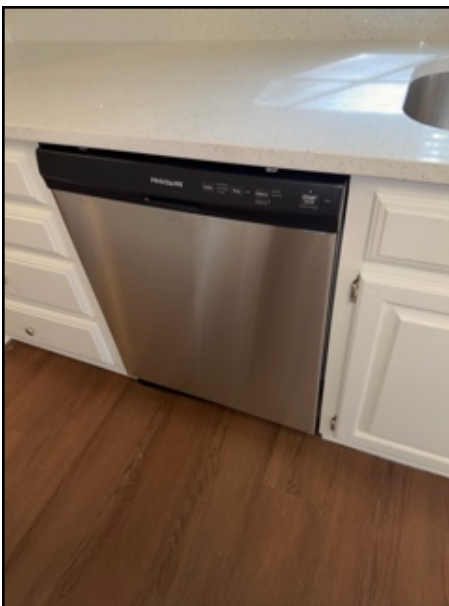
Figure 16-1

Comment 16:  
dishwasher not operating at time of inspection.

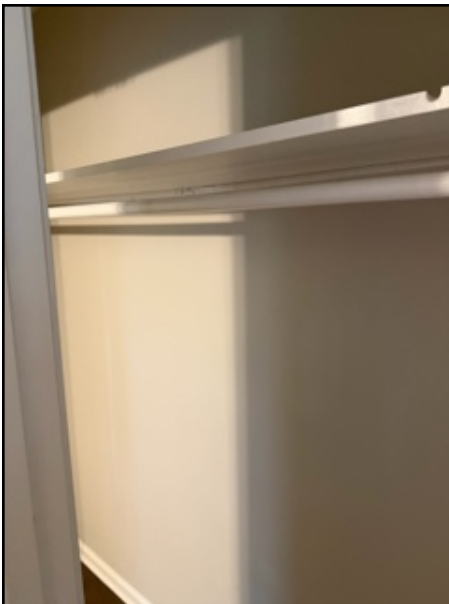
Figure 19-1

Comment 19:  
support bracket needed in master bedroom closet.

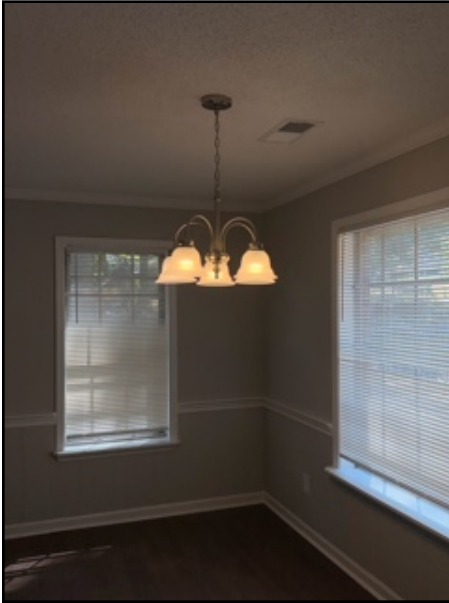
Figure 20-1

Comment 20:  
dining room light could not be turned off.

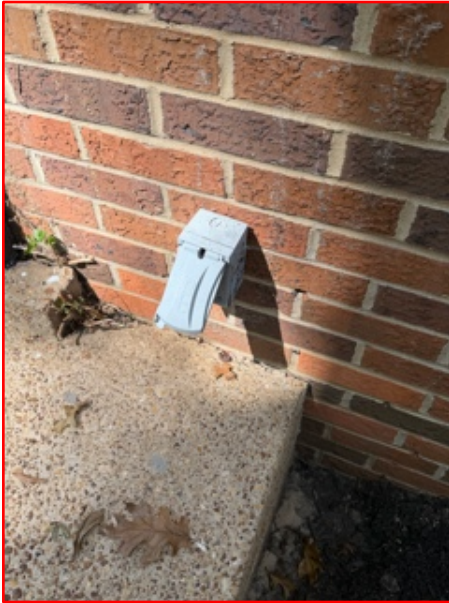
Figure 3-1

1) GFI outlet not working at front of house.

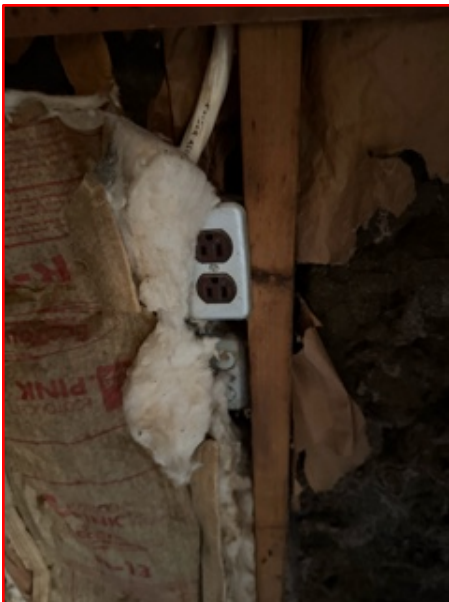
Figure 4-1

2) electrical outlet not working in storage room.

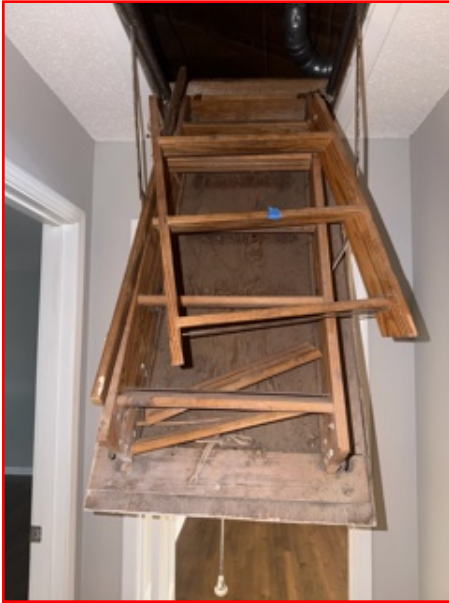
Figure 6-1

4) was not able to access attic due to attic stairs damage.

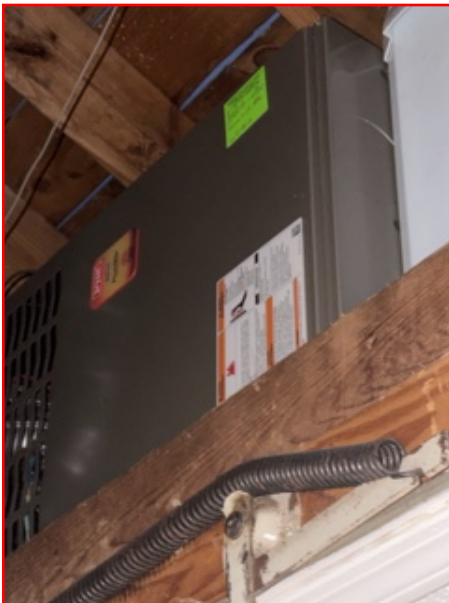
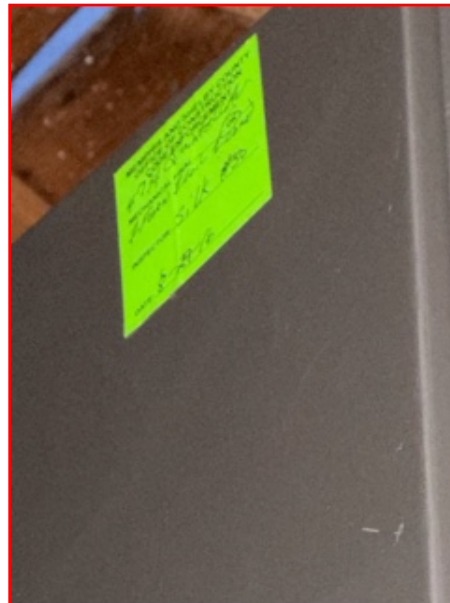
5) furnace not operating at time of inspection Further evaluation needed by HVAC tech technician.

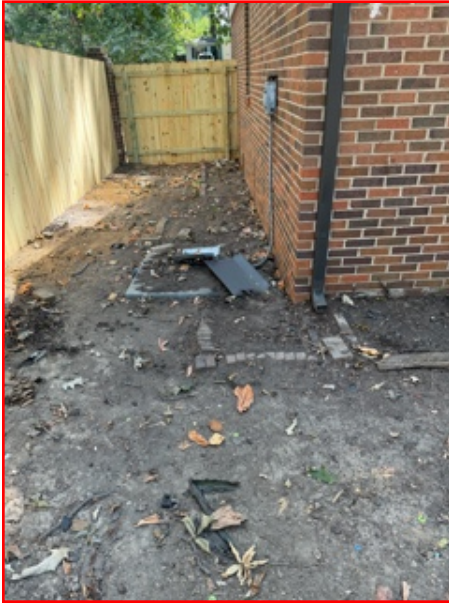
Figure 10-1

6) no AC condenser installed at time of inspection.

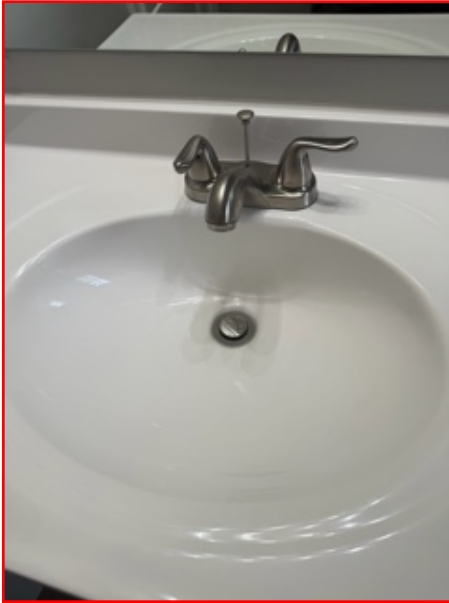
Figure 13-1

8) no hot water flowing in Hall bathroom downstairs although valve is turned on.

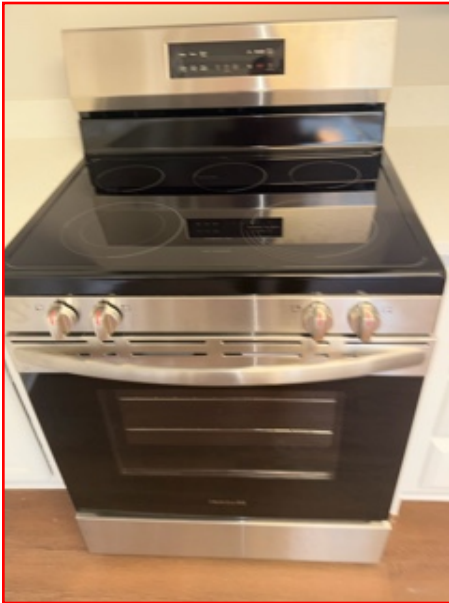
Figure 15-1

9) stove not operating at time of inspection.

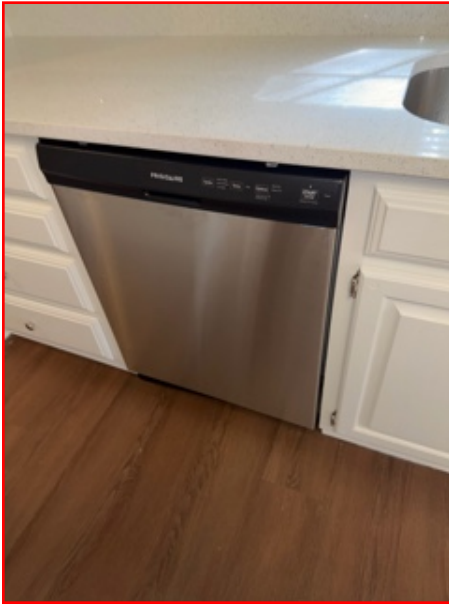
Figure 16-1

10) dishwasher not operating at time of inspection.

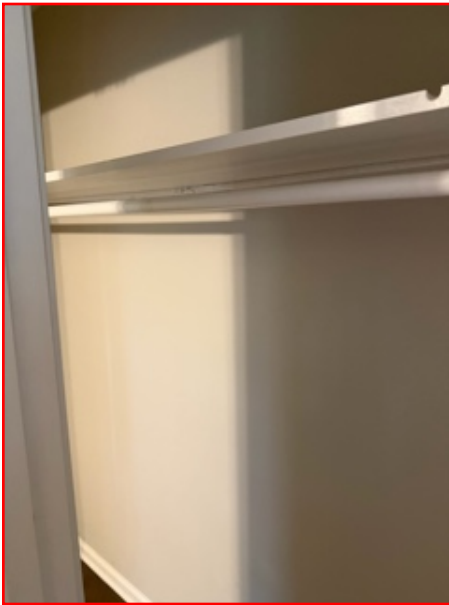
Figure 19-1

11) support bracket needed in master bedroom closet.

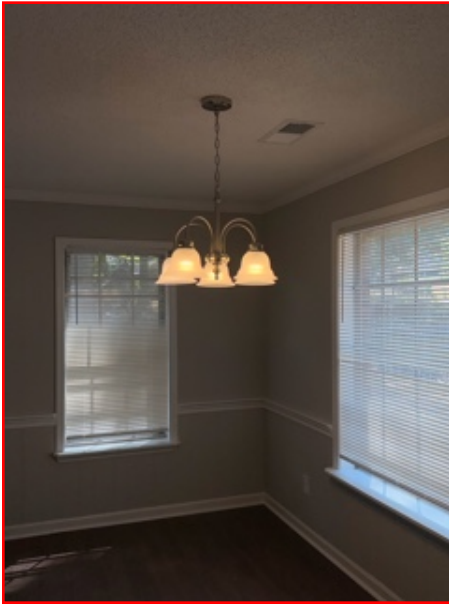
Figure 20-1

12) dining room light could not be turned off.
