## Home Inspection Report

**1633**

**puryear**

**Memphis, Tn 38116**

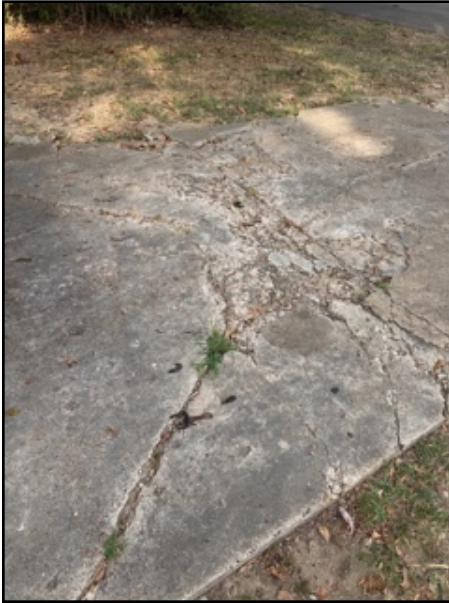
Figure 2-1

minor concrete repair needed on driveway as noted by picture.

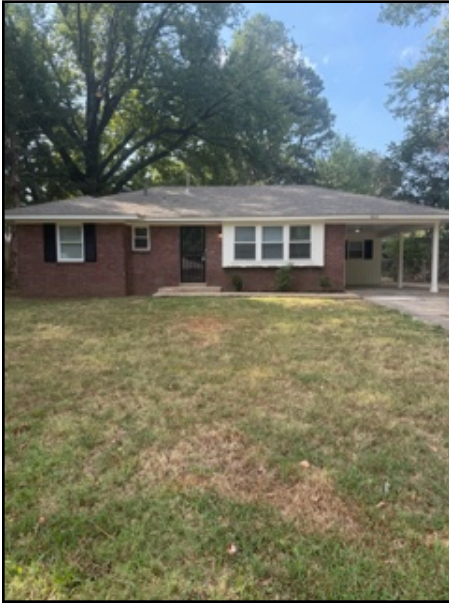
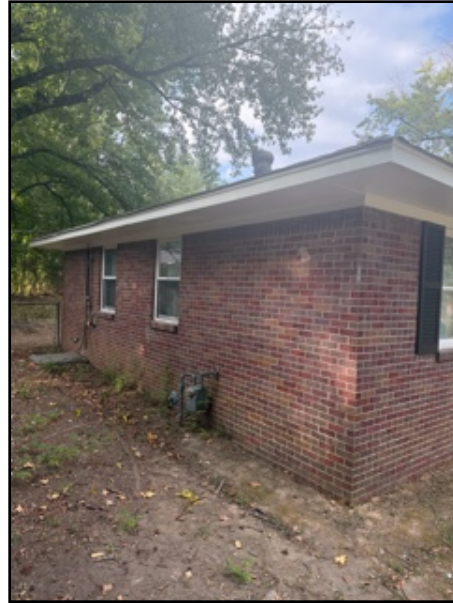
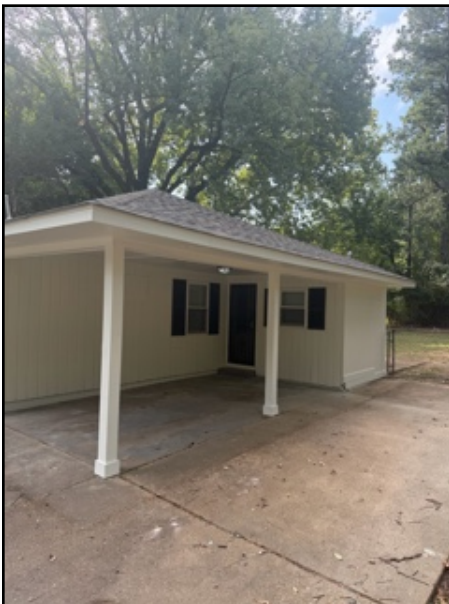
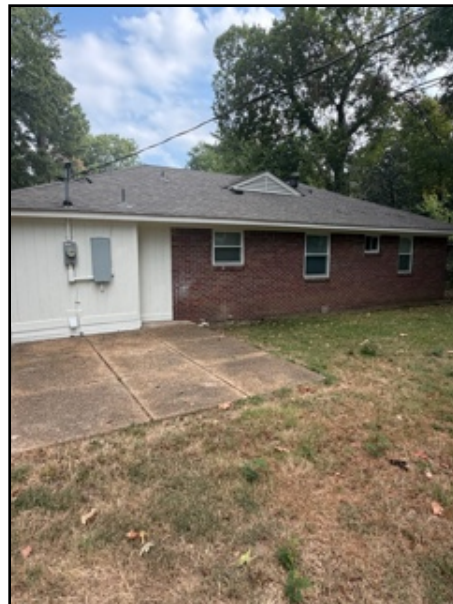
Comment 3:  
General pictures of exterior.

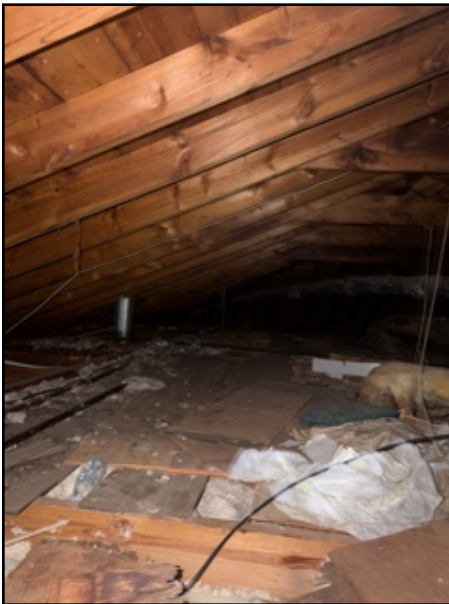
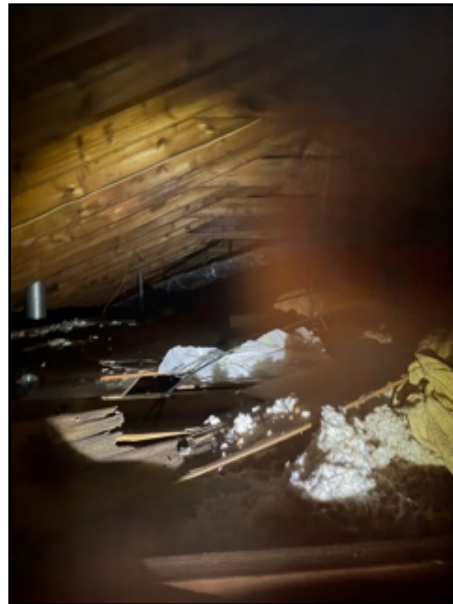
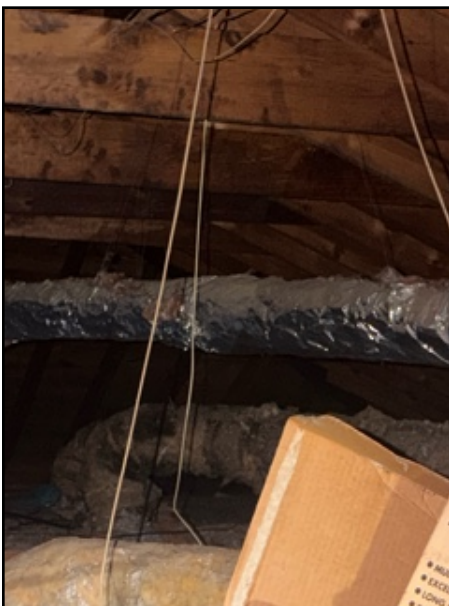
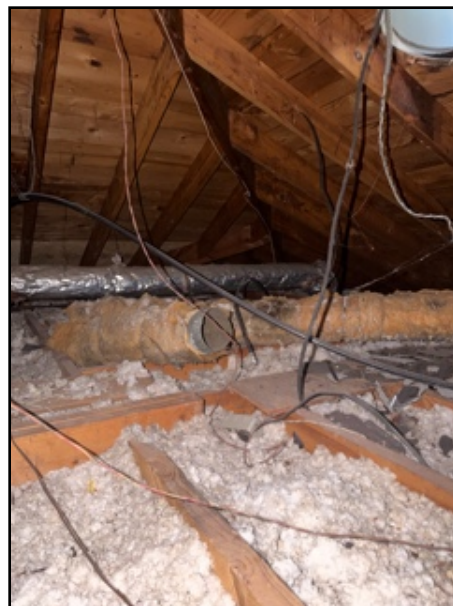
Attic is in good condition.. Framing is sound and there is no evidence of leaks

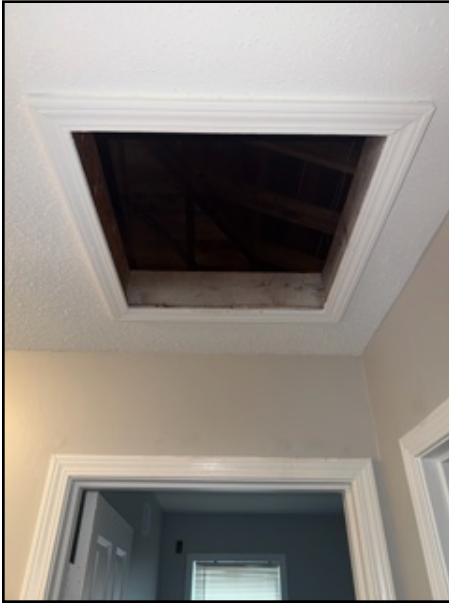
Figure 5-1

Comment 5:  
attic access door needed as noted by picture.

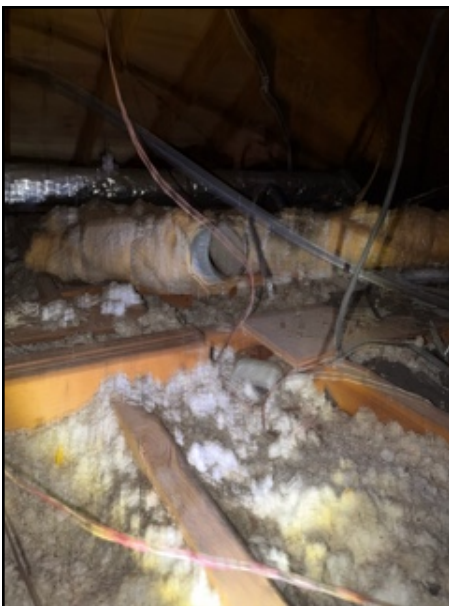
Figure 6-1

Comment 6:  
ductwork appears to be disconnected in attic as noted by picture.

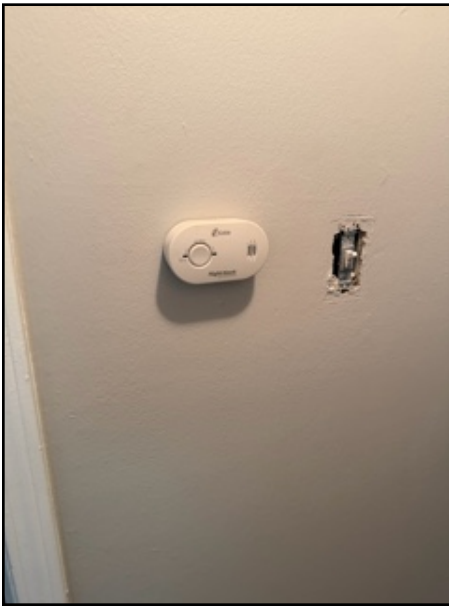
Figure 8-1

Comment 8:  
carbon monoxide detector is installed.

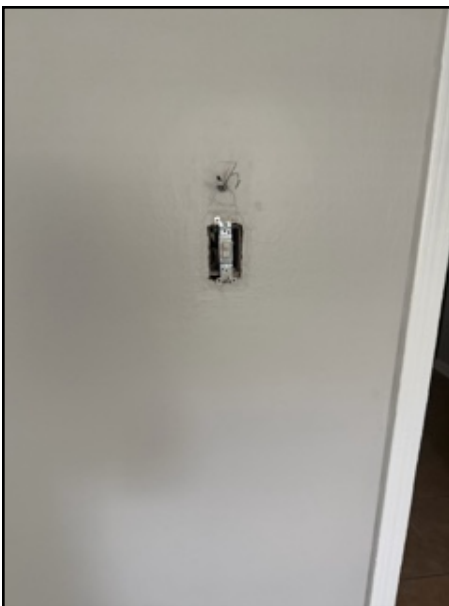
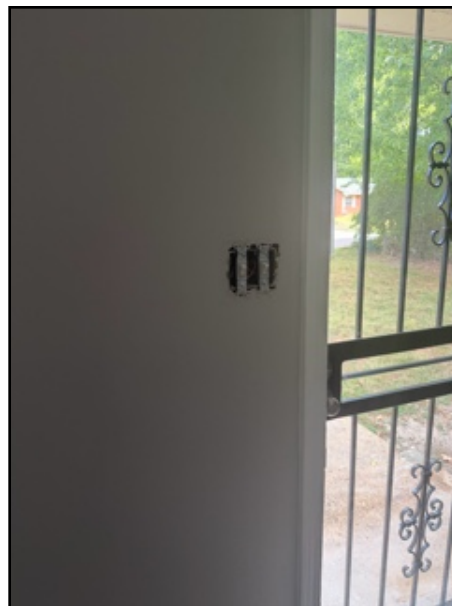
Comment 9:  
electrical outlet and light switch covers needed throughout house.

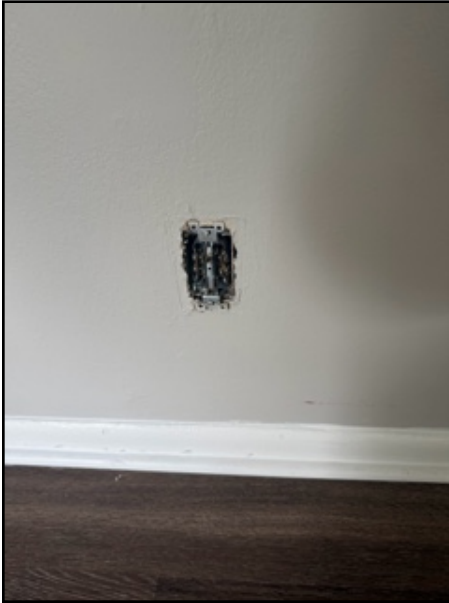
Figure 10-1

Comment 10:  
electrical outlet needs to be replaced in living room.

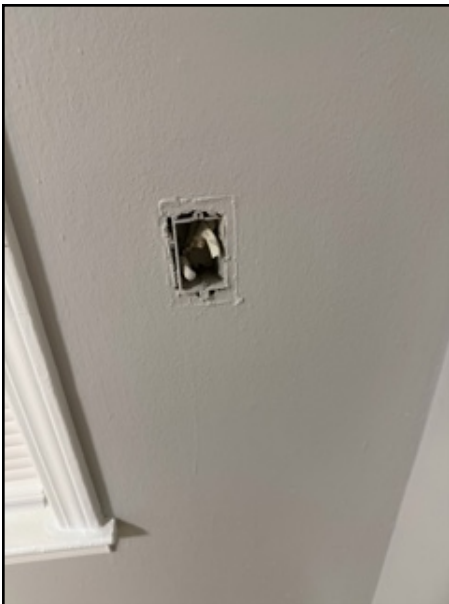
Figure 11-1

Comment 11:  
junction box cover needed in kitchen.

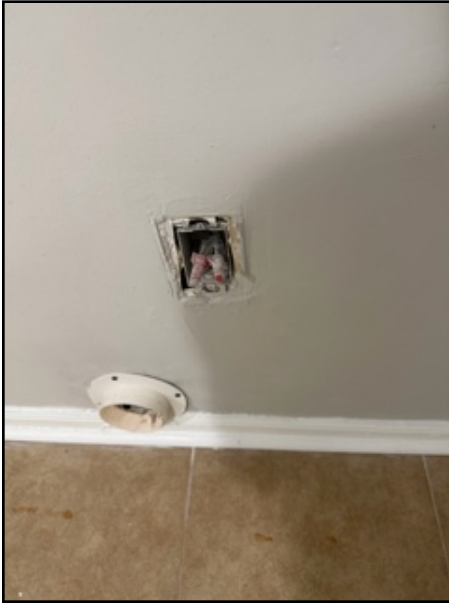
Figure 12-1

Comment 12:  
exposed wires noted in laundry room.

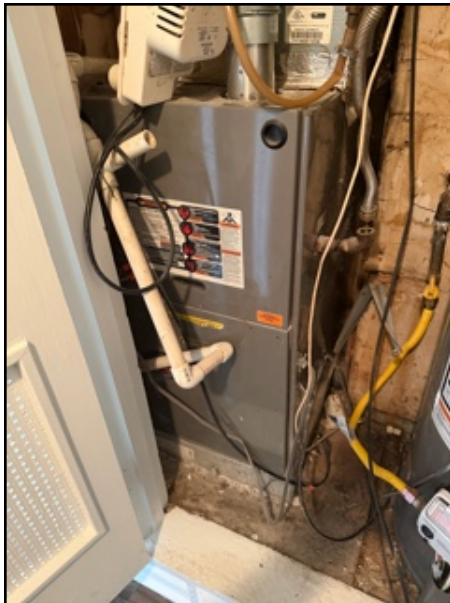
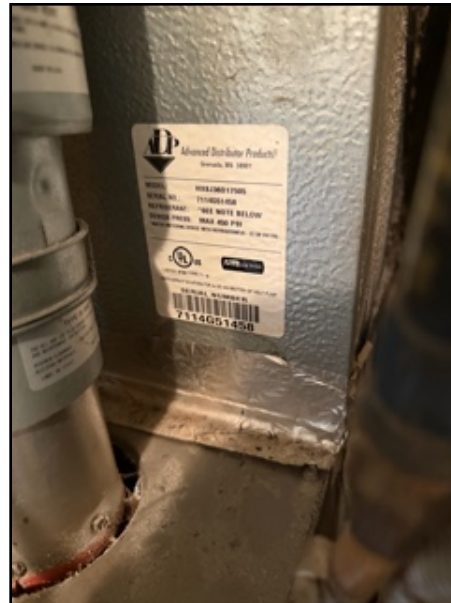
furnace not operating that time of inspection No gas turned on.

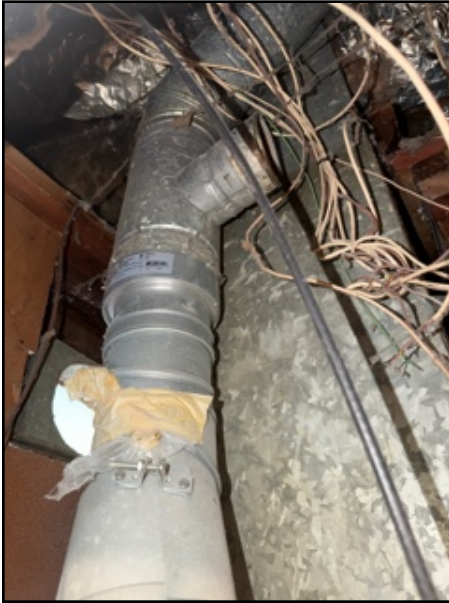
Figure 14-1

Comment 14:  
incorrect vent installed on furnace as noted by picture.

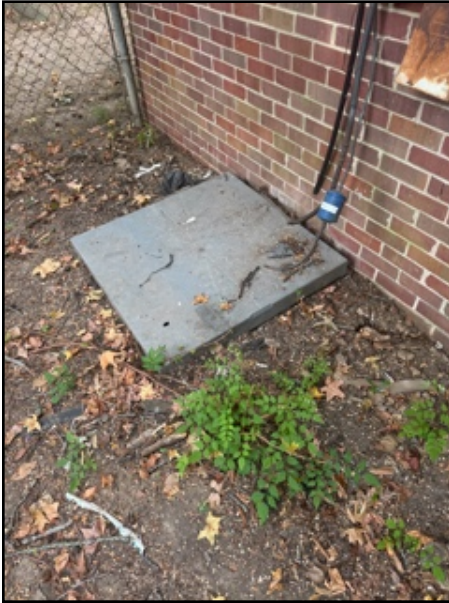
Figure 15-1

Comment 15:  
no AC condenser installed at time of inspection.

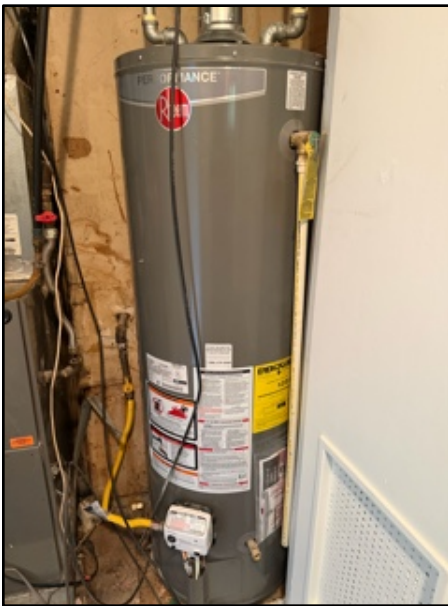
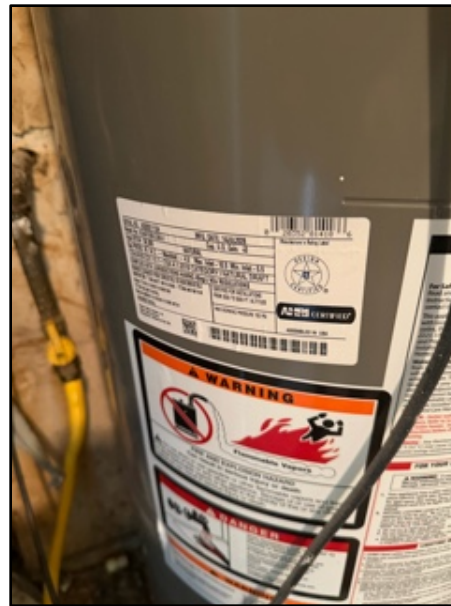
Hot water temperature only lukewarm Further evaluation needed by Plumber.

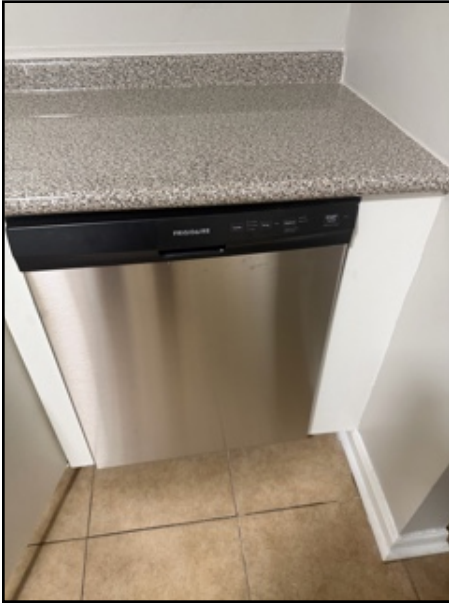
Figure 19-1

Comment 19:  
dishwasher not operating at time of inspection.

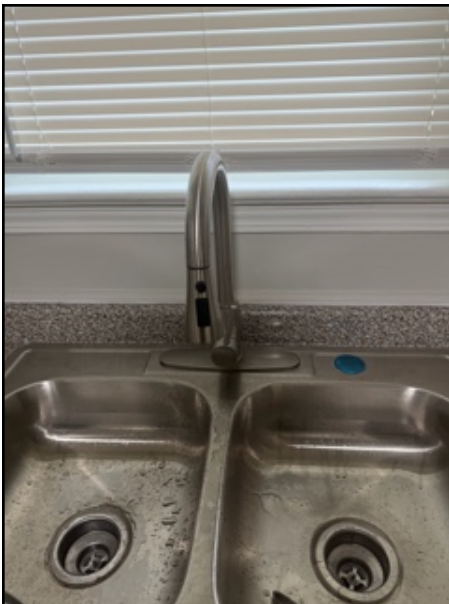
Figure 20-1

Comment 20:  
kitchen faucet, not working at time of inspection.

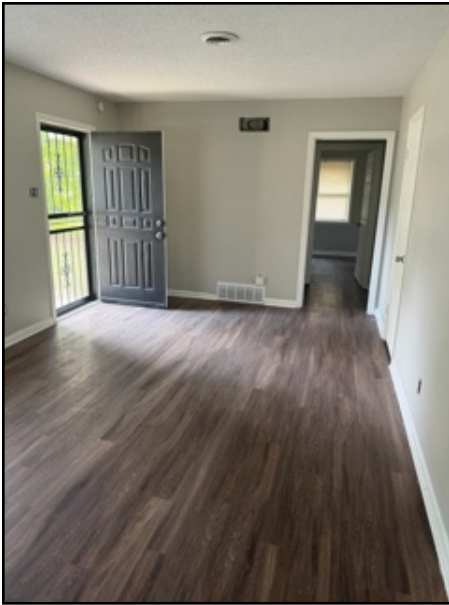
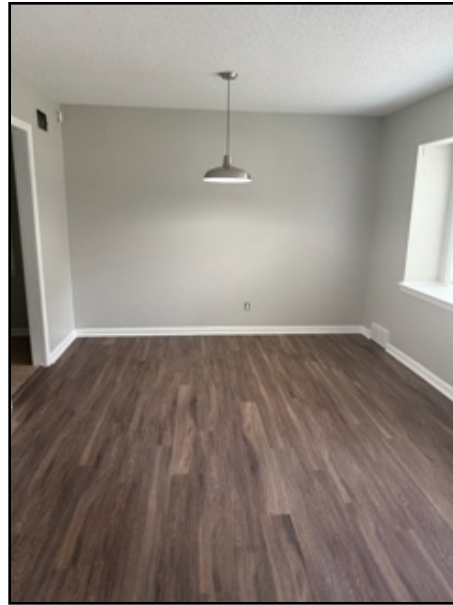
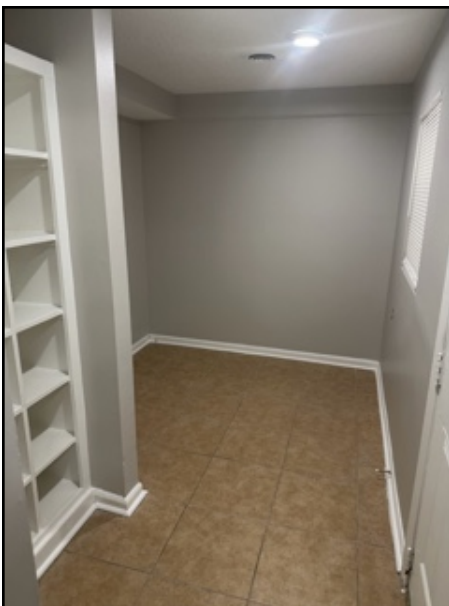
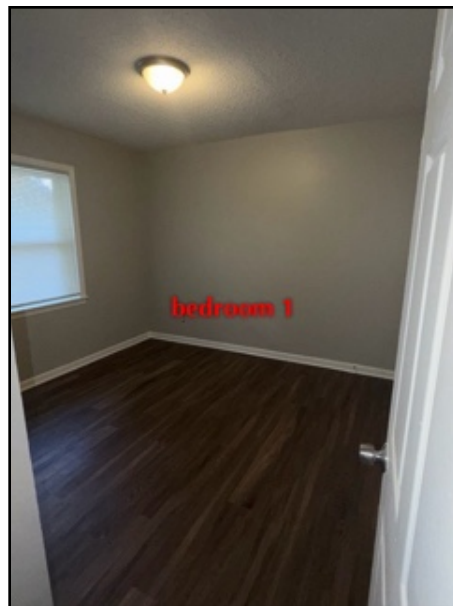
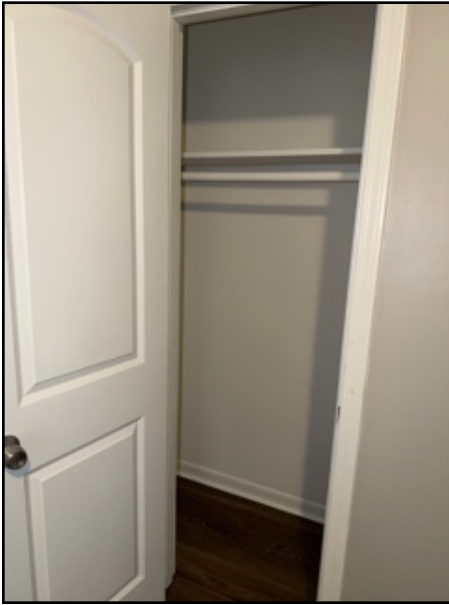
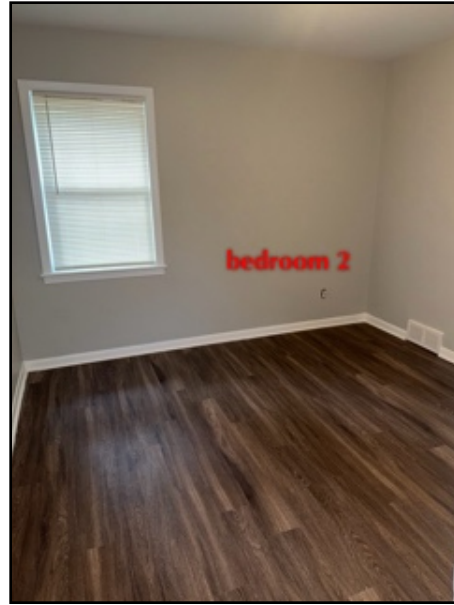
Comment 22:  
General pictures of Living room, dining area, bedrooms and closets.

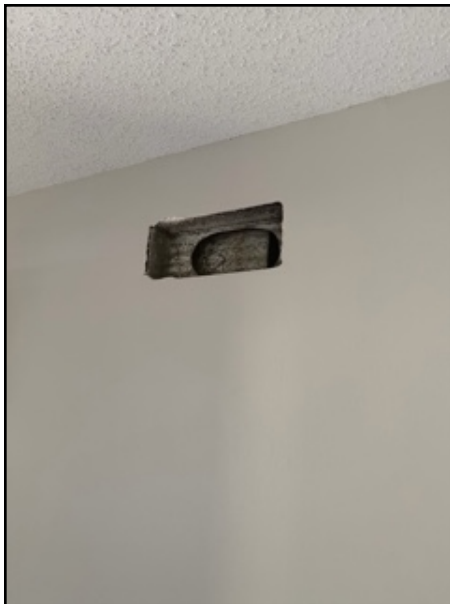
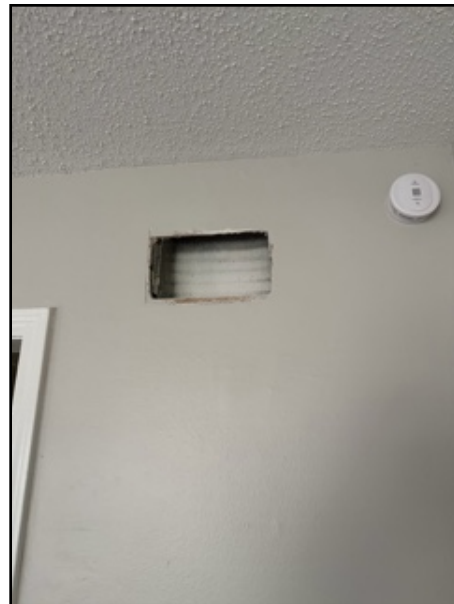
Comment 23:  
vent covers missing in living room.

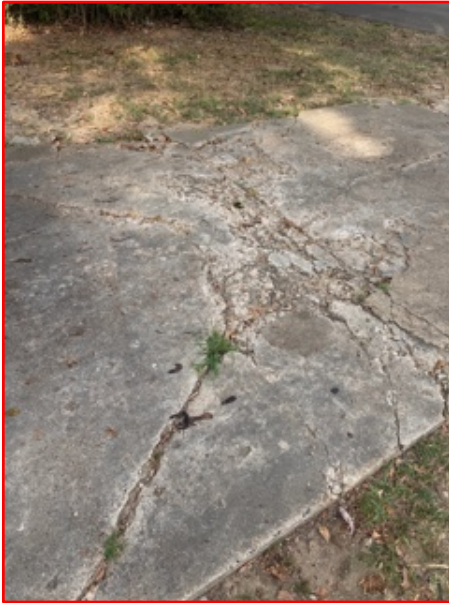
Figure 2-1

1) minor concrete repair needed on driveway as noted by picture.

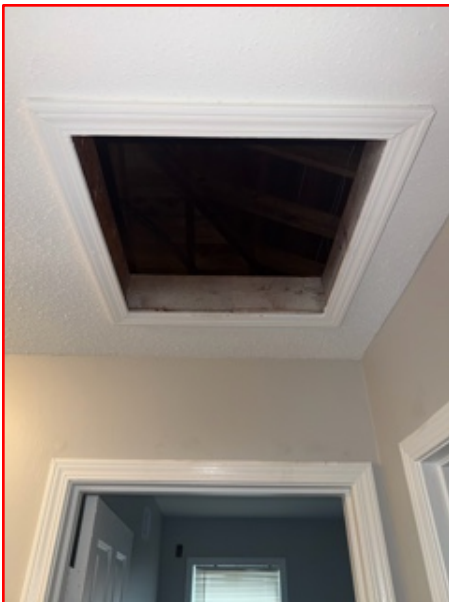
Figure 5-1

2) attic access door needed as noted by picture.

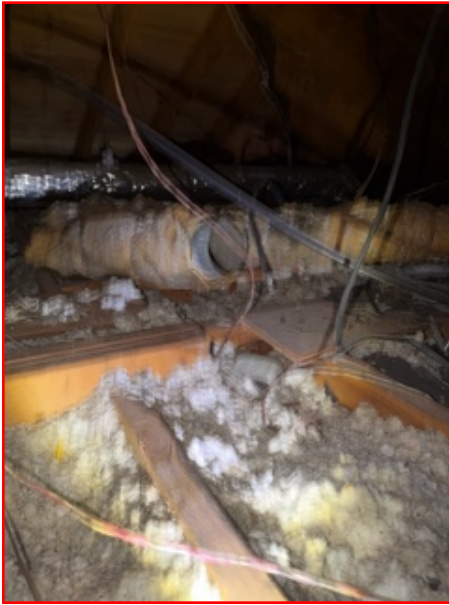
Figure 6-1

3) ductwork appears to be disconnected in attic as noted by picture.

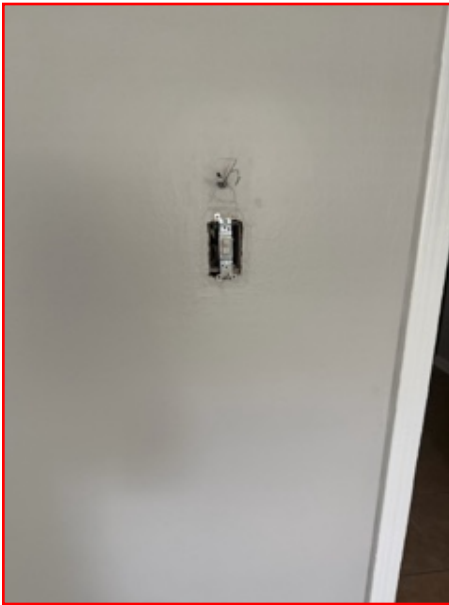
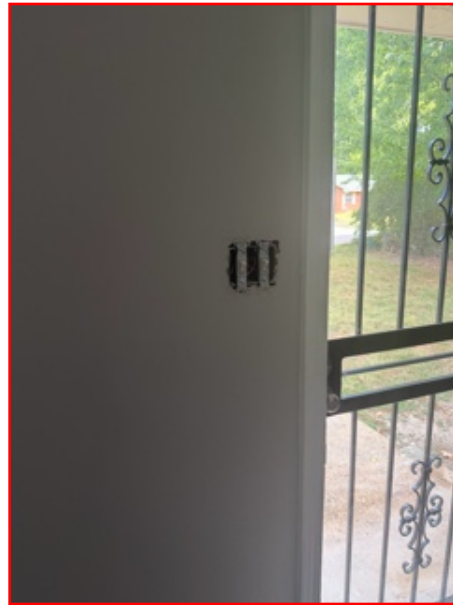
4) electrical outlet and light switch covers needed throughout house.

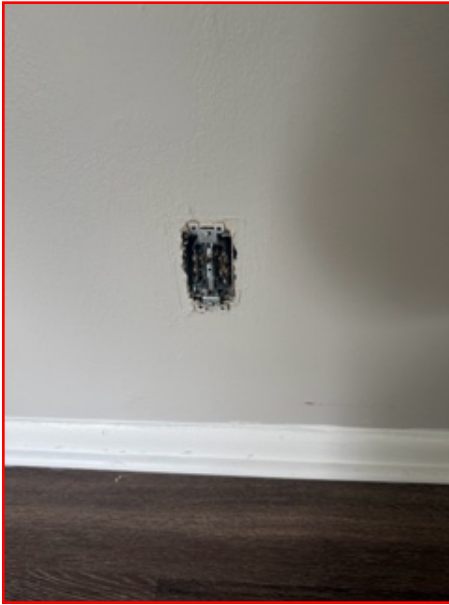
Figure 10-1

5) electrical outlet needs to be replaced in living room.

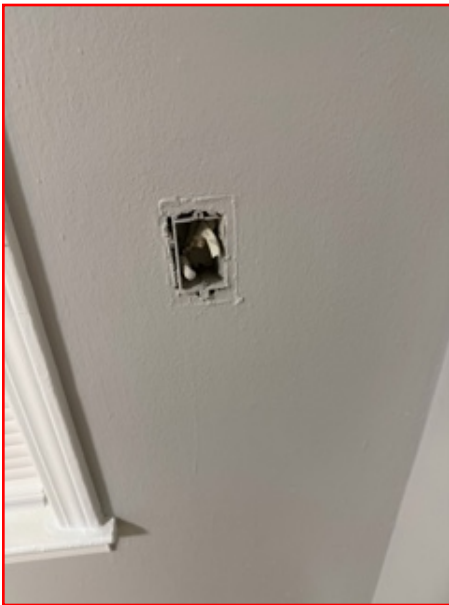
Figure 11-1

6) junction box cover needed in kitchen.

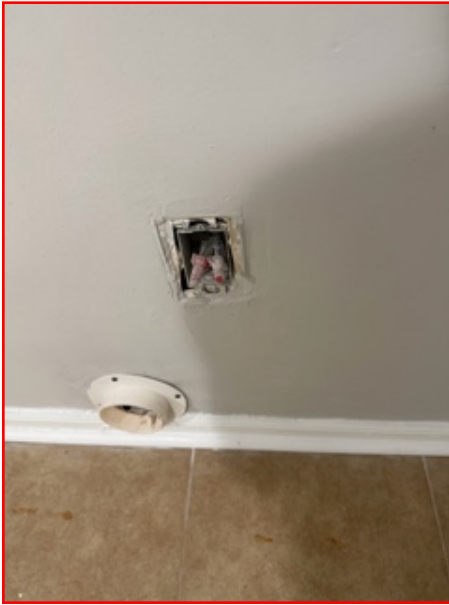
Figure 12-1

7) exposed wires noted in laundry room.

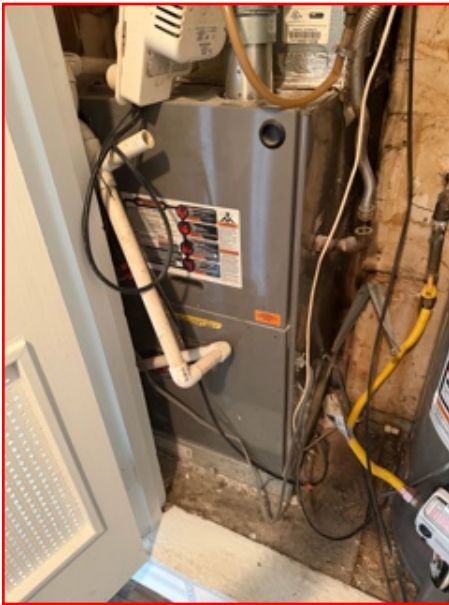
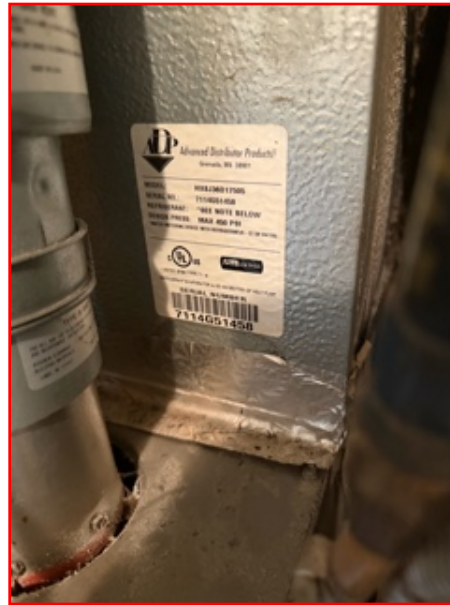
8) furnace not operating that time of inspection No gas turned on.

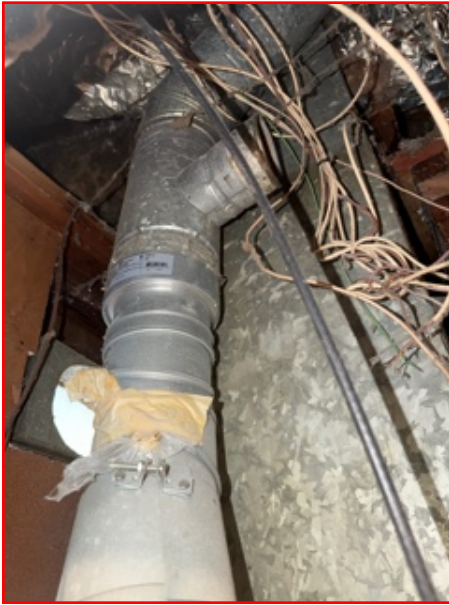
Figure 14-1

9) incorrect vent installed on furnace as noted by picture.

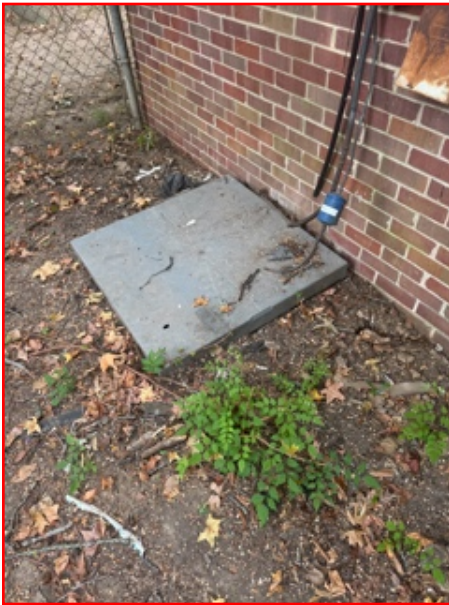
Figure 15-1

10) no AC condenser installed at time of inspection.

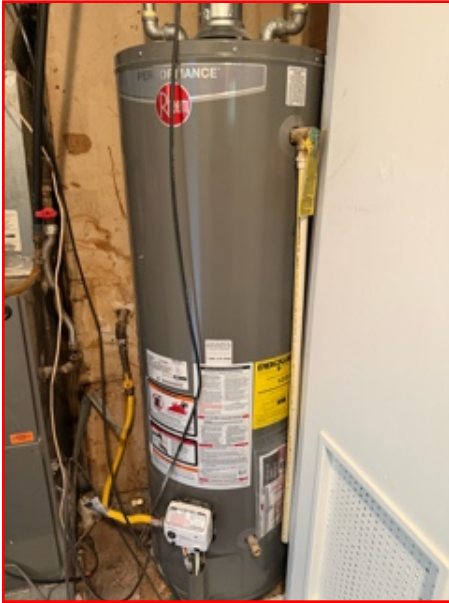
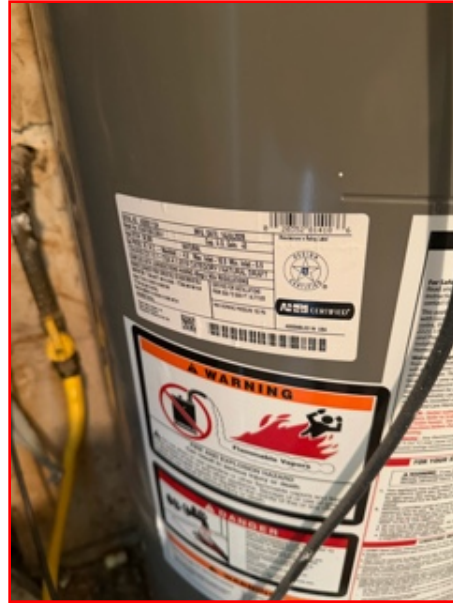
11) Hot water temperature only lukewarm Further evaluation needed by Plumber.

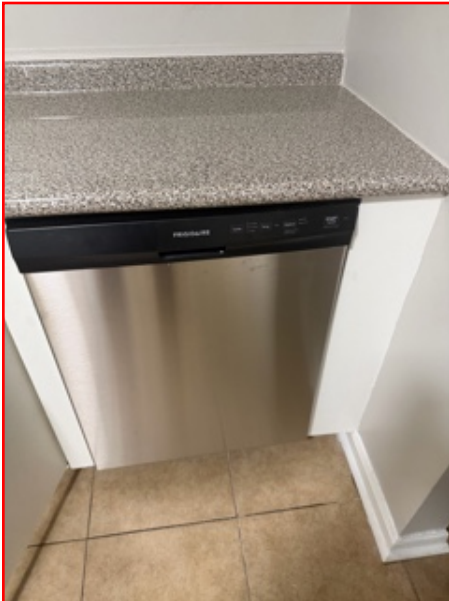
Figure 19-1

12) dishwasher not operating at time of inspection.

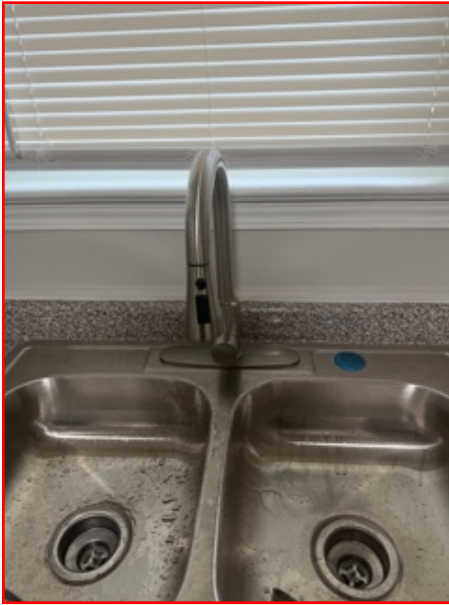
Figure 20-1

13) kitchen faucet, not working at time of inspection.

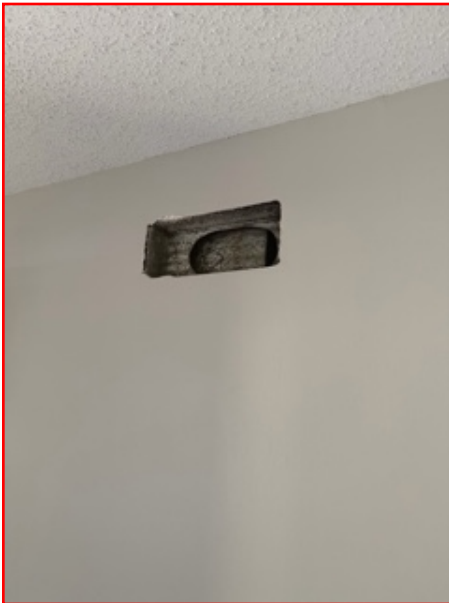
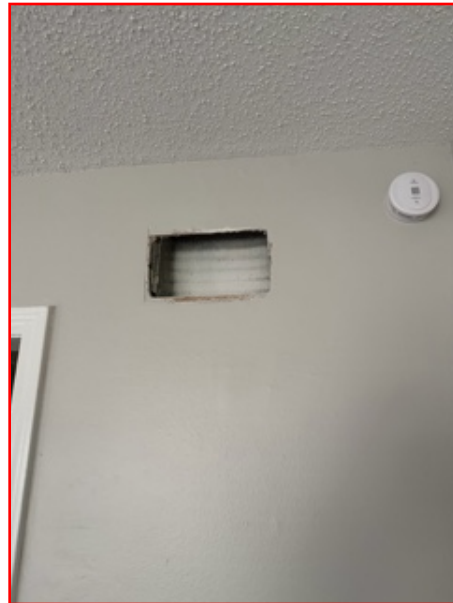
14) vent covers missing in living room.
