MidSouth Home Inspections  
1280 River Hollow Cove  
Cordova, TN 38016  
(901) 336-3551  
midsouthhomeinspections.com  
diley1231@gmail.com  
Inspected By: Dan Iley

## Home Inspection Report

**2003**

**W. Big Bend**

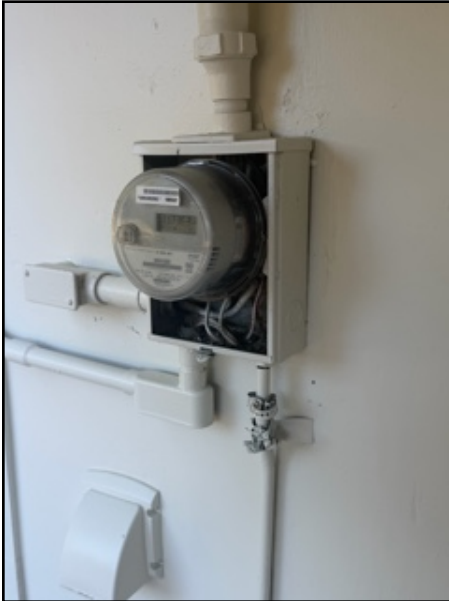
Figure 3-1

Comment 3:  
meter base needs cover installed.

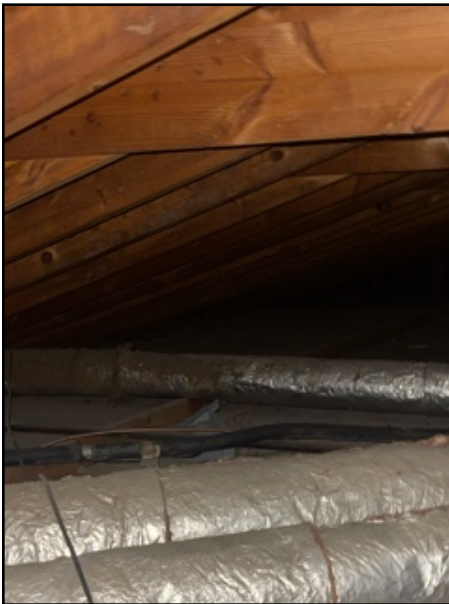
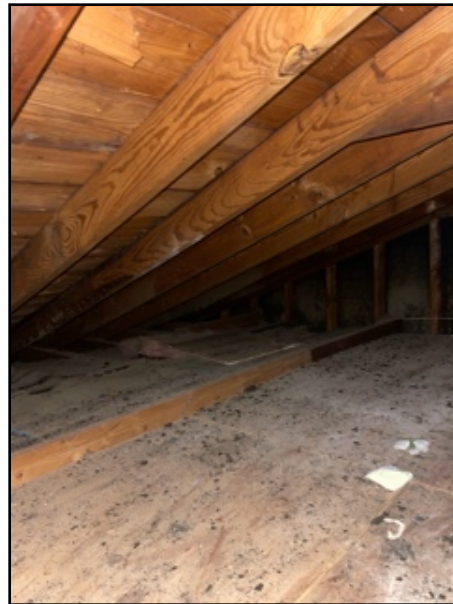
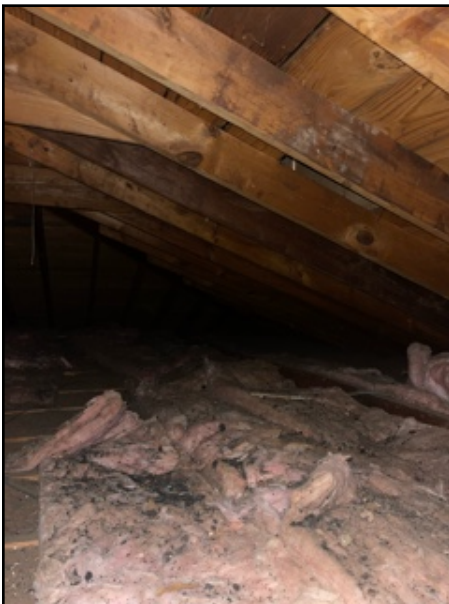
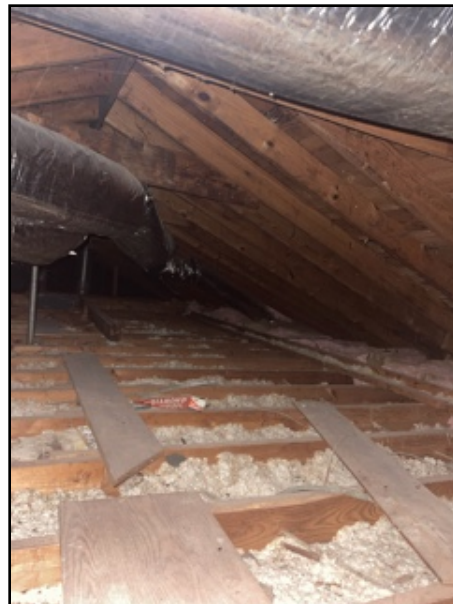
Attic is in good condition.. Framing is sound and there is no evidence of leaks

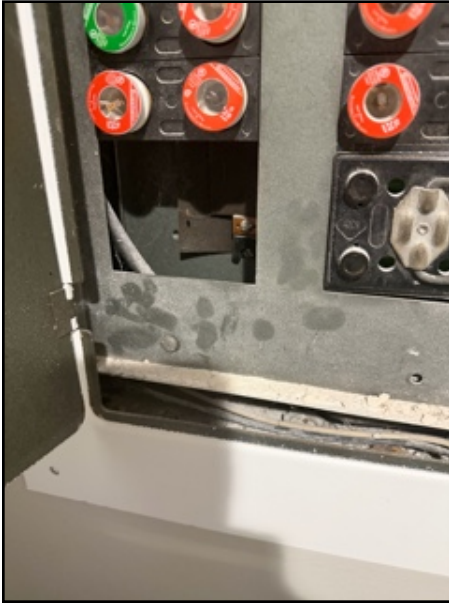
Figure 6-1

Open slot in fuse box needs to be covered for Safety.

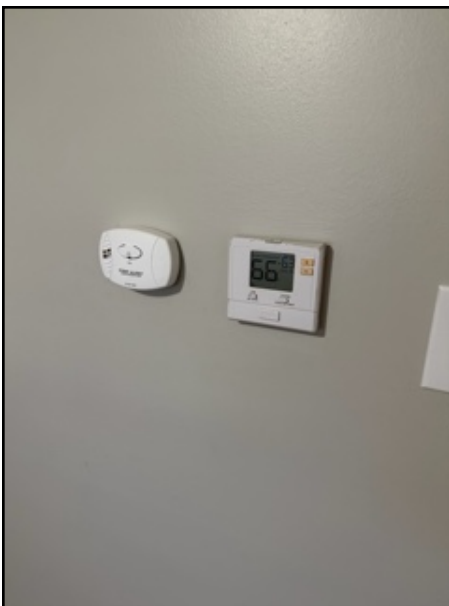
Figure 7-1

carbon monoxide detector is installed.

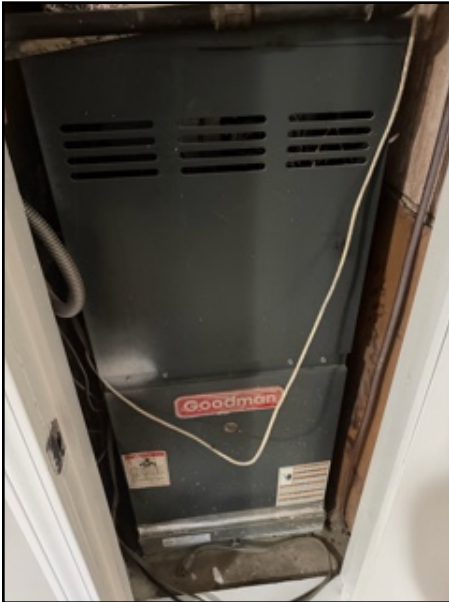
Figure 8-1

furnace not operating at time of inspection Further evaluation needed by HVAC tech technician.

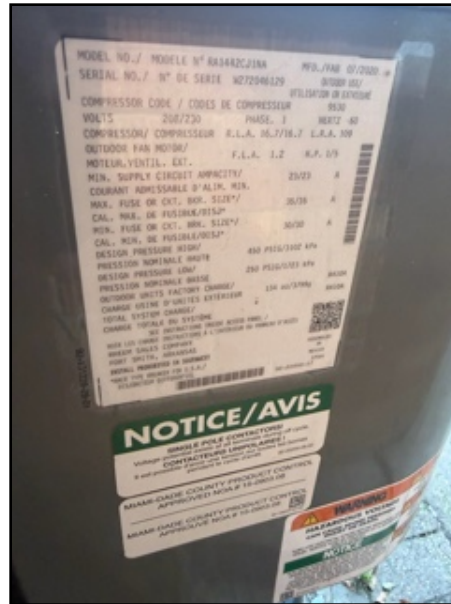
Figure 9-2

4) air-conditioning not operating at time of inspection.

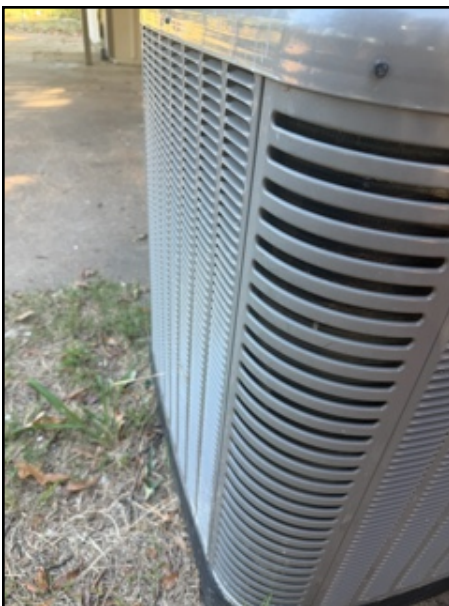
Figure 10-1

5) AC Condenser needs cleaning.

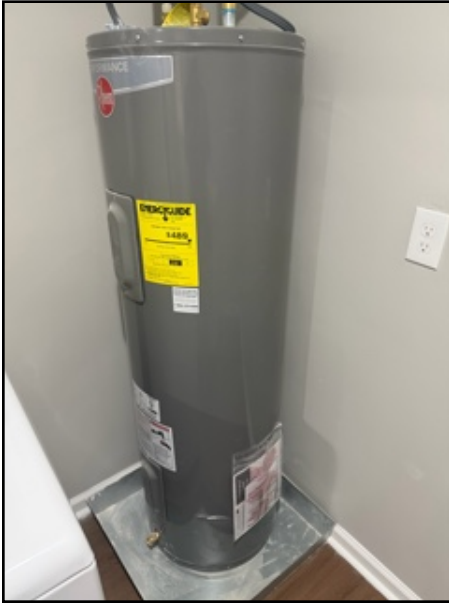
Figure 11-1

Hot water heater not operating at time of inspection.

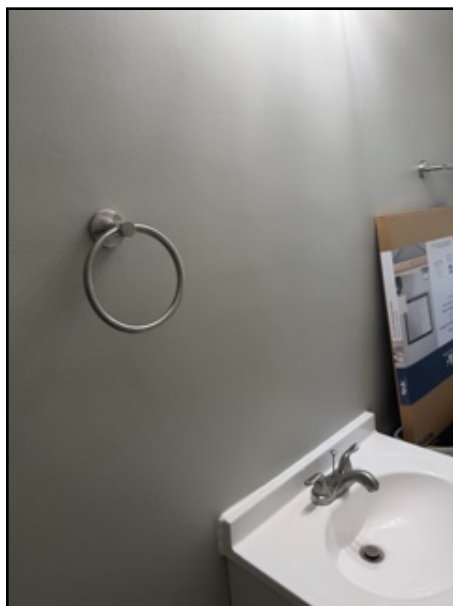
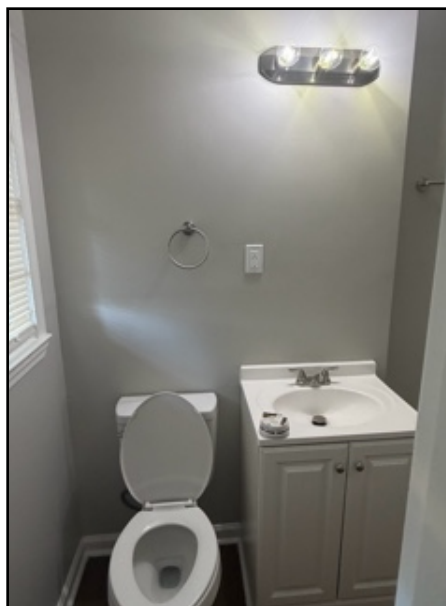
Comment 13:  
mirrors need to be installed in both bathrooms.

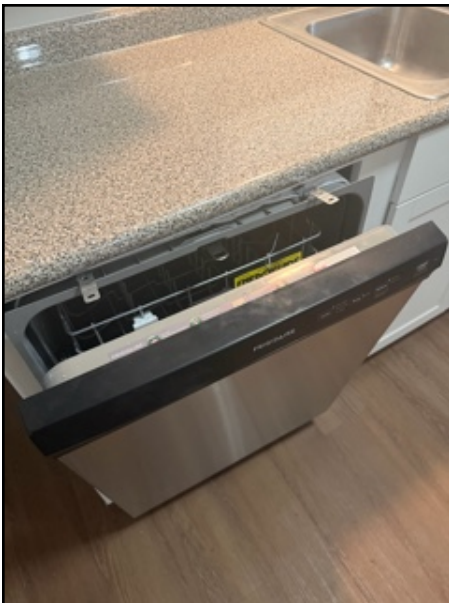
Figure 15-1

Comment 15:  
dishwasher needs to be installed correctly.

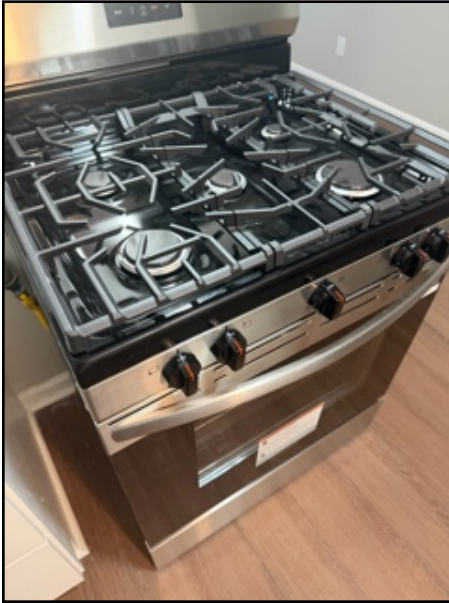
Figure 16-1

Comment 16:  
stove not operating at time of inspection.

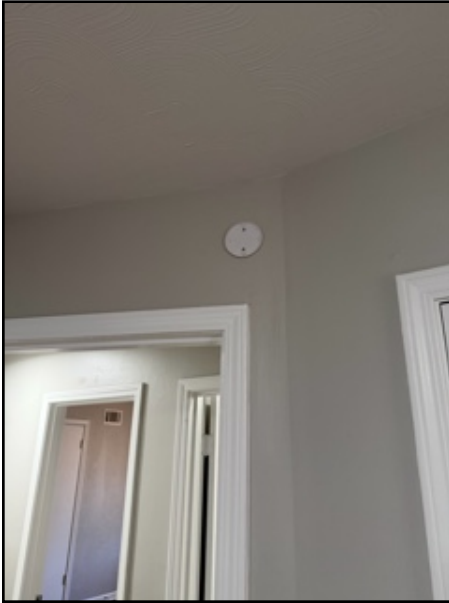
Figure 19-1

Comment 19:  
smoke detector missing in master bedroom.

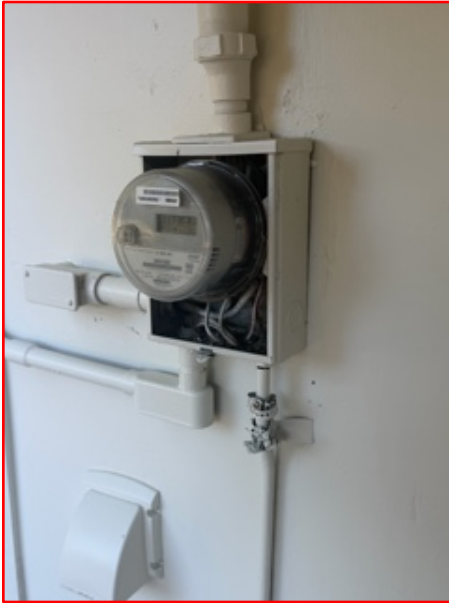
Figure 3-1

1) meter base needs cover installed.

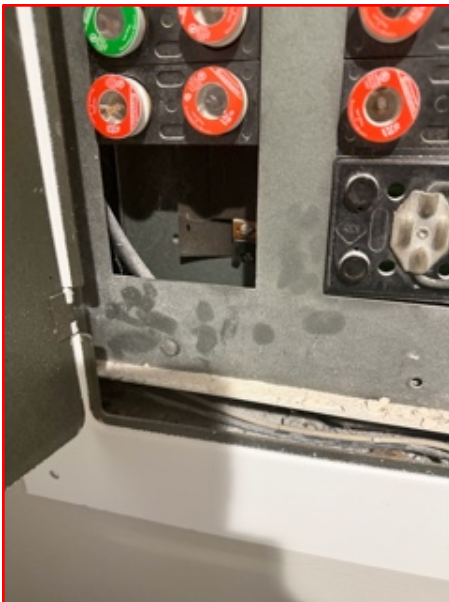
Figure 6-1

2) Open slot in fuse box needs to be covered for Safety.

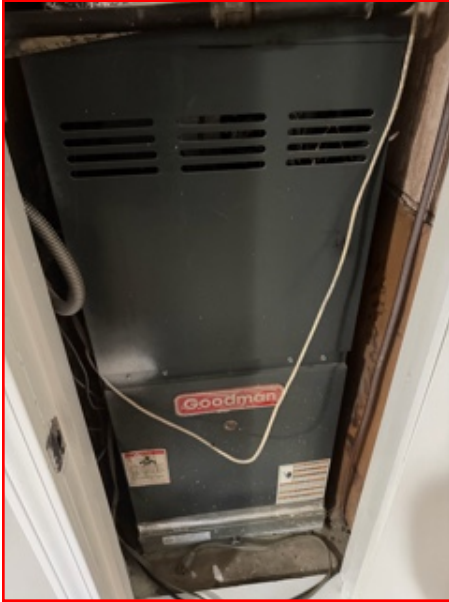
Figure 8-1

3) furnace not operating at time of inspection Further evaluation needed by HVAC tech technician.

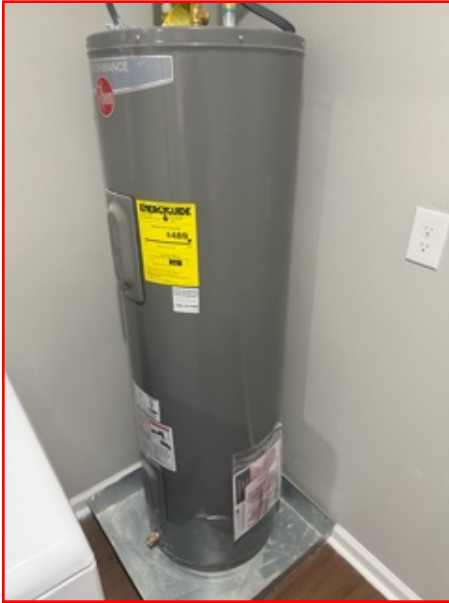
Figure 11-1

6) Hot water heater not operating at time of inspection.

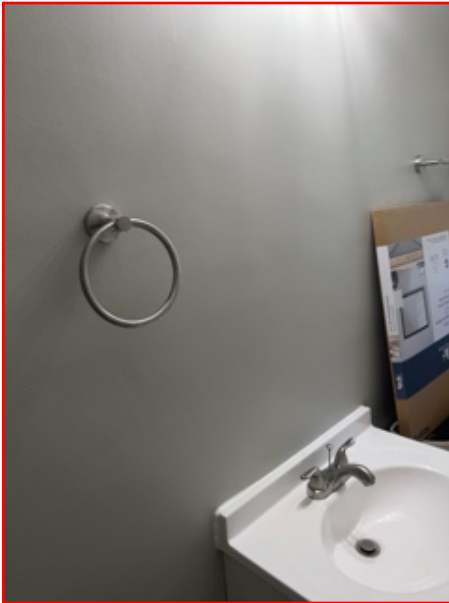
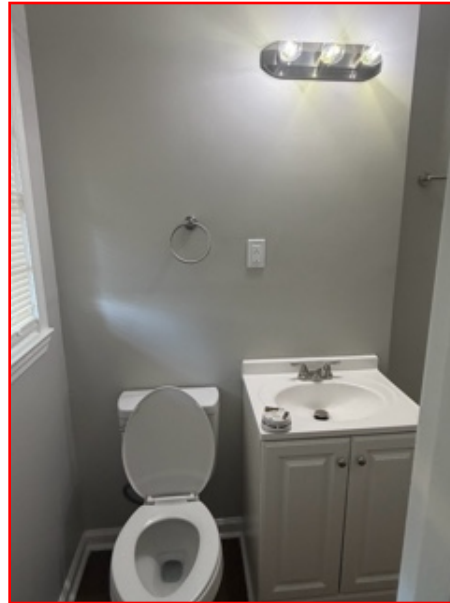
7) mirrors need to be installed in both bathrooms.

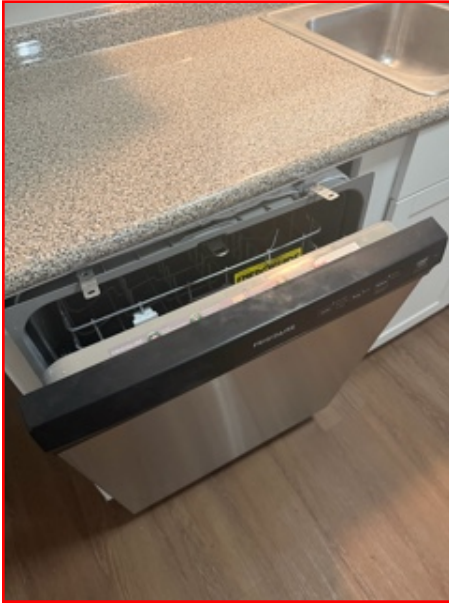
Figure 15-1

8) dishwasher needs to be installed correctly.

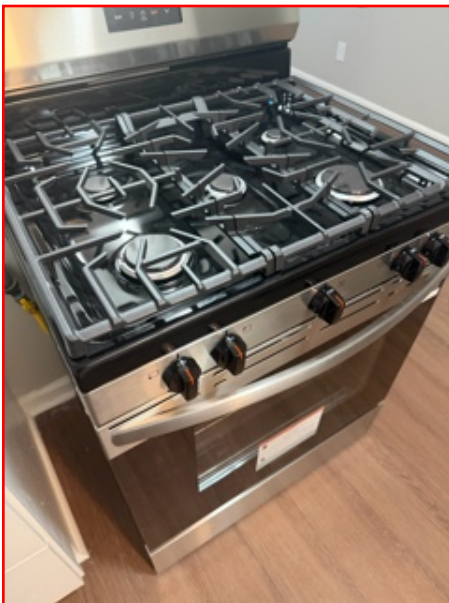
Figure 16-1

9) stove not operating at time of inspection.

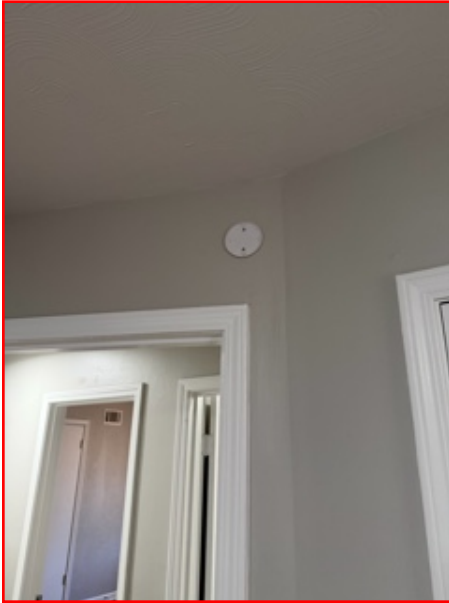
Figure 19-1

10) smoke detector missing in master bedroom.
