Midsouth Home Inspections  
1280 River Hollow Cove  
Cordova, TN 38016  
(901) 336-3551  
midsouthhomeinspections.com  
diley123@yahoo.com  
Inspected By: Dan Iley

## Home Inspection Report

**5293**

Inspected on Mon, Apr 27 2026 at 10:15AM

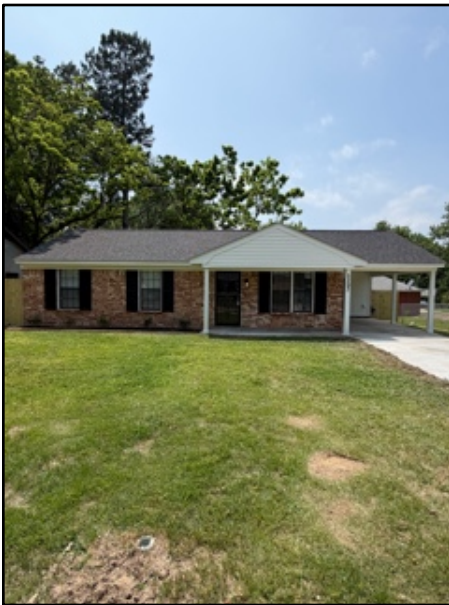
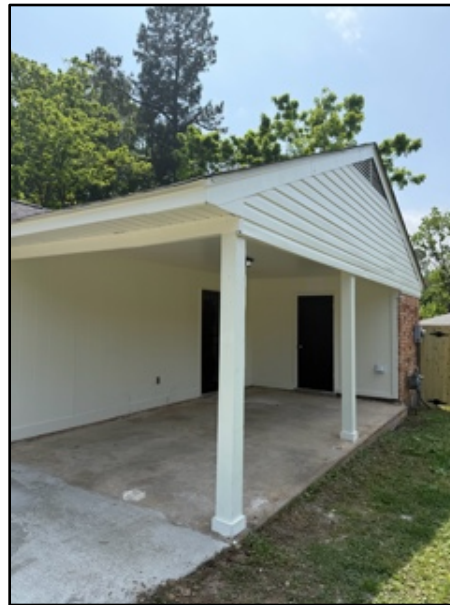
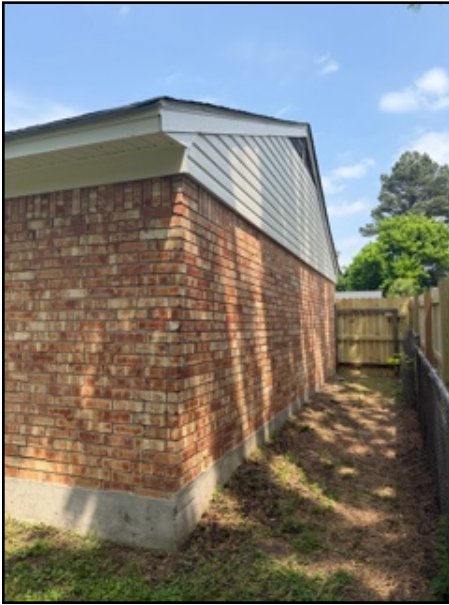
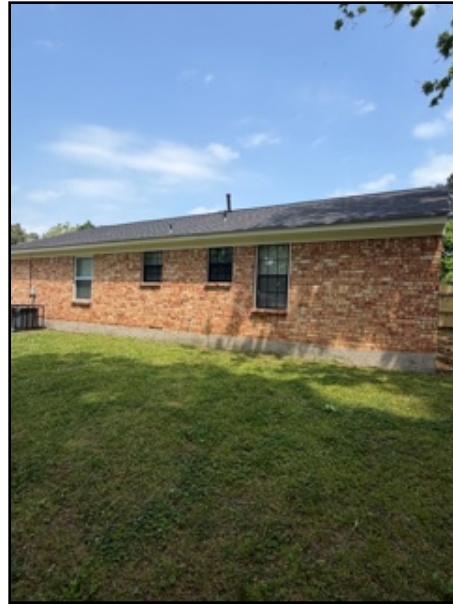
Comment 2:  
General pictures of exterior.

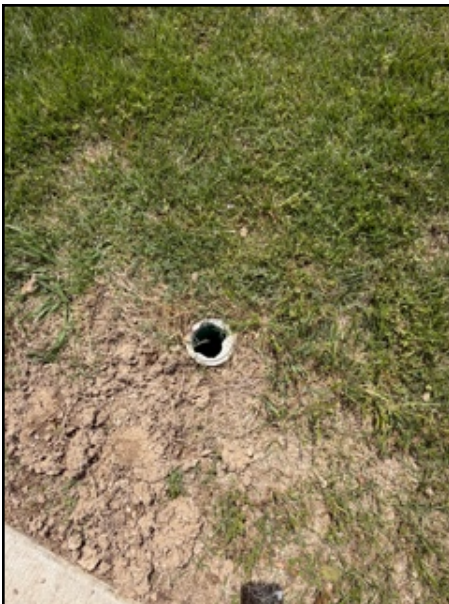
Figure 3-1

Comment 3:  
New cleanout cap needed in front yard.

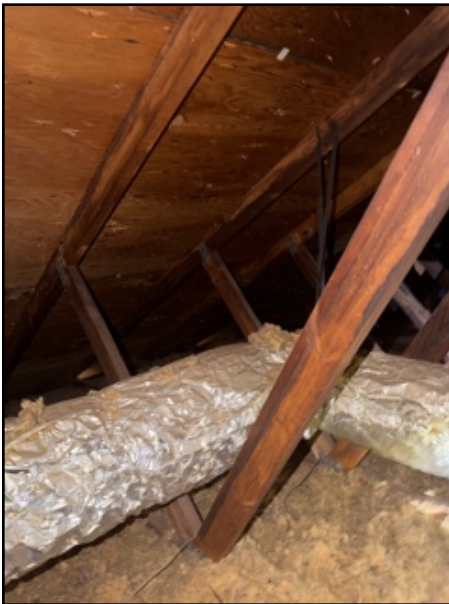
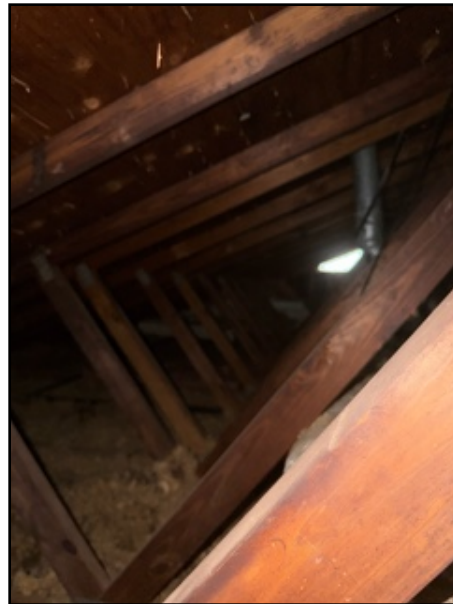
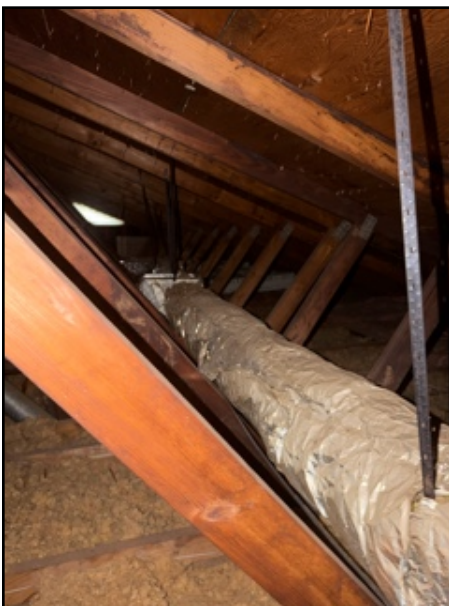
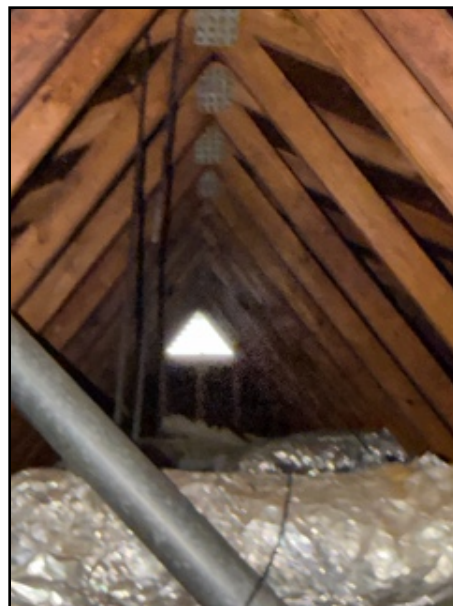
Attic is in good condition.. Framing is sound and there is no evidence of leaks

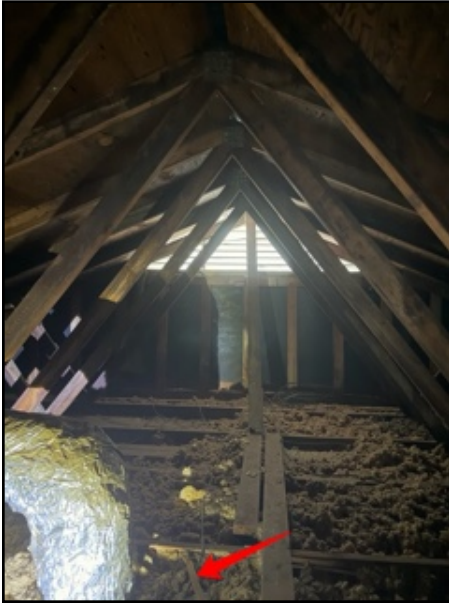
Figure 5-1

Comment 5:  
junction box cover needed in attic.

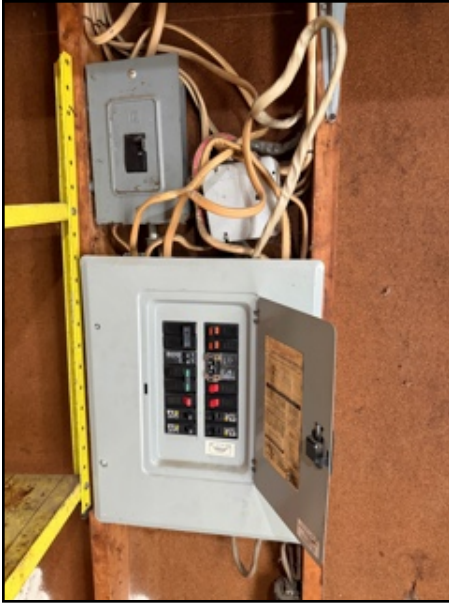
Figure 6-1

Comment 6:  
wires need to be organized a little better or cover installed over them.

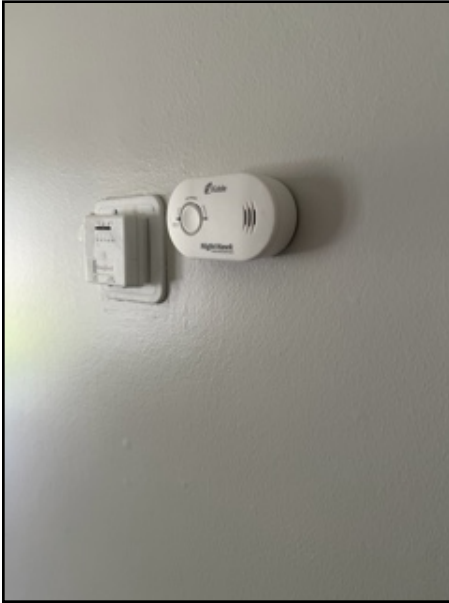
Figure 7-1

Comment 7:  
carbon monoxide detector is installed.

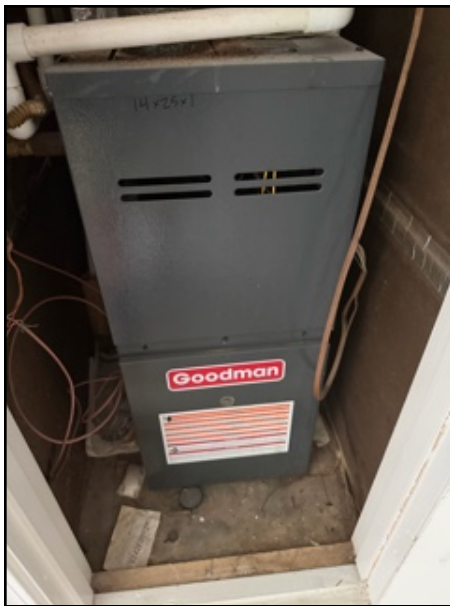
Figure 8-1

Heat operating as intended.

Register temps above 100 degrees

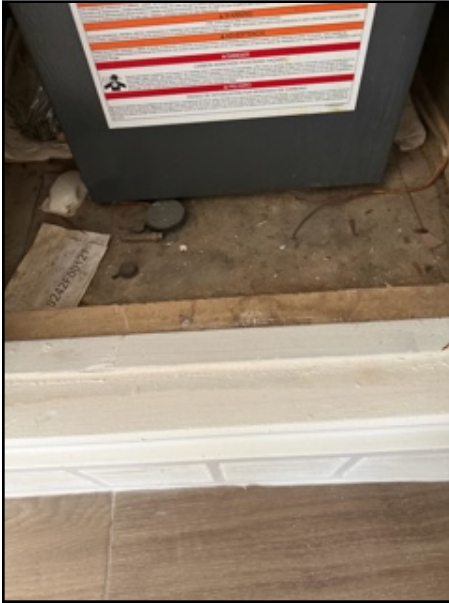
Figure 9-1

no air filter box install installed under furnace as noted by picture.

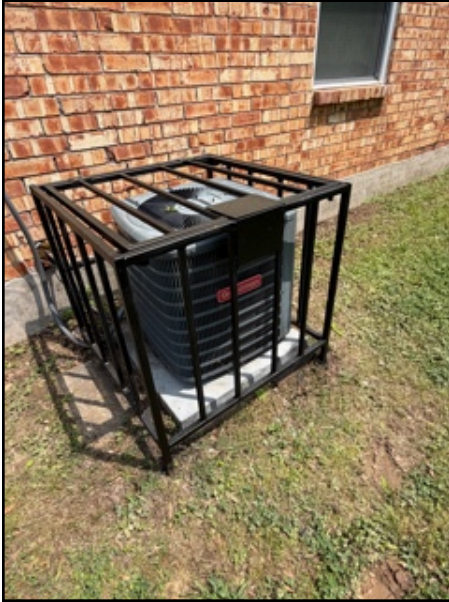
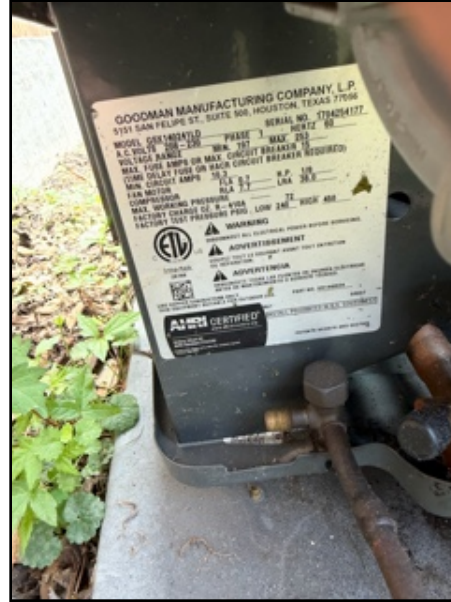
Air conditioning needs to be serviced by HVAC technician Register temps too high in relation to outside temperature.

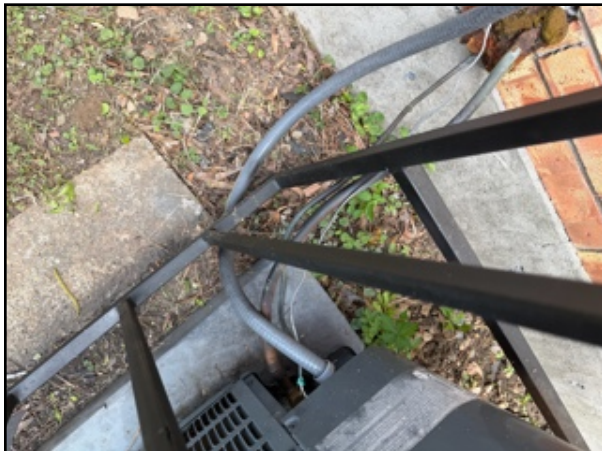
Figure 11-1

copper line needs insulating.

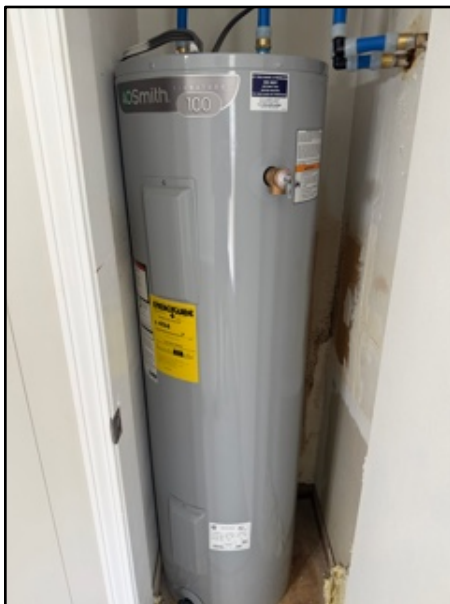
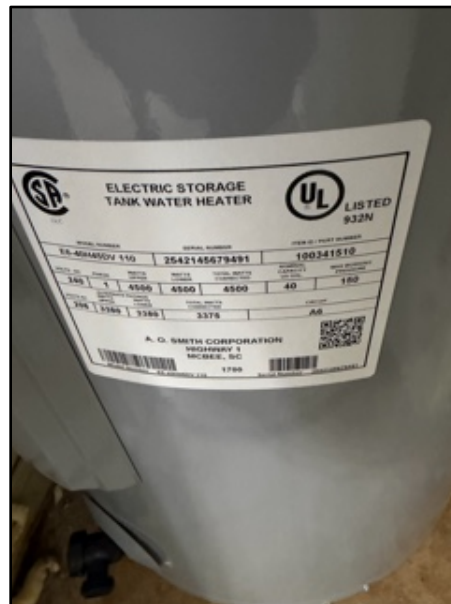
Comment 12:  
 Hot water temperature 118°.

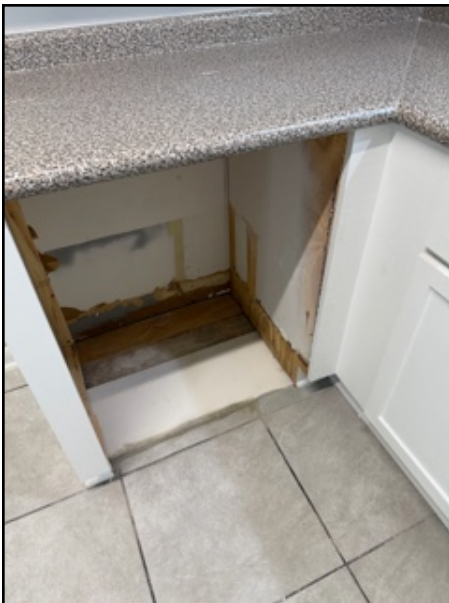
Figure 15-1

Comment 15:  
no dishwasher installed at time of inspection.

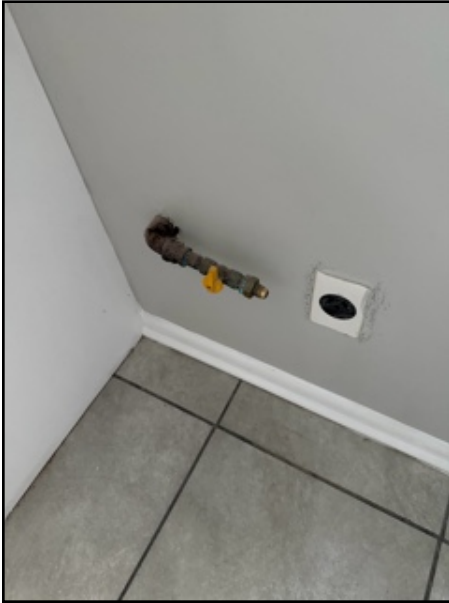
Figure 16-1

Comment 16:  
cap needed on gas line in kitchen for Safety.

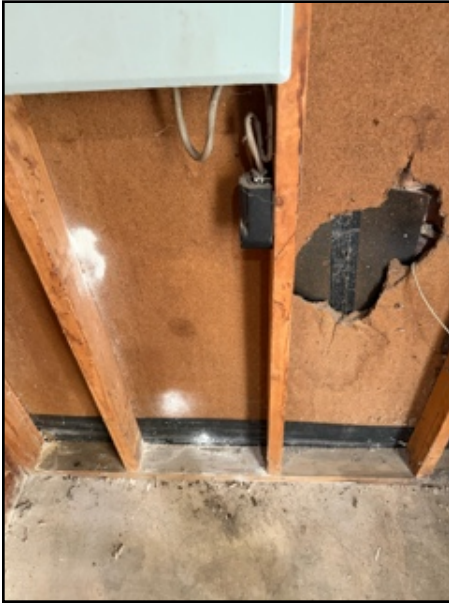
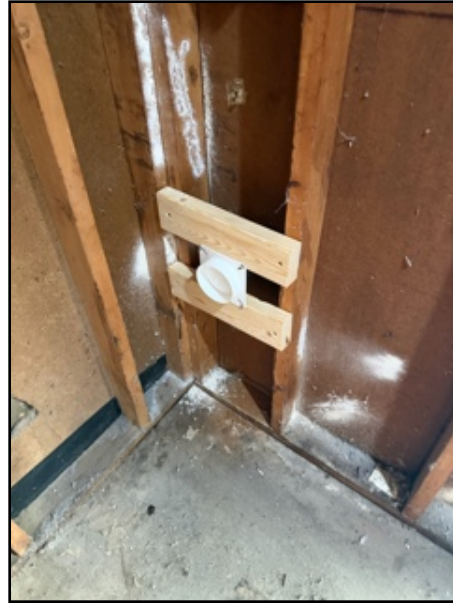
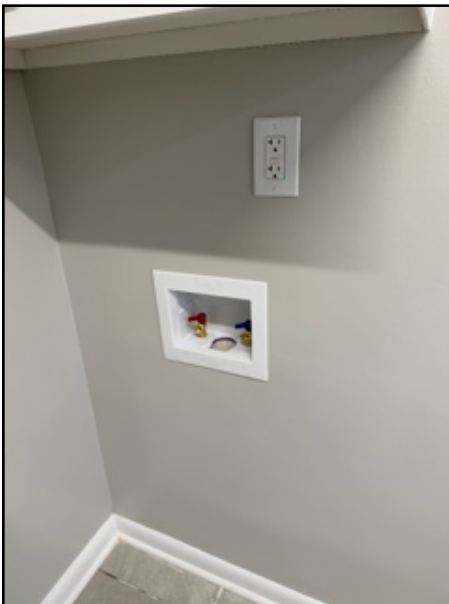
Comment 17:  
dryer Connection located in storage room.

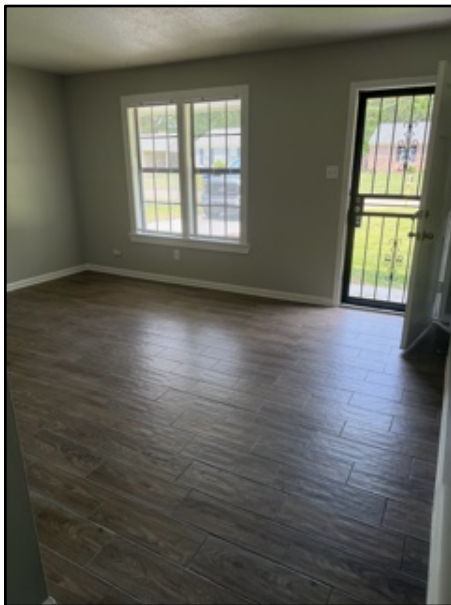
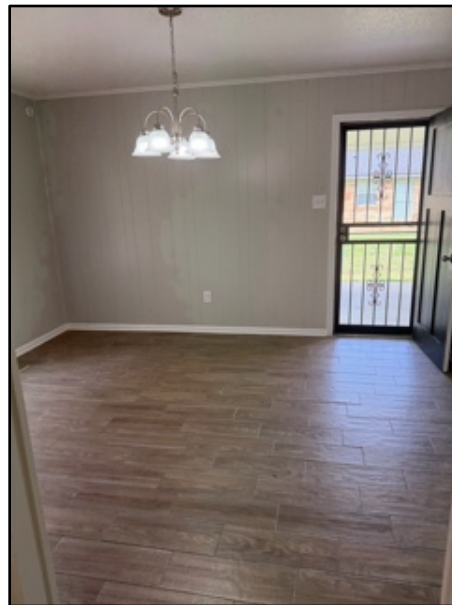
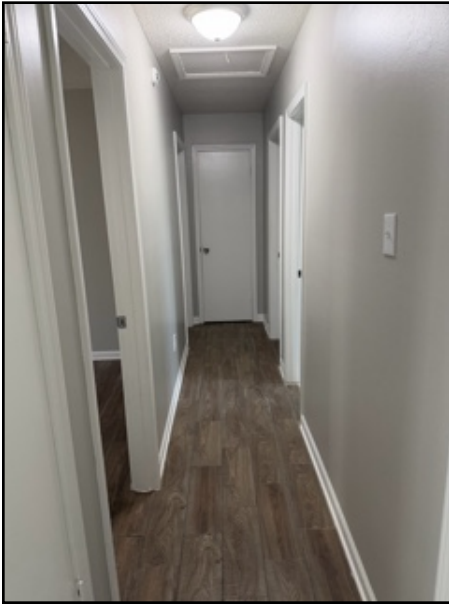
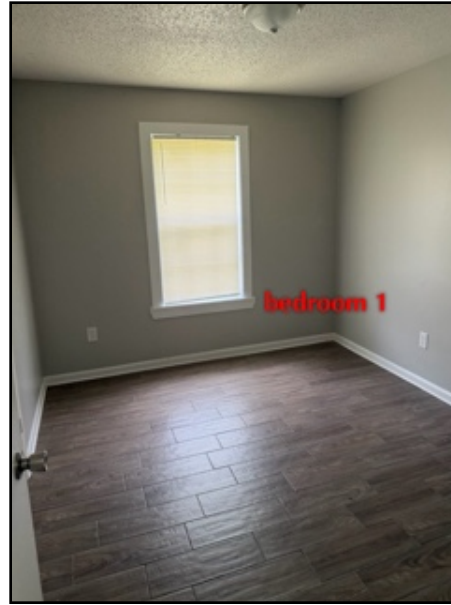
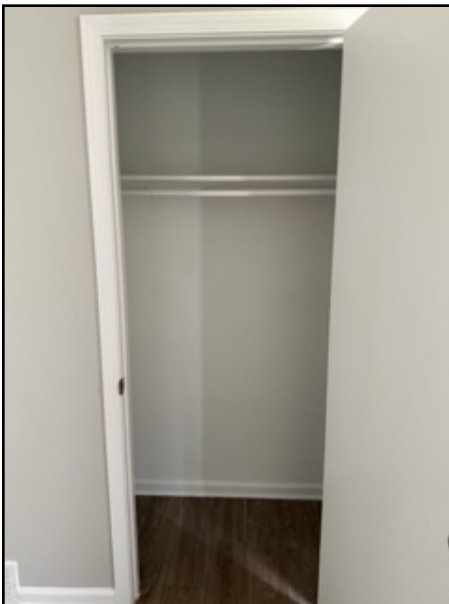
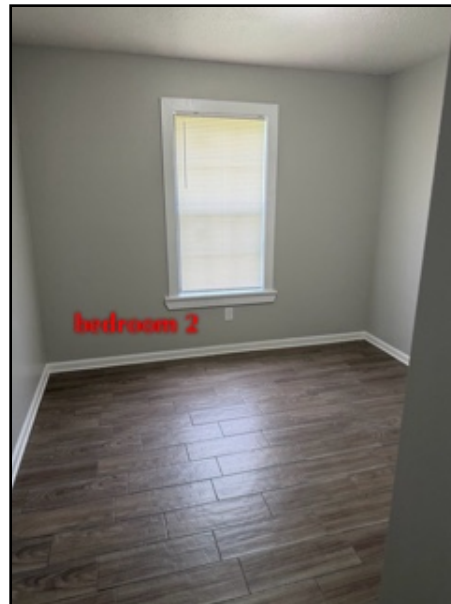
General pictures of Living room, dining area, bedrooms and closets.

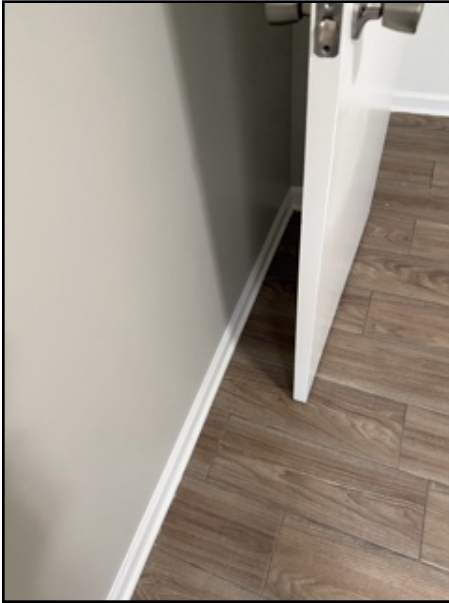
Figure 19-1

no doorstop installed in second bedroom as noted by picture.

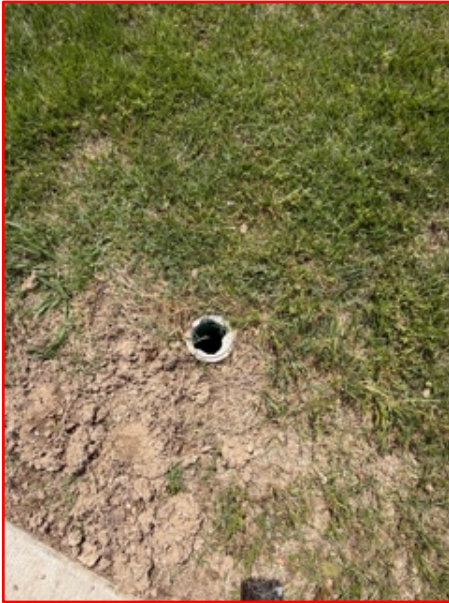
Figure 3-1

1) New cleanout cap needed in front yard.

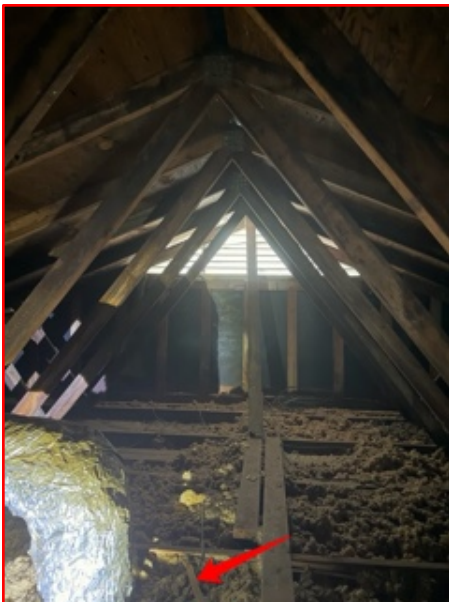
Figure 5-1

2) junction box cover needed in attic.

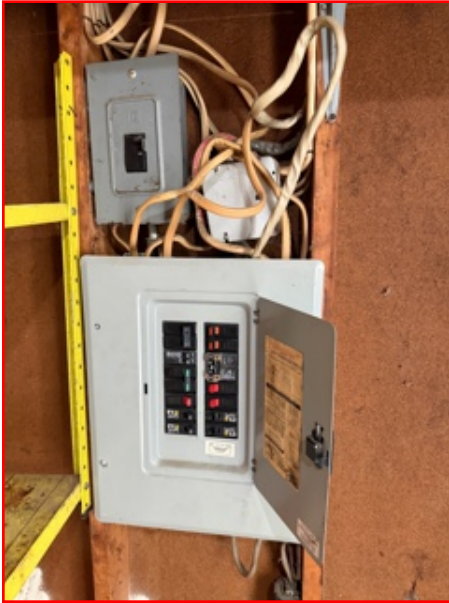
Figure 6-1

3) wires need to be organized a little better or cover installed over them.

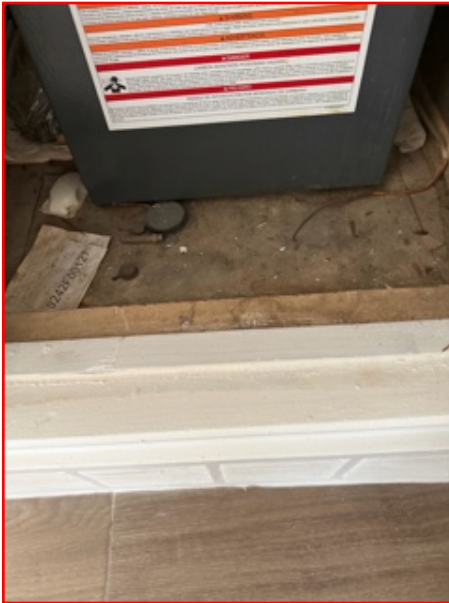
Figure 9-1

4) no air filter box install installed under furnace as noted by picture.

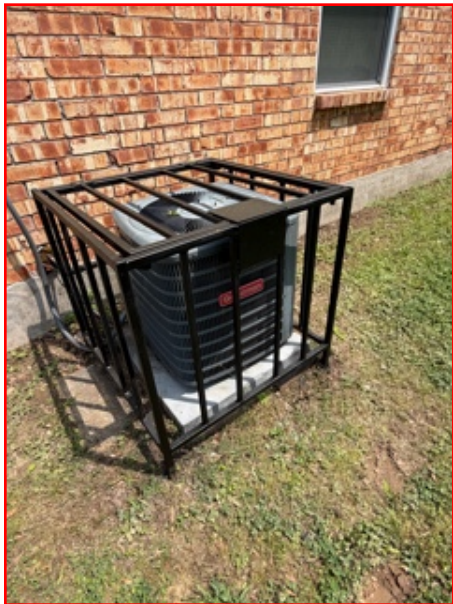
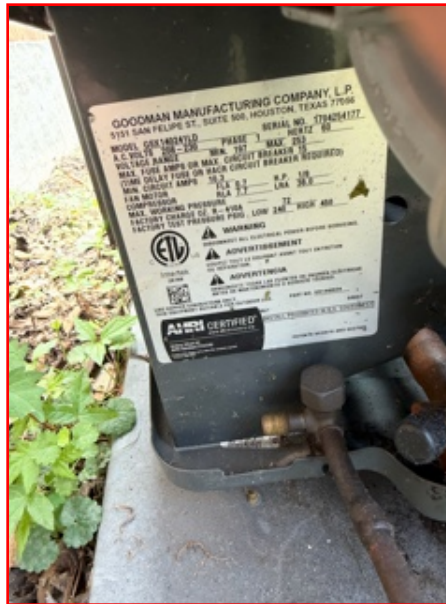
5) Air conditioning needs to be serviced by HVAC technician Register temps too high in relation to outside temperature.

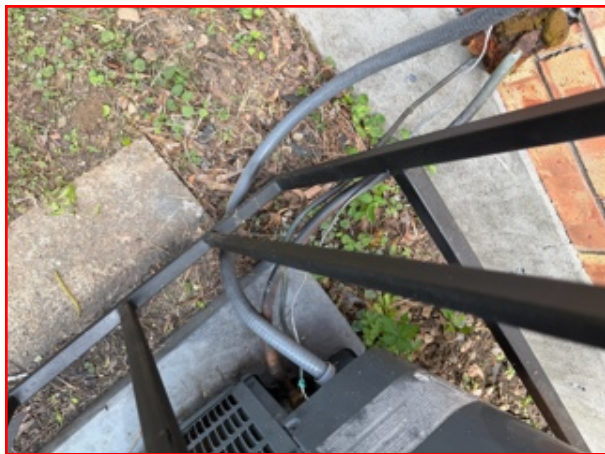
Figure 11-1

6) copper line needs insulating.

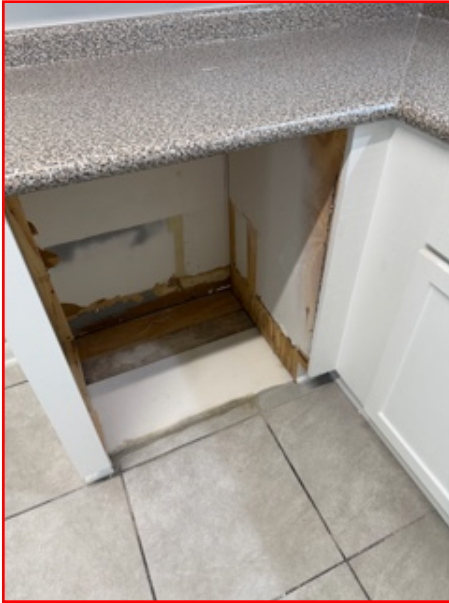
Figure 15-1

7) no dishwasher installed at time of inspection.

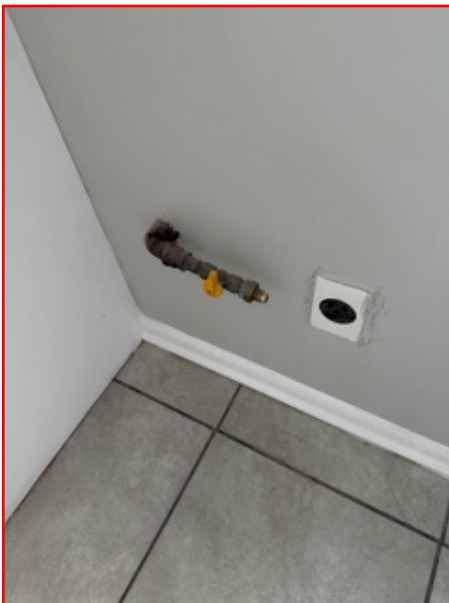
Figure 16-1

8) cap needed on gas line in kitchen for Safety.

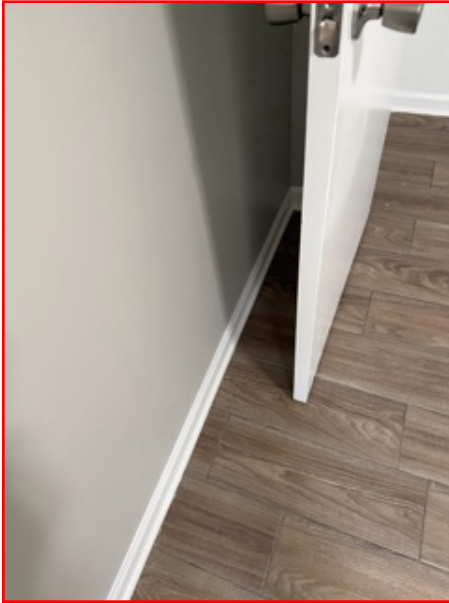
Figure 19-1

9) no doorstop installed in second bedroom as noted by picture.
