## Home Inspection Report

Property Address:

**5286**

**Broken Oak**

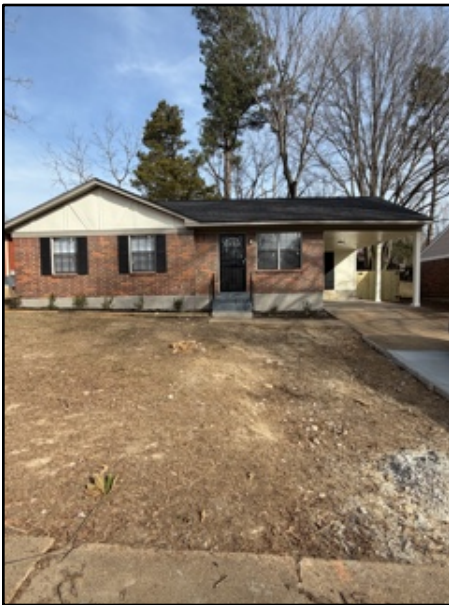
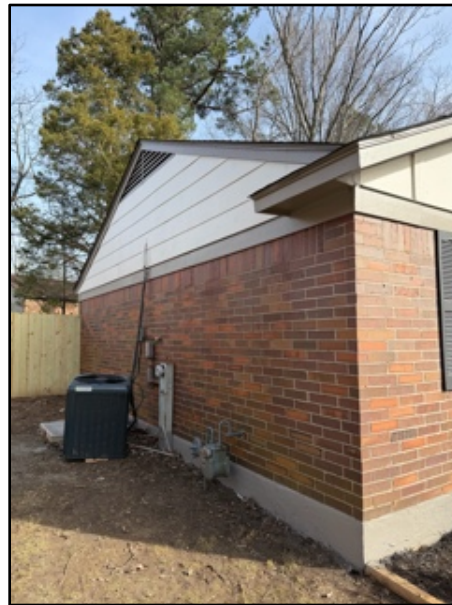
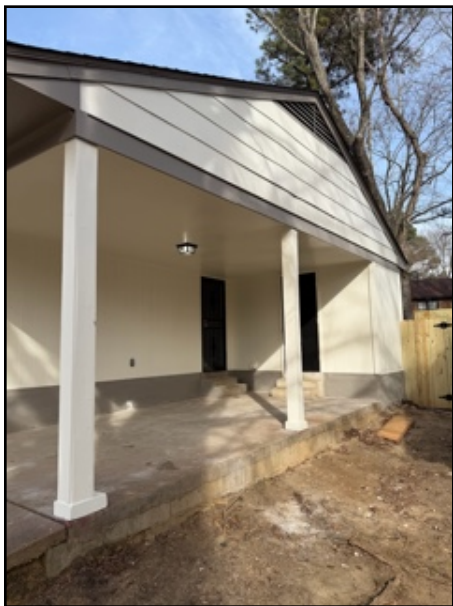
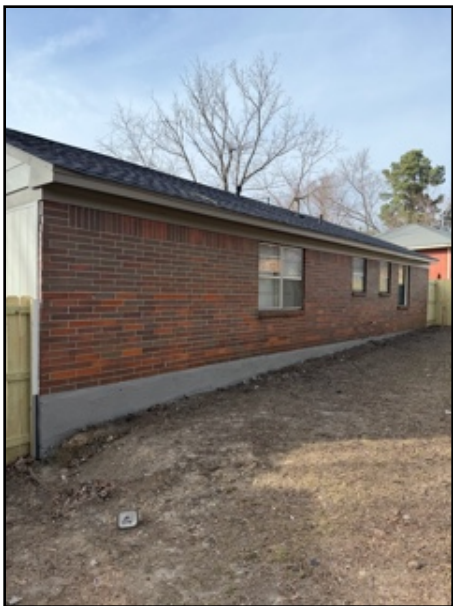
Comment 2:  
General pictures of exterior.

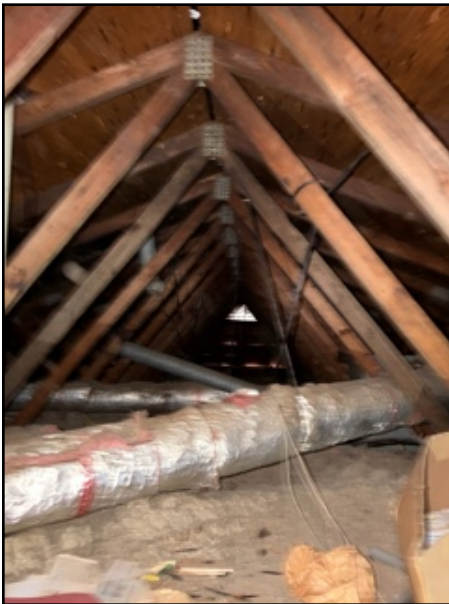
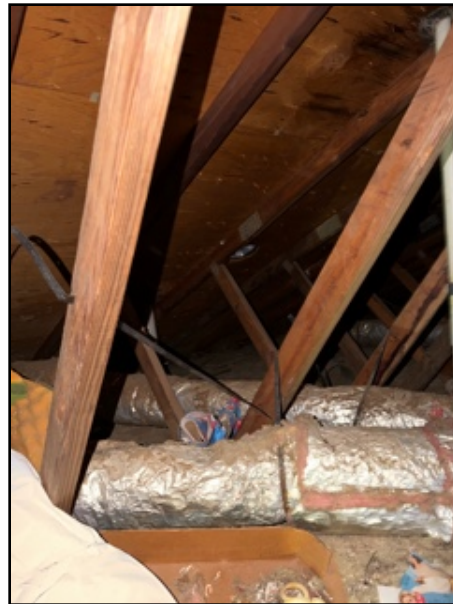
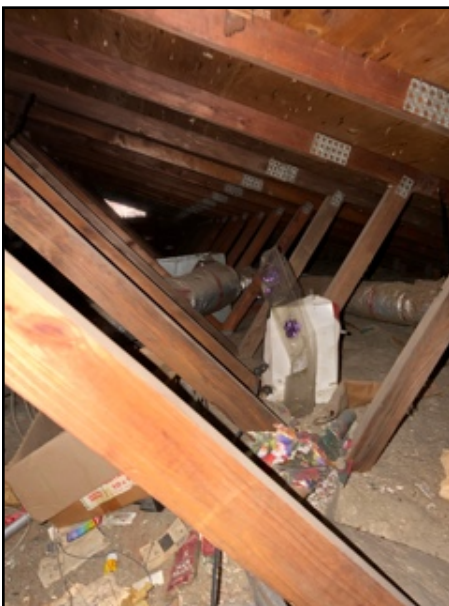
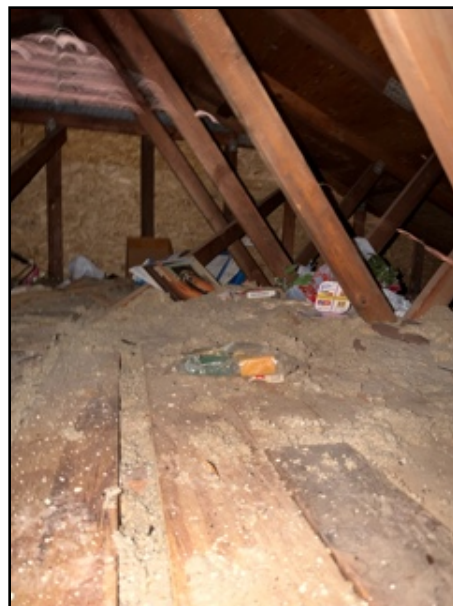
Attic is in good condition.. Framing is sound and there is no evidence of leaks

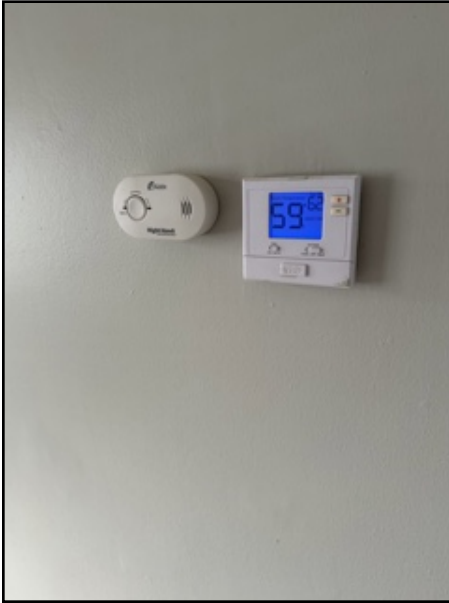
Figure 5-1

Comment 5:  
carbon monoxide detector is installed.

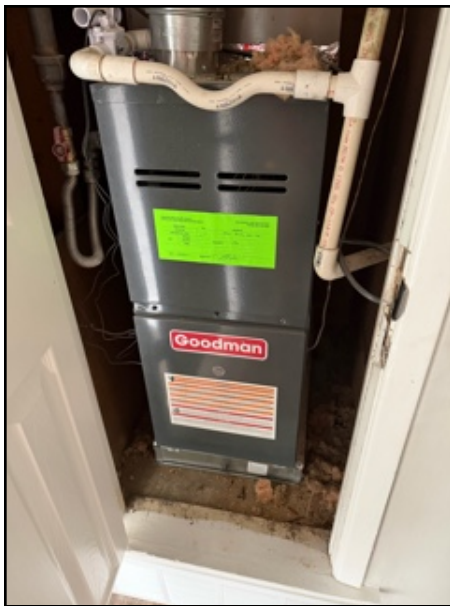
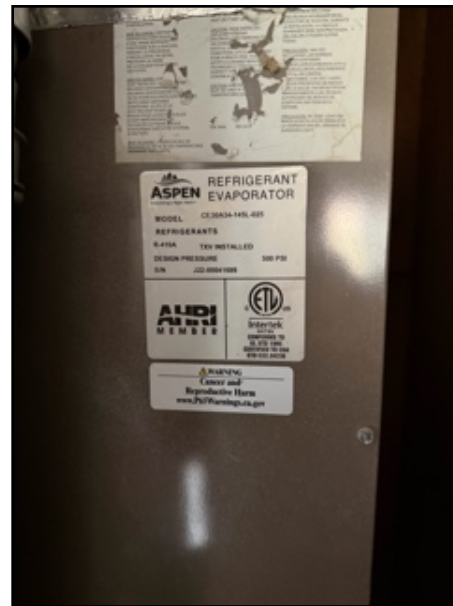
Heat operating as intended.

Register temps above 95 degrees

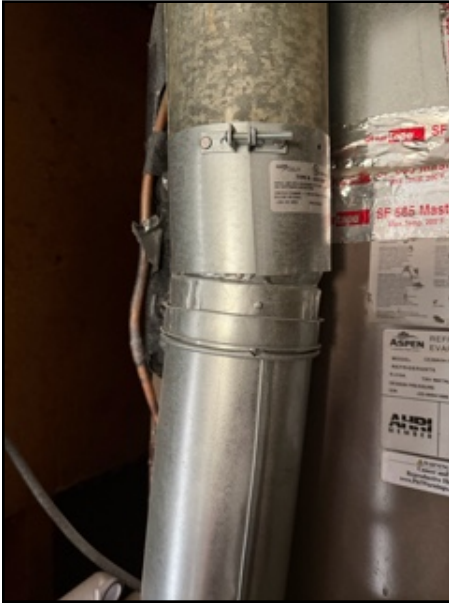
Figure 7-1

incorrect vent pipe installed on furnace Piping should overlap from top to bottom.

Furnaces over 10 years old should be checked, cleaned and serviced yearly by a licensed contractor.

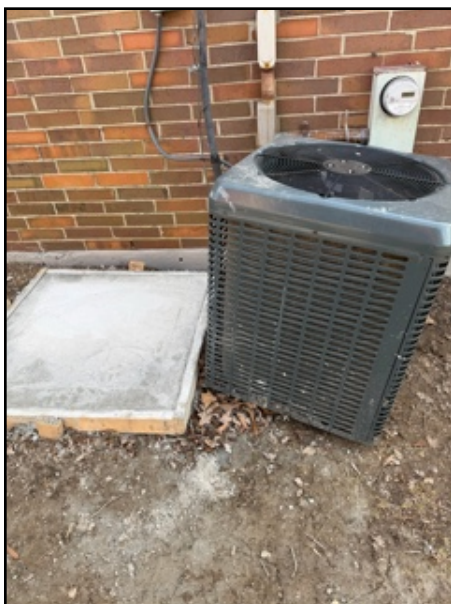
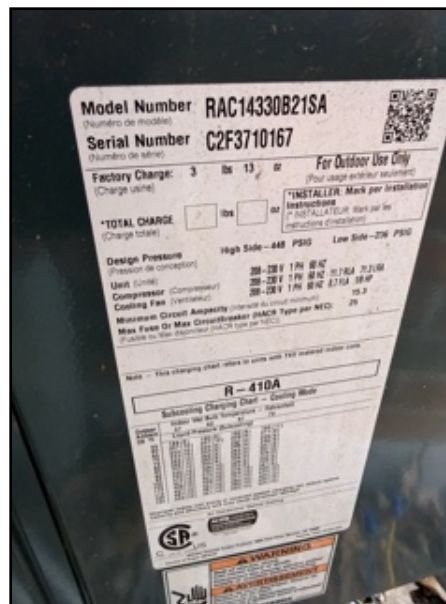
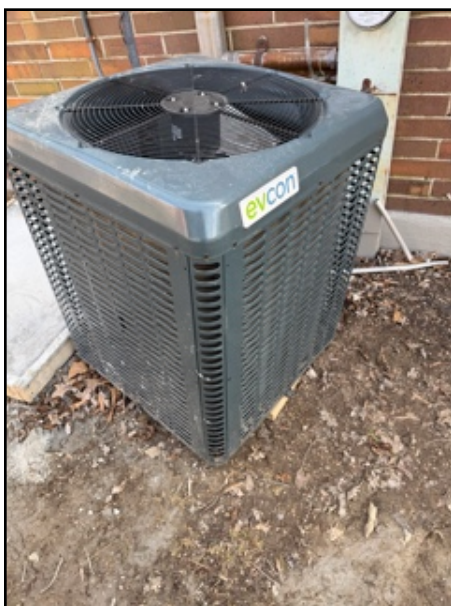
**Comment 8:**  
AC conditioner not set at time of inspection.

Air conditioners over 10 years old and heat pumps over 5 years old should be checked, cleaned and serviced yearly by a licensed contractor.

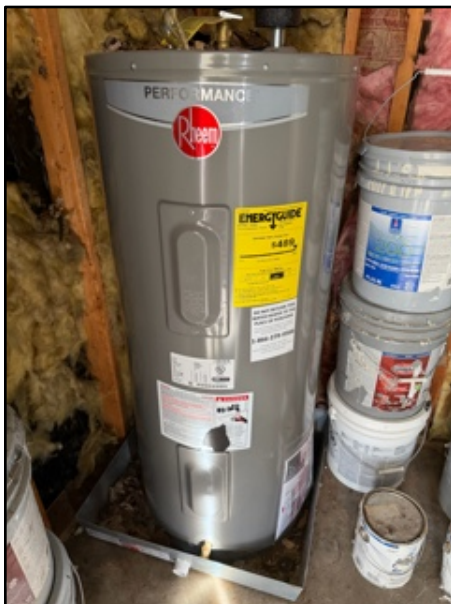
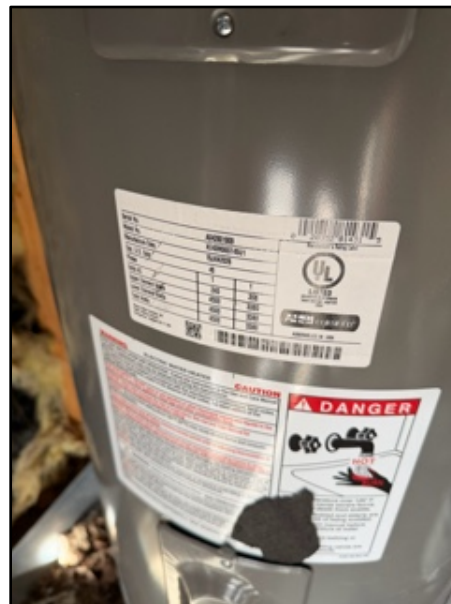
Comment 9:  
Hot water heater not operating at time of inspection.

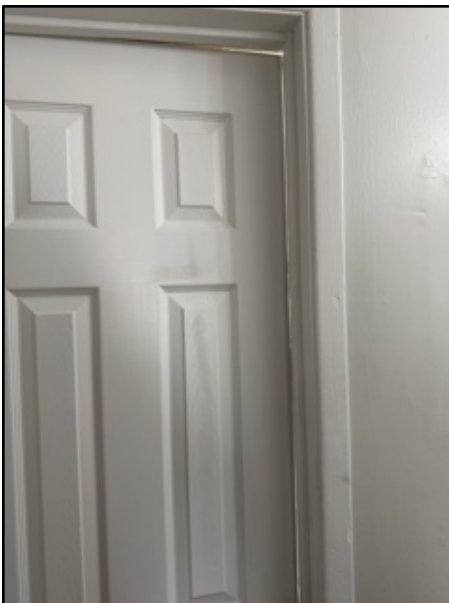
Figure 11-1

Comment 11:  
bathroom door difficult to shut.

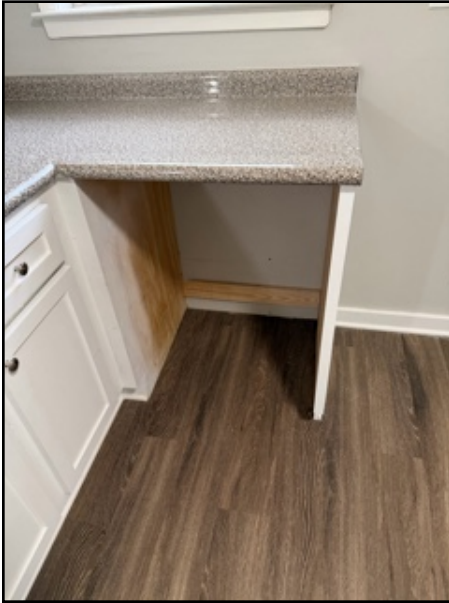
Figure 13-1

Comment 13:  
no dishwasher installed at time of inspection.

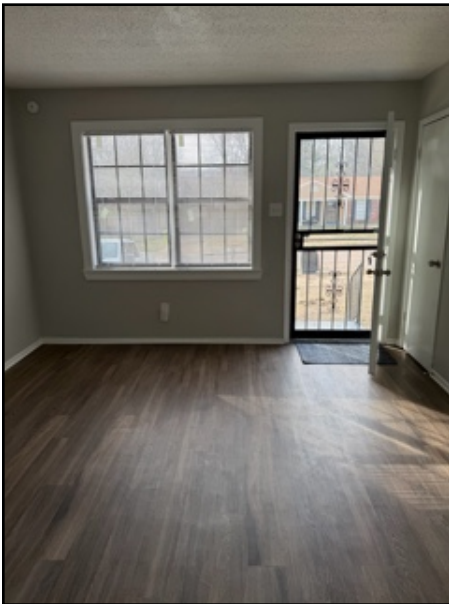
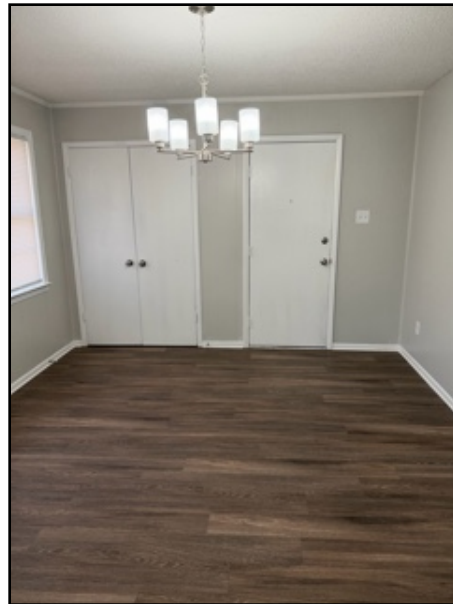
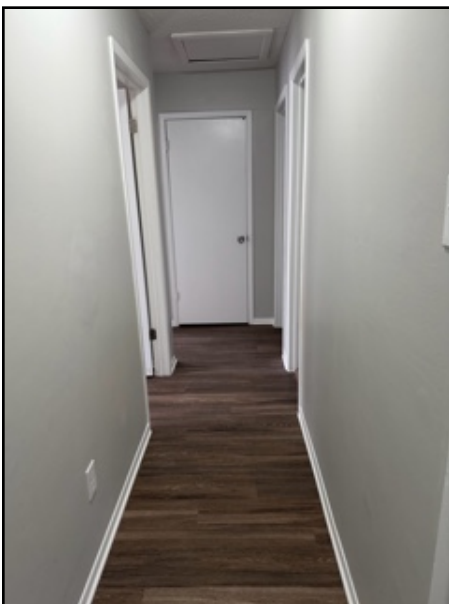
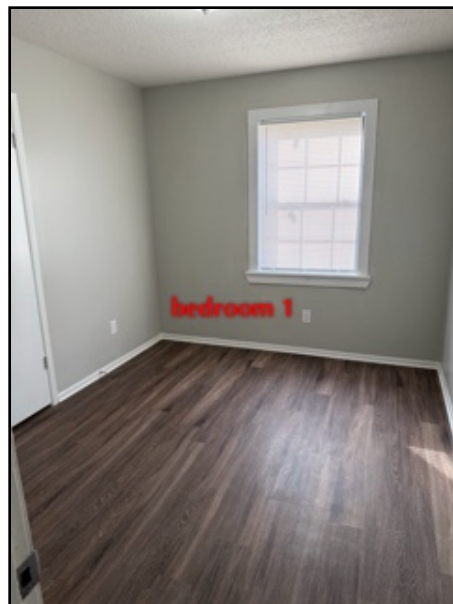
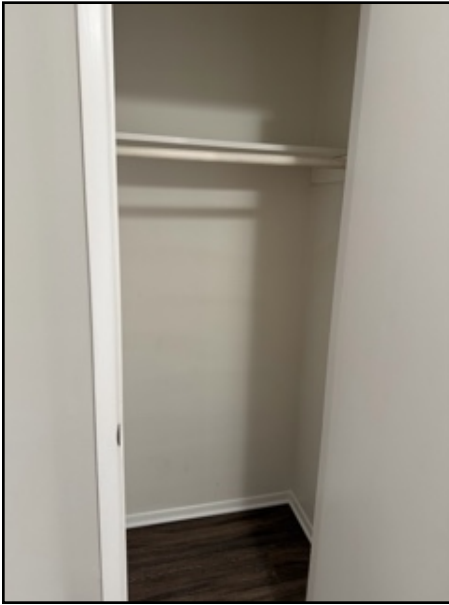
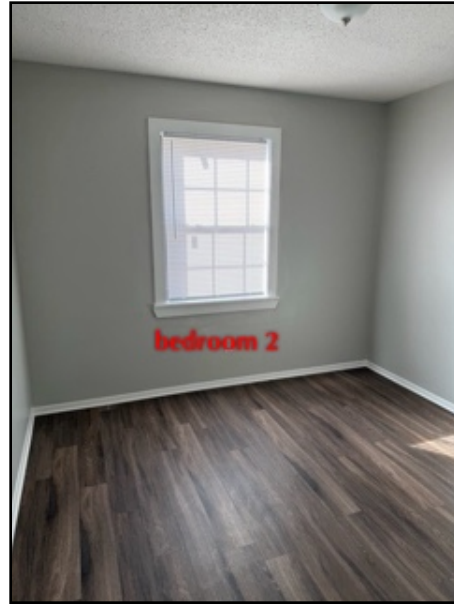
General pictures of Living room, dining area, bedrooms and closets.

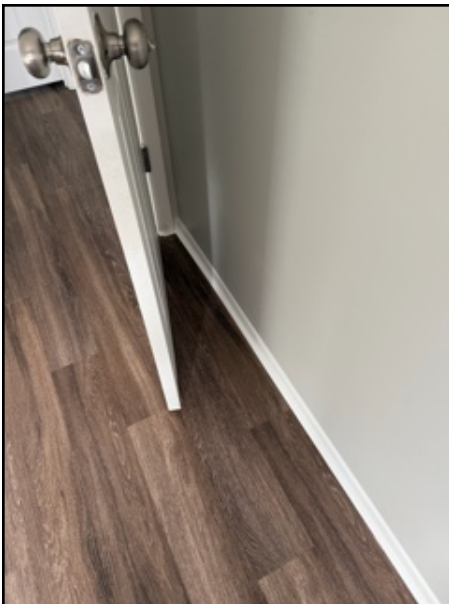
Figure 16-1

Comment 16:  
doorstop needed in second bedroom.

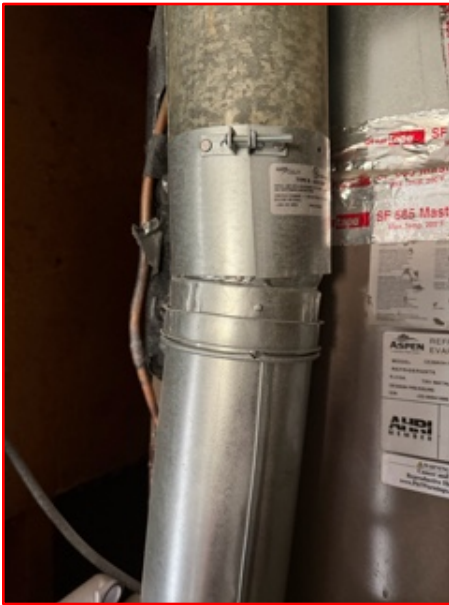
Figure 7-1

1) incorrect vent pipe installed on furnace Piping should overlap from top to bottom.

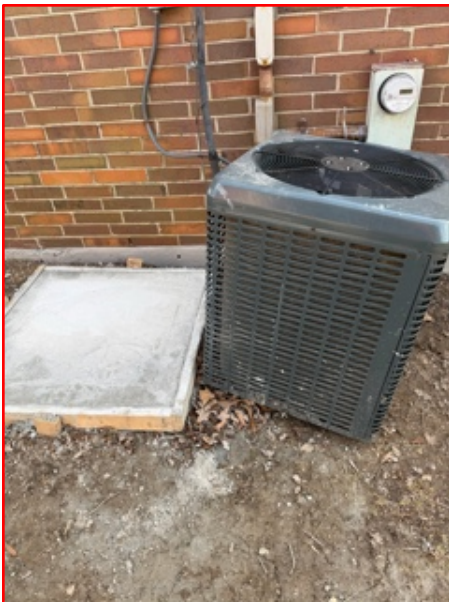
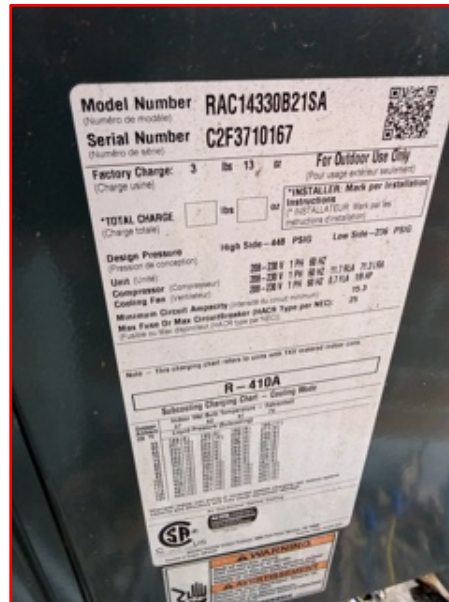
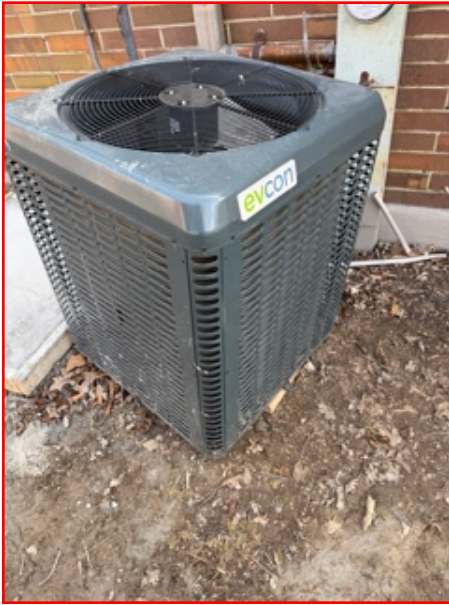
2) AC conditioner not set at time of inspection.

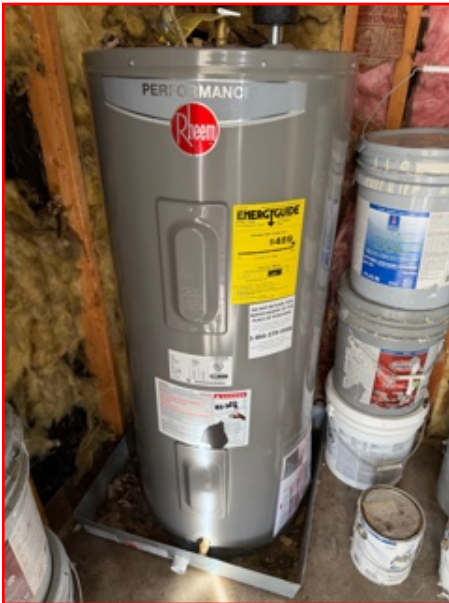
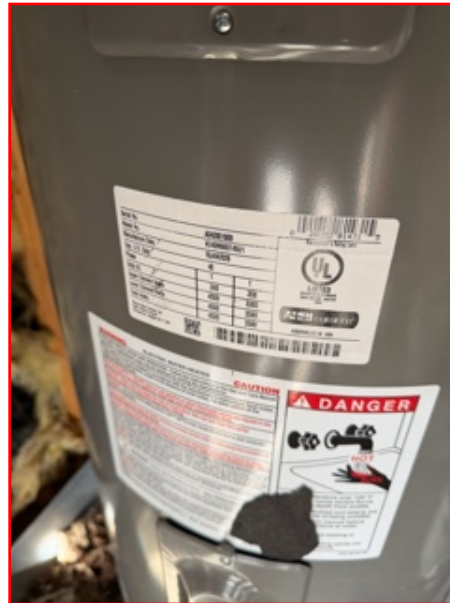
3) Hot water heater not operating at time of inspection.

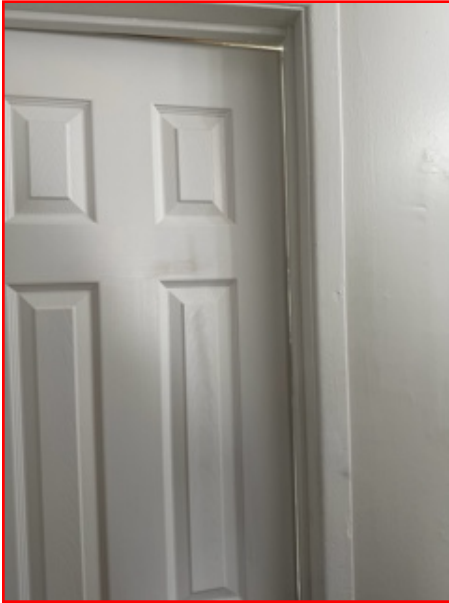
Figure 11-1

4) bathroom door difficult to shut.

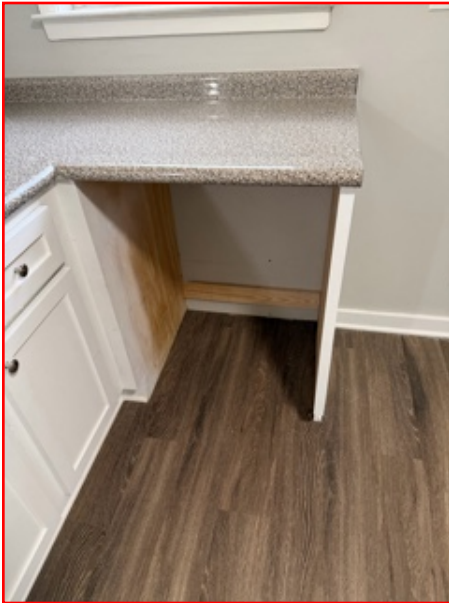
Figure 13-1

5) no dishwasher installed at time of inspection.

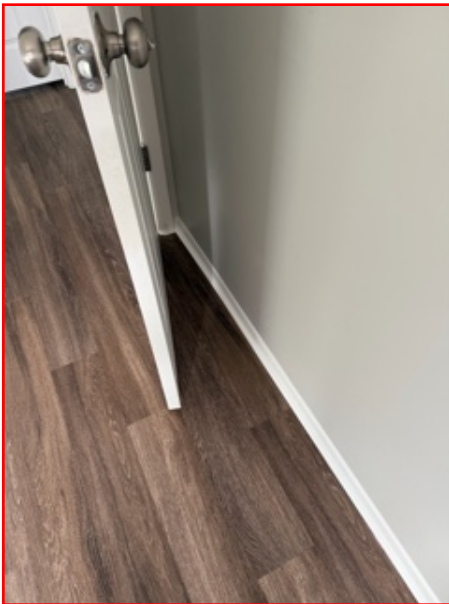
Figure 16-1

6) doorstop needed in second bedroom.
