Home Inspection Report

1863
Burnham
Memphis, Tn 38127

Inspected on Fri, Aug 28 2026 at 11:45AM

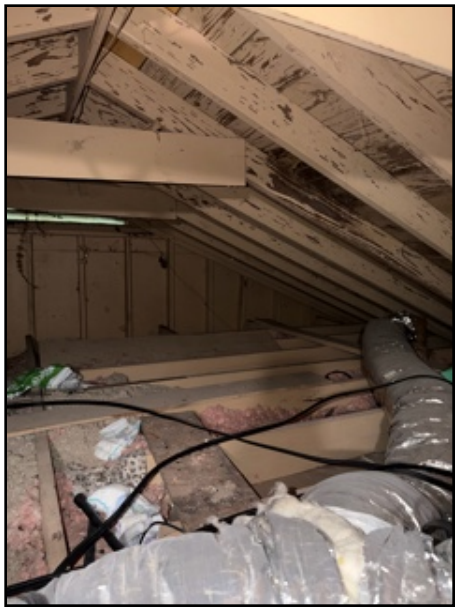
Figure 6-1

Comment 6:
Attic is in good condition.. Framing is sound and there is no evidence of leaks

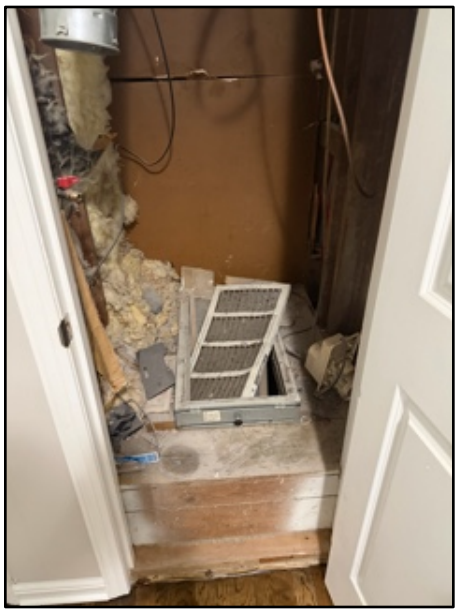
Figure 9-1

Comment 9:
no furnace installed at time of inspection.

Furnaces over 10 years old should be checked, cleaned and serviced yearly by a licensed contractor.

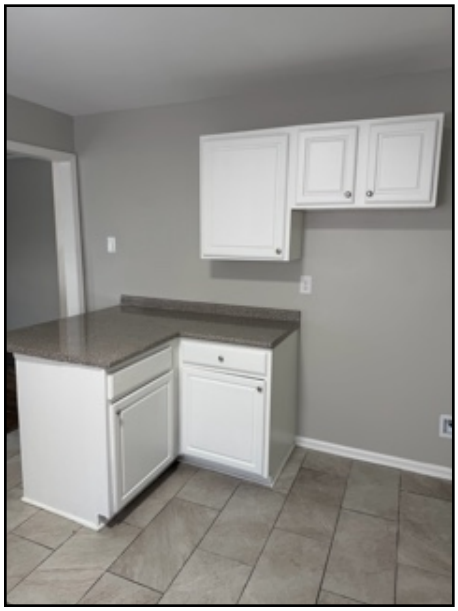
Figure 13-1

Cabinets:	Wood Condition: Satisfactory
Countertops:	Laminated Condition: Satisfactory
Sink:	Double Condition: Satisfactory

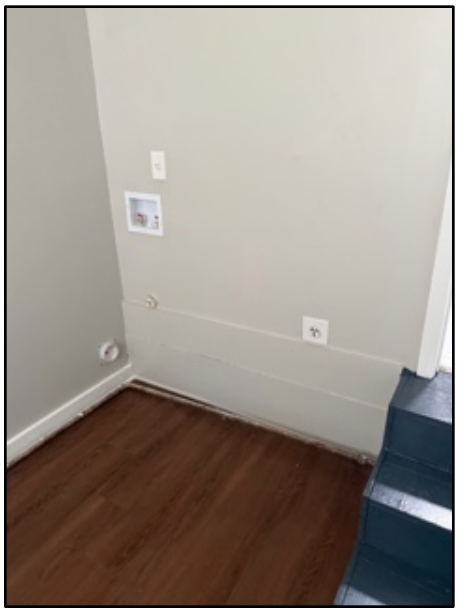
Figure 15-1

Dryer Venting: To Exterior
Condition: Satisfactory

Laundry Hook Ups: Yes
Condition: Satisfactory

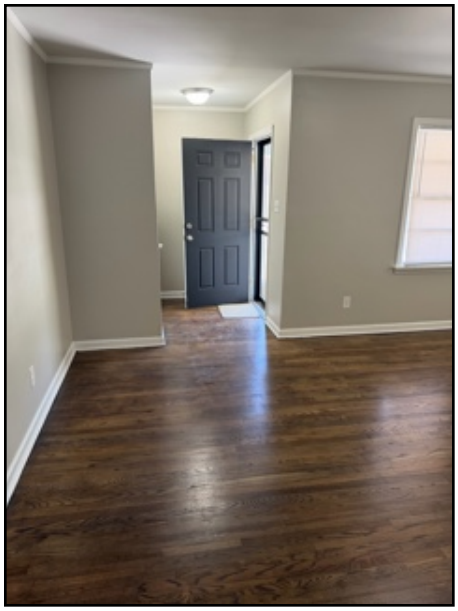
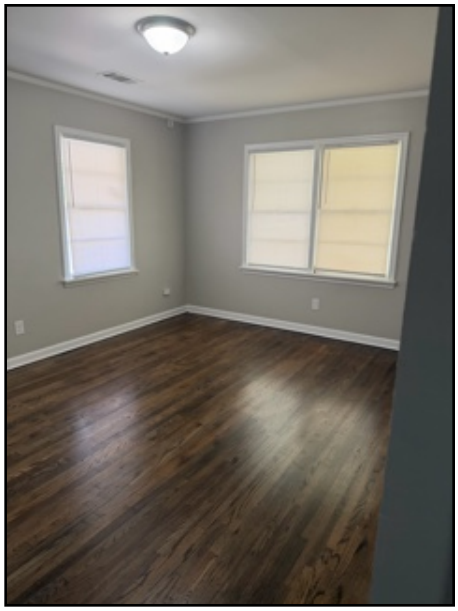
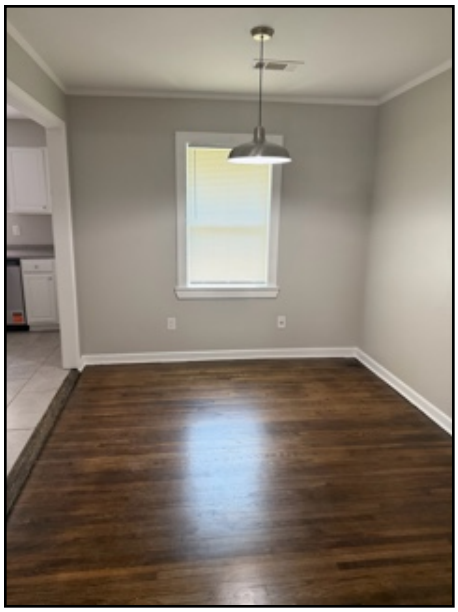
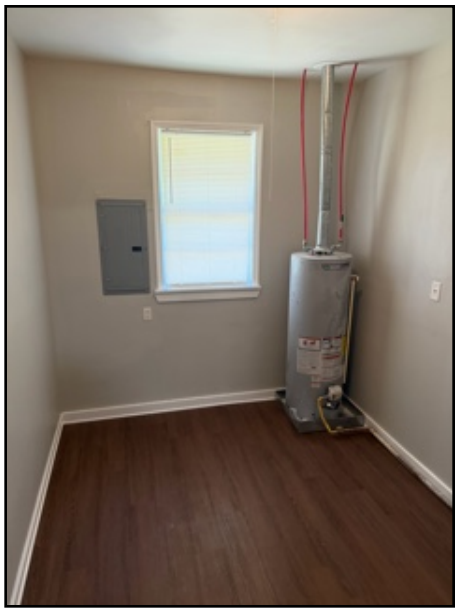
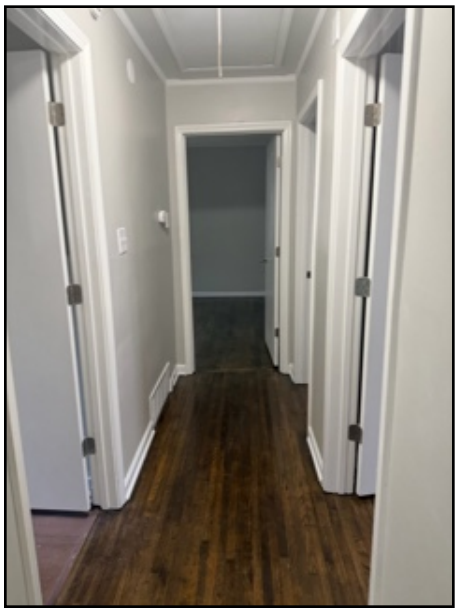
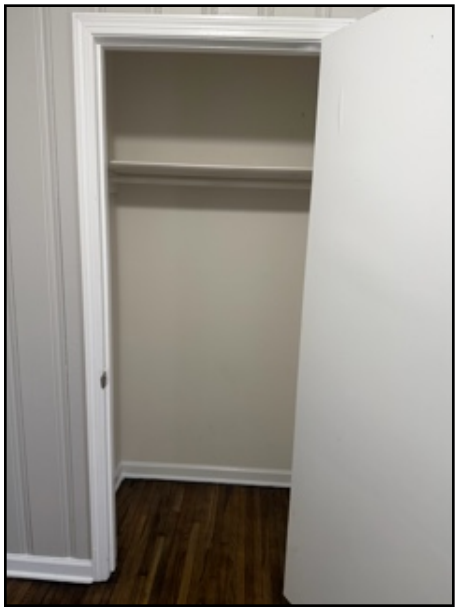
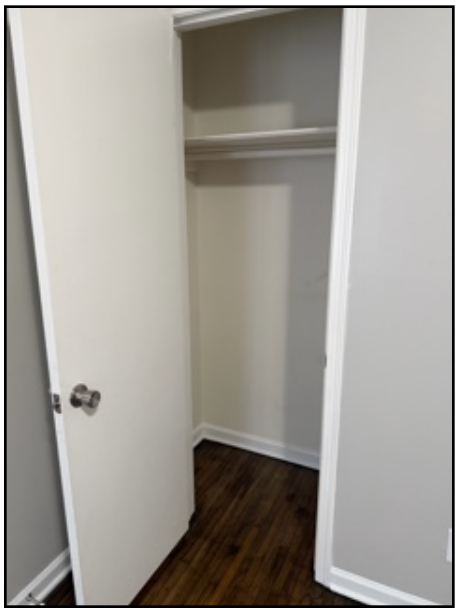
Comment 16:
General pictures of Living room, dining area, bedrooms and closets.

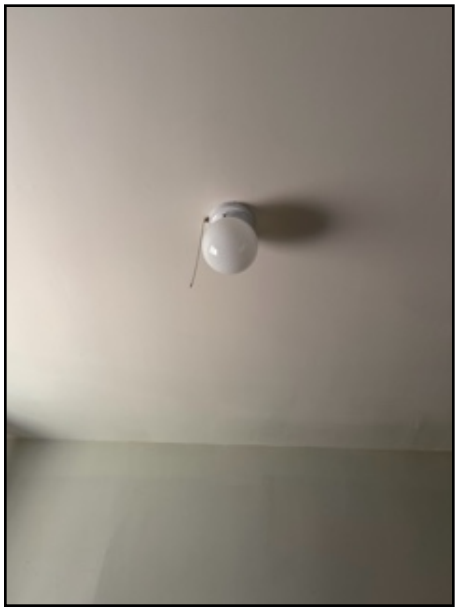
Figure 17-1

Comment 17:
overhead light in laundry area needs longer chain installed.

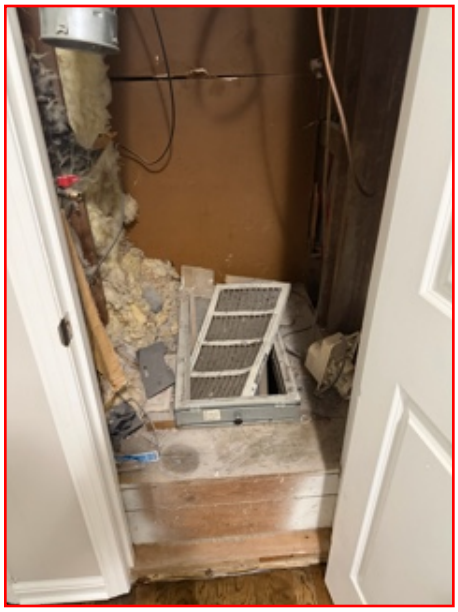
Figure 9-1

4) no furnace installed at time of inspection.

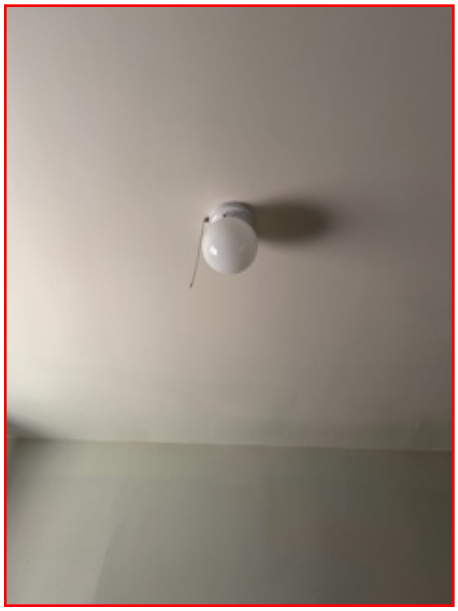
Figure 17-1

7) overhead light in laundry area needs longer chain installed.
