Midsouth Home Inspections
1280 River Hollow Cove
Cordova, TN 38016
(901) 336-3551
midsouthhomeinspections.com
diley123@yahoo.com
Inspected By: Dan Iley

Home Inspection Report

630
Mohawk
Memphis, Tn 38109

Inspected on Mon, Sep 21 2026 at 11:45AM

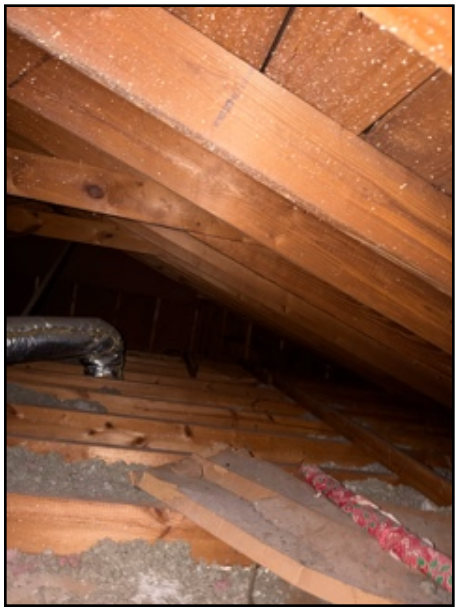
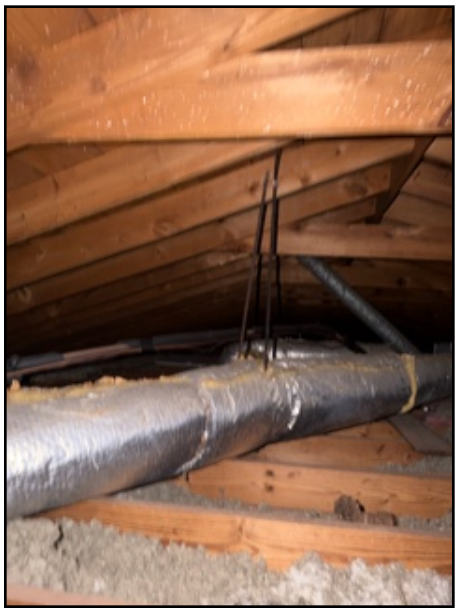
Comment 5:
Attic is in good condition.. Framing is sound and there is no evidence of leaks

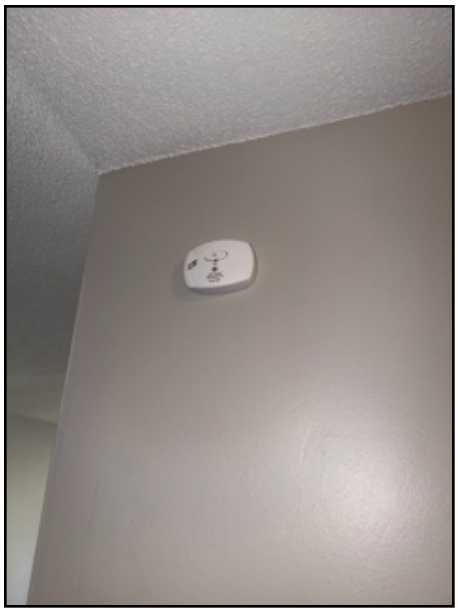
Figure 7-1

Comment 7:
carbon monoxide detector is installed but should be installed around light switch height.

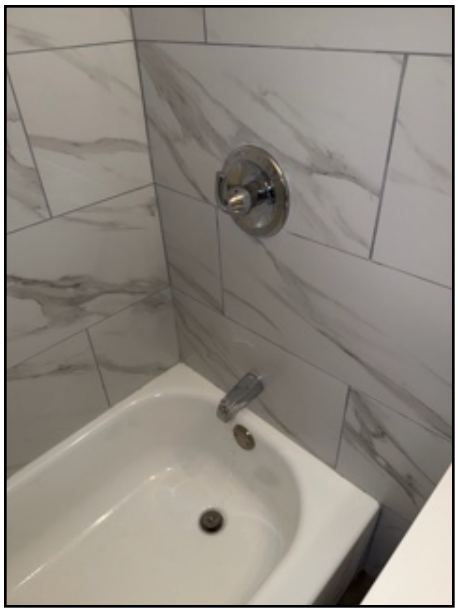
Figure 12-1

Comment 12:
shower valve not operating at time inspection Also, when hot water heater is operating normally Plumber should check for proper hot water temperature.

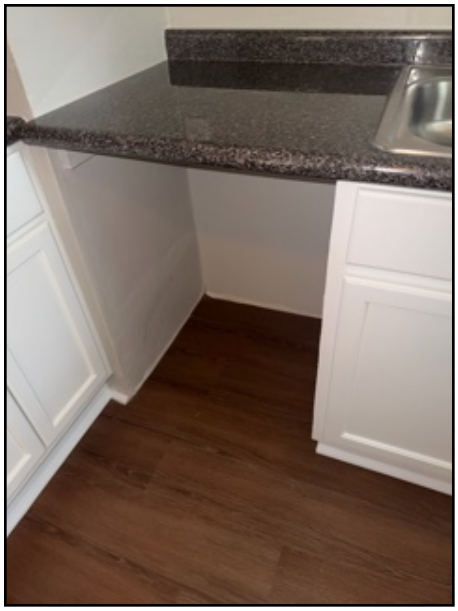
Figure 14-1

Comment 14:
no dishwasher installed at time of inspection.

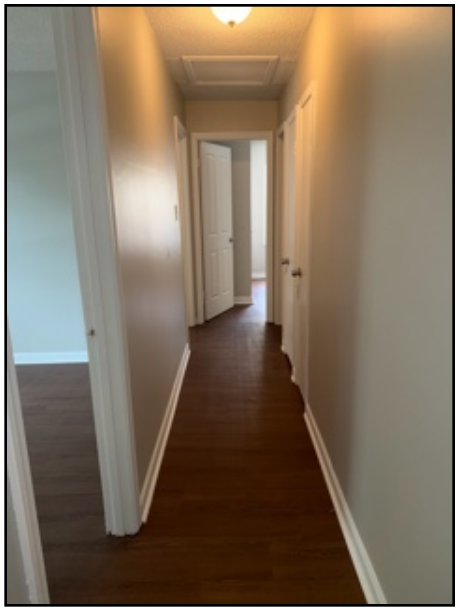
Figure 16-2

Comment 16:
General pictures of Living room, dining area, bedrooms and closets.

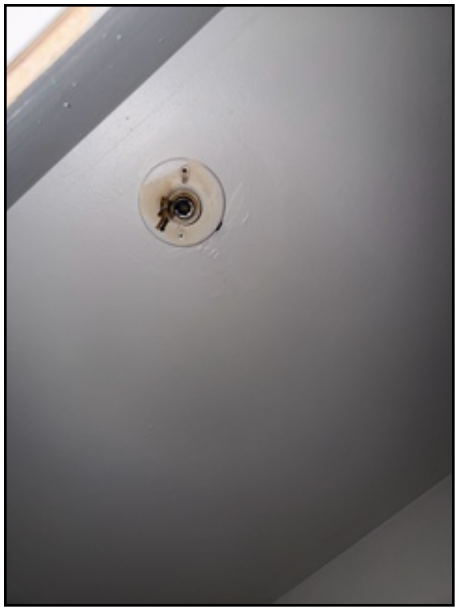
Figure 17-1

Comment 17:
lightbulb needed in living room closet.

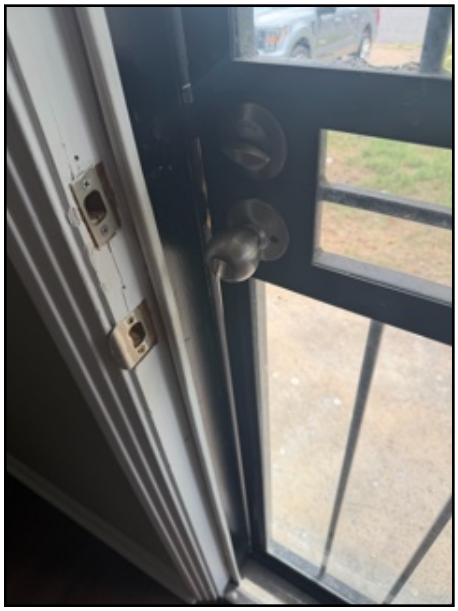
Figure 18-1

Comment 18:
Front security door will not latch.

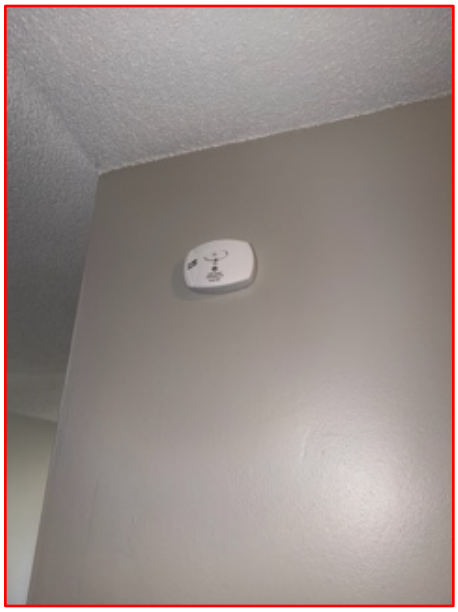
Figure 7-1

1) carbon monoxide detector is installed but should be installed around light switch height.

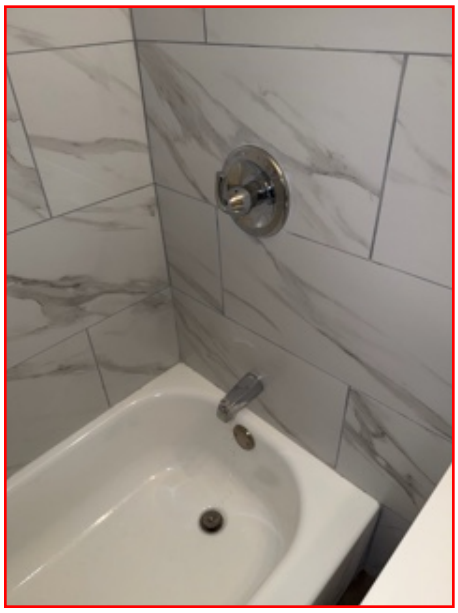
Figure 12-1

5) shower valve not operating at time inspection Also, when hot water heater is operating normally Plumber should check for proper hot water temperature.

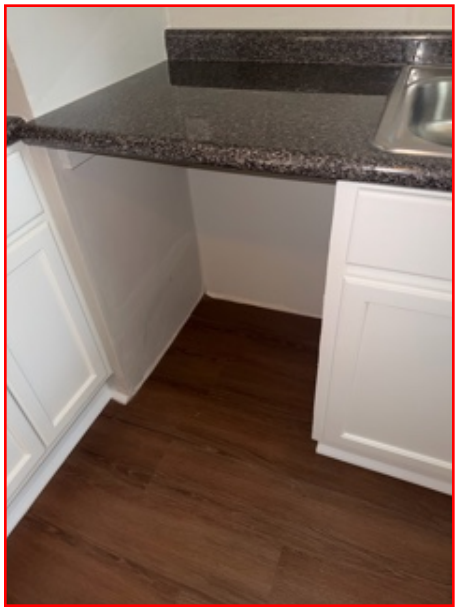
Figure 14-1

6) no dishwasher installed at time of inspection.

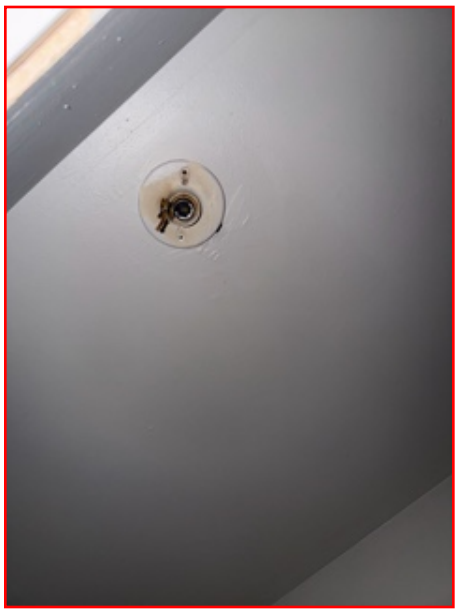
Figure 17-1

7) lightbulb needed in living room closet.

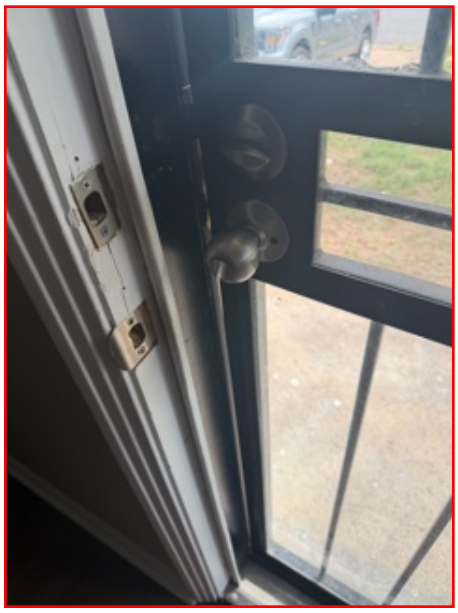
Figure 18-1

8) Front security door will not latch.
