Midsouth Home Inspections
1280 River Hollow Cove
Cordova, TN 38016
(901) 336-3551
midsouthhomeinspections.com
diley123@yahoo.com
Inspected By: Dan Iley

Home Inspection Report

1950
Corning
Memphis, Tn 38127

Inspected on Fri, Aug 28 2026 at 10:15AM

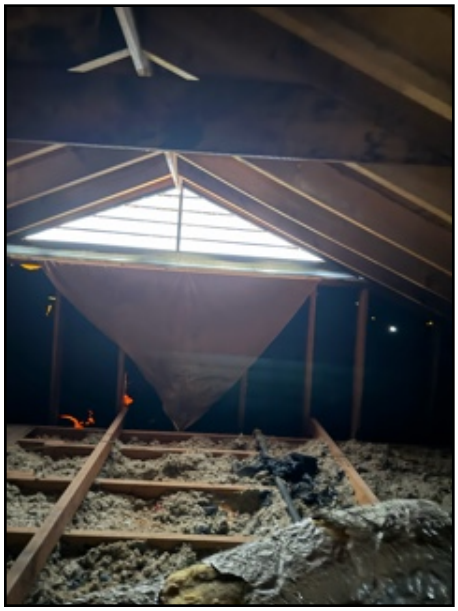
Figure 6-1

Comment 6:
Attic is in good condition.. Framing is sound and there is no evidence of leaks

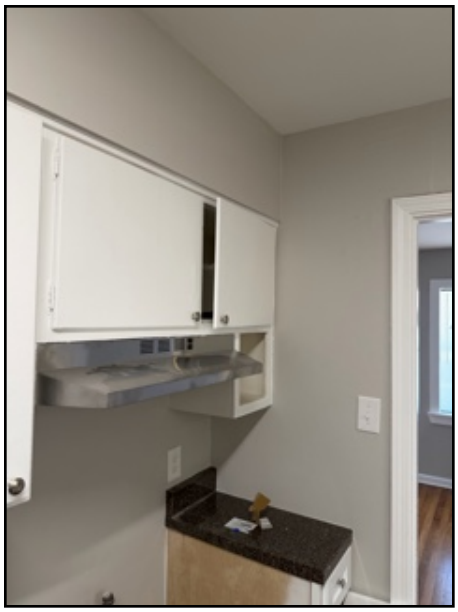
Figure 15-1

Comment 15:
cabinet door will not stay shut in kitchen.

6) cabinet door will not stay shut in kitchen.

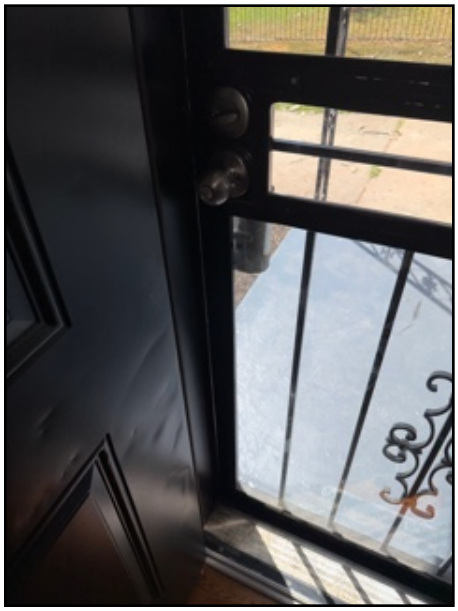
Figure 21-1

Comment 21:
Air gap noted around front security door.

10) Air gap noted around front security door.
