## Home Inspection Report

**4225**

**Arrowhead**

**Memphis, Tn 38118**

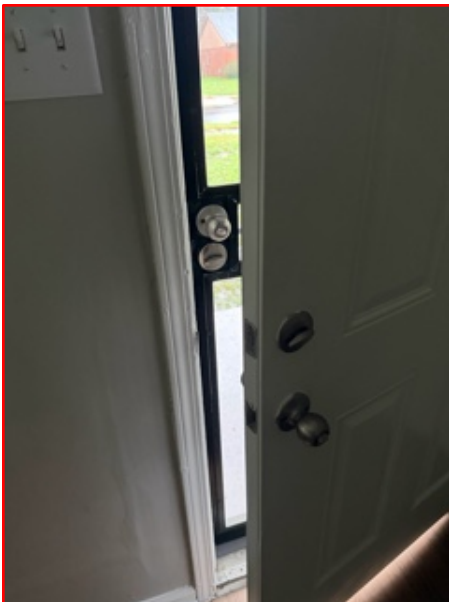
Figure 4-1

2) no doorbell installed at time of inspection.

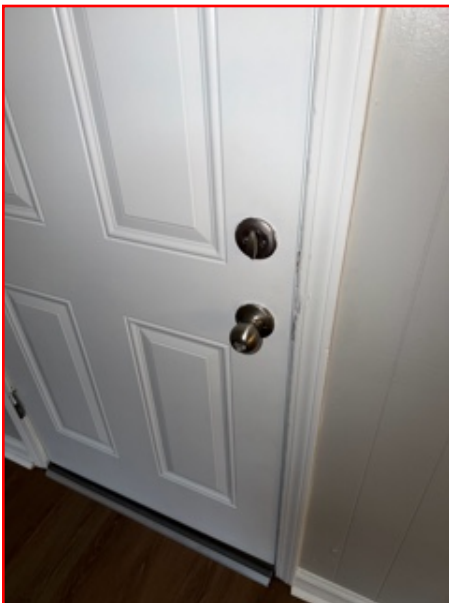
Figure 18-1

9) door leading to carport will not open.
